Lido Pump Station Sewage Spill

Operations
Committee

December 7, 2022

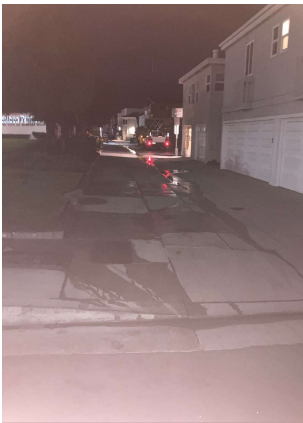
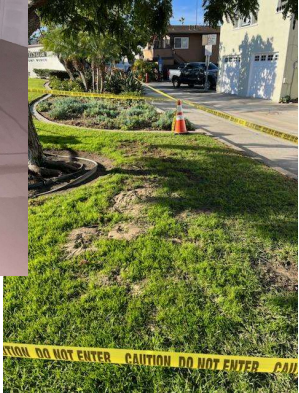
- West force main was in operation
- Wednesday (11/2/22) - Switched from West to East force main
- Friday (11/4/22) - Leak reported, standby crew responded and approx. 10,000 gallons spilled
 - Standby crew switched back to West force main, leak stopped
- Currently operating with West force main

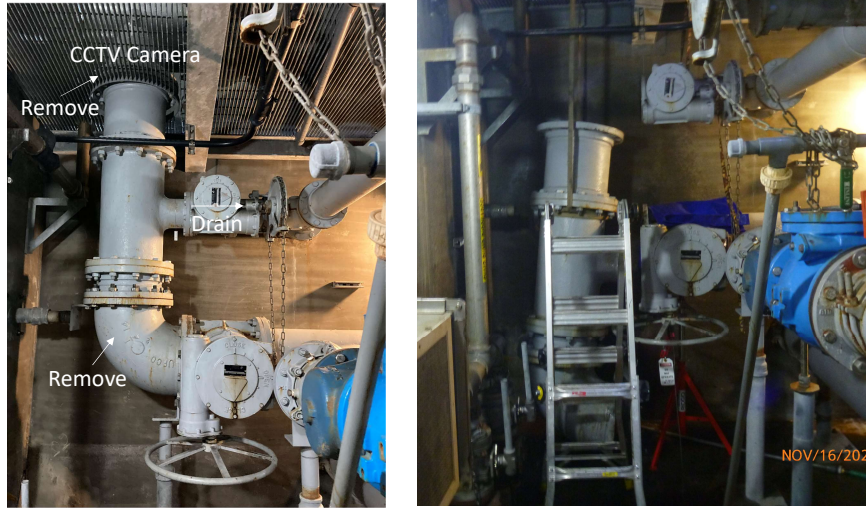
Piping below the force main was removed to provide access for CCTV on 11/16/2022

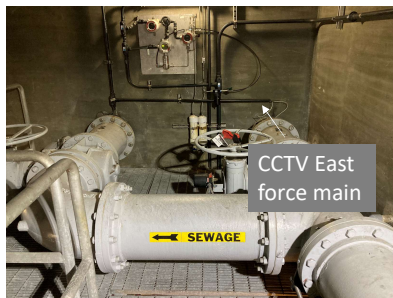
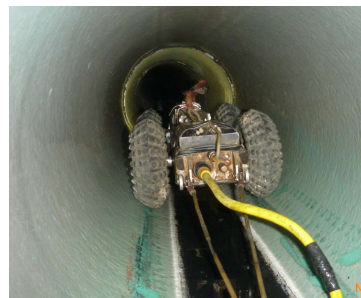
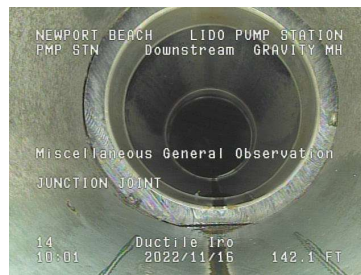
- Initial CCTV was performed on 11/16/22 to locate break
- Approximately 142 feet of East force main was inspected
- Inspection stops at a junction joint
- Additional 416 feet of CCTV was performed from where pipe was excavated and removed

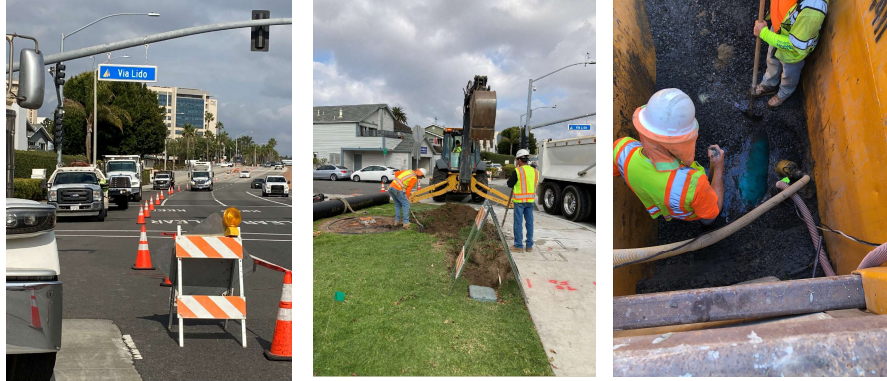
- Opened a project to repair the pipe
- Setup Traffic Control
- Excavate to further assess the external pipe condition
