2021 Asset Management Plan

“OC San will know the condition of assets we own and will have a plan to operate and maintain these assets to deliver the required level of service, at the lowest life cycle cost, with an acceptable level of risk.”

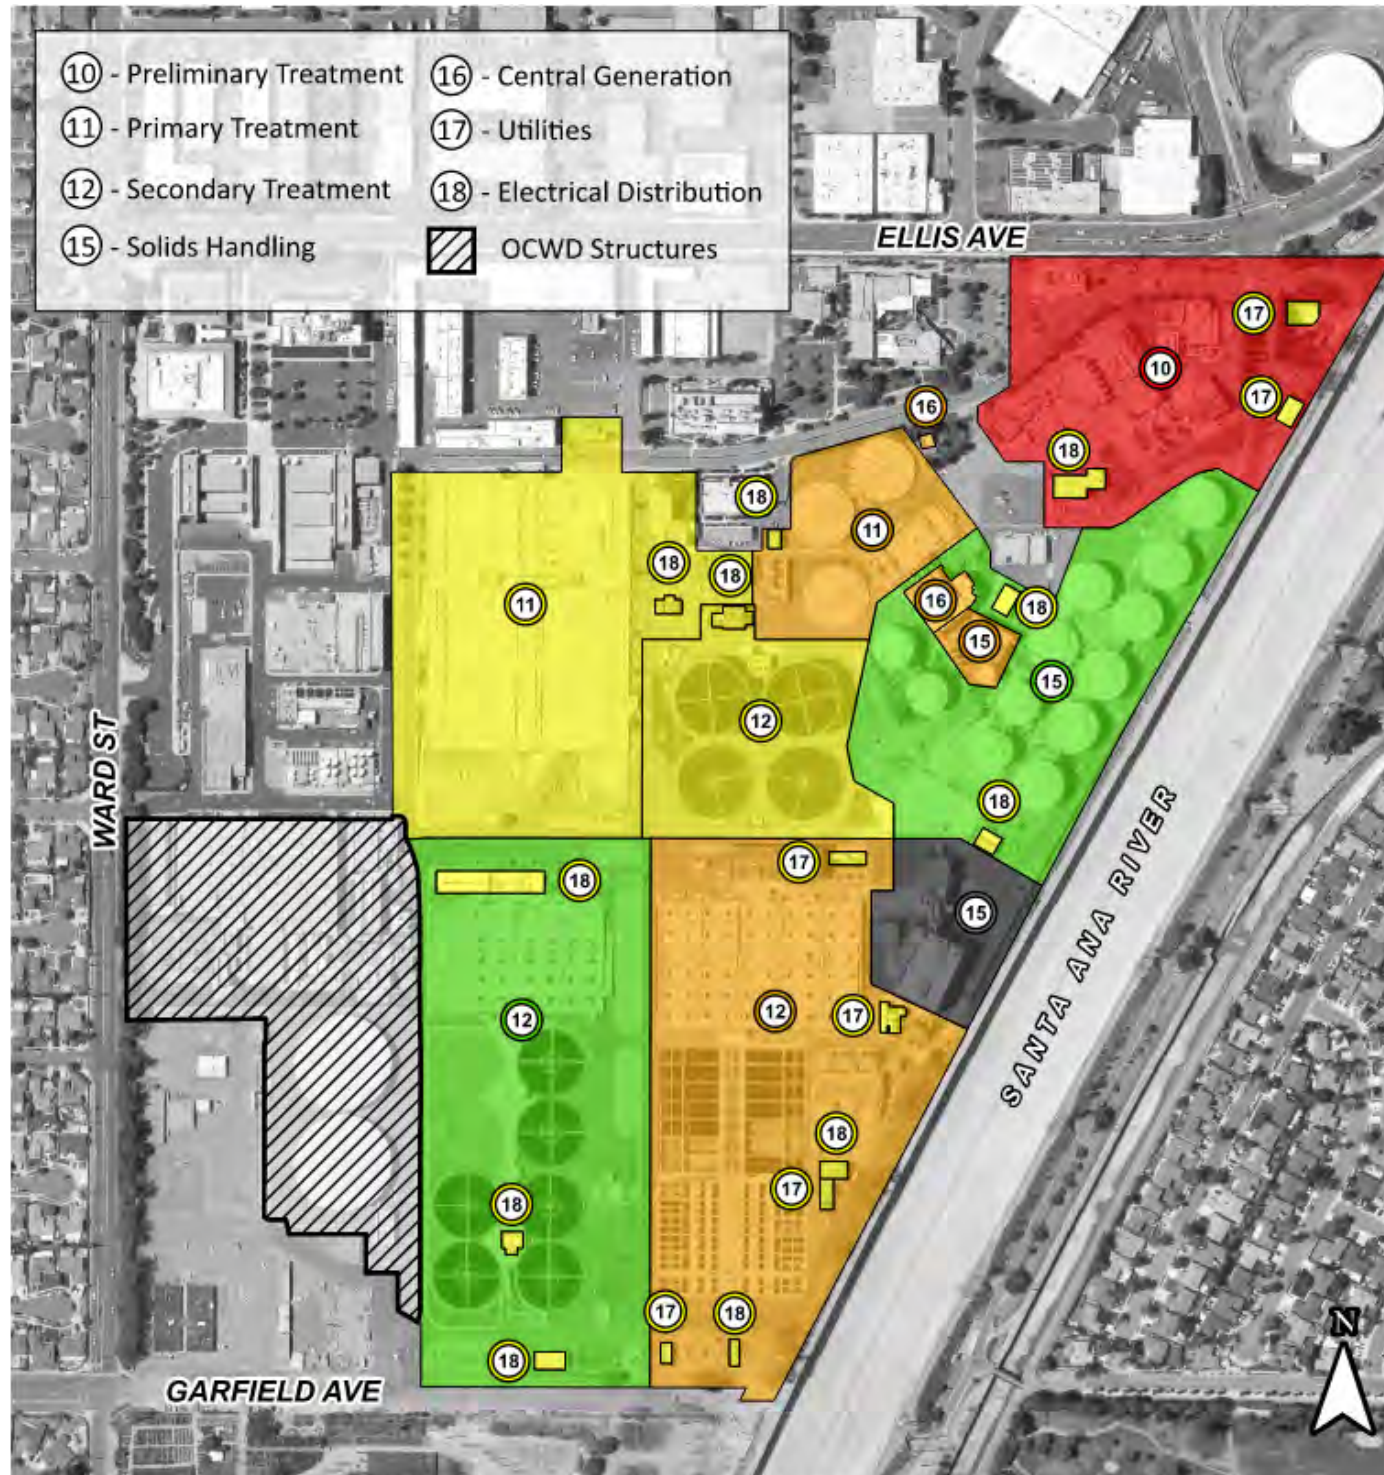
Figure ES-1-3. Plant No. 1 Process Area – Remaining Useful Life Score Map

Area No.	Area Name	Average Remaining Useful Life Score						Percentage of RUL Scores with 4s or 5s	Replacement Value (\$ Millions, in 2021 Dollars)	
		Civil	Structural	Mechanical	Electrical	Instrumentation	All Assets			
10	Preliminary Treatment	2	3	5	5	5	5	67%	\$386.9	
11	Primary Treatment - Basins (1-5)	4	2	4	5	5	4	67%	\$107.2	
11	Primary Treatment - Basins (6-31)	4	2	3	3	3	3	20%	\$390.3	
12	Secondary Treatment - Activated Sludge 1	3	3	4	4	5	4	51%	\$604.1	
12	Secondary Treatment - Activated Sludge 2	1	1	2	3	2	2	13%	\$373.4	
12	Secondary Treatment - Tricking Filter	1	1	3	4	3	3	7%	\$67.8	
14	Interplant	2	2	2	2		2	17%	\$752.6	
15	Solids Handling - Digesters	2	1	2	2	2	2	3%	\$254.7	
15	Solids Handling - T&D Facilities	1	1	1	2	1	1	0%	\$190.2	
15	Solids Handling - Gas Handling	3	4	4	4	5	4	67%	\$37.3	
16	Central Generation ^a		3	3	4	4	4	46%	\$170.5	
17	Utilities	3	3	3	2	2	3	0%	\$194.2	
18	Electrical Distribution ^a				3		3	42%	\$81.6

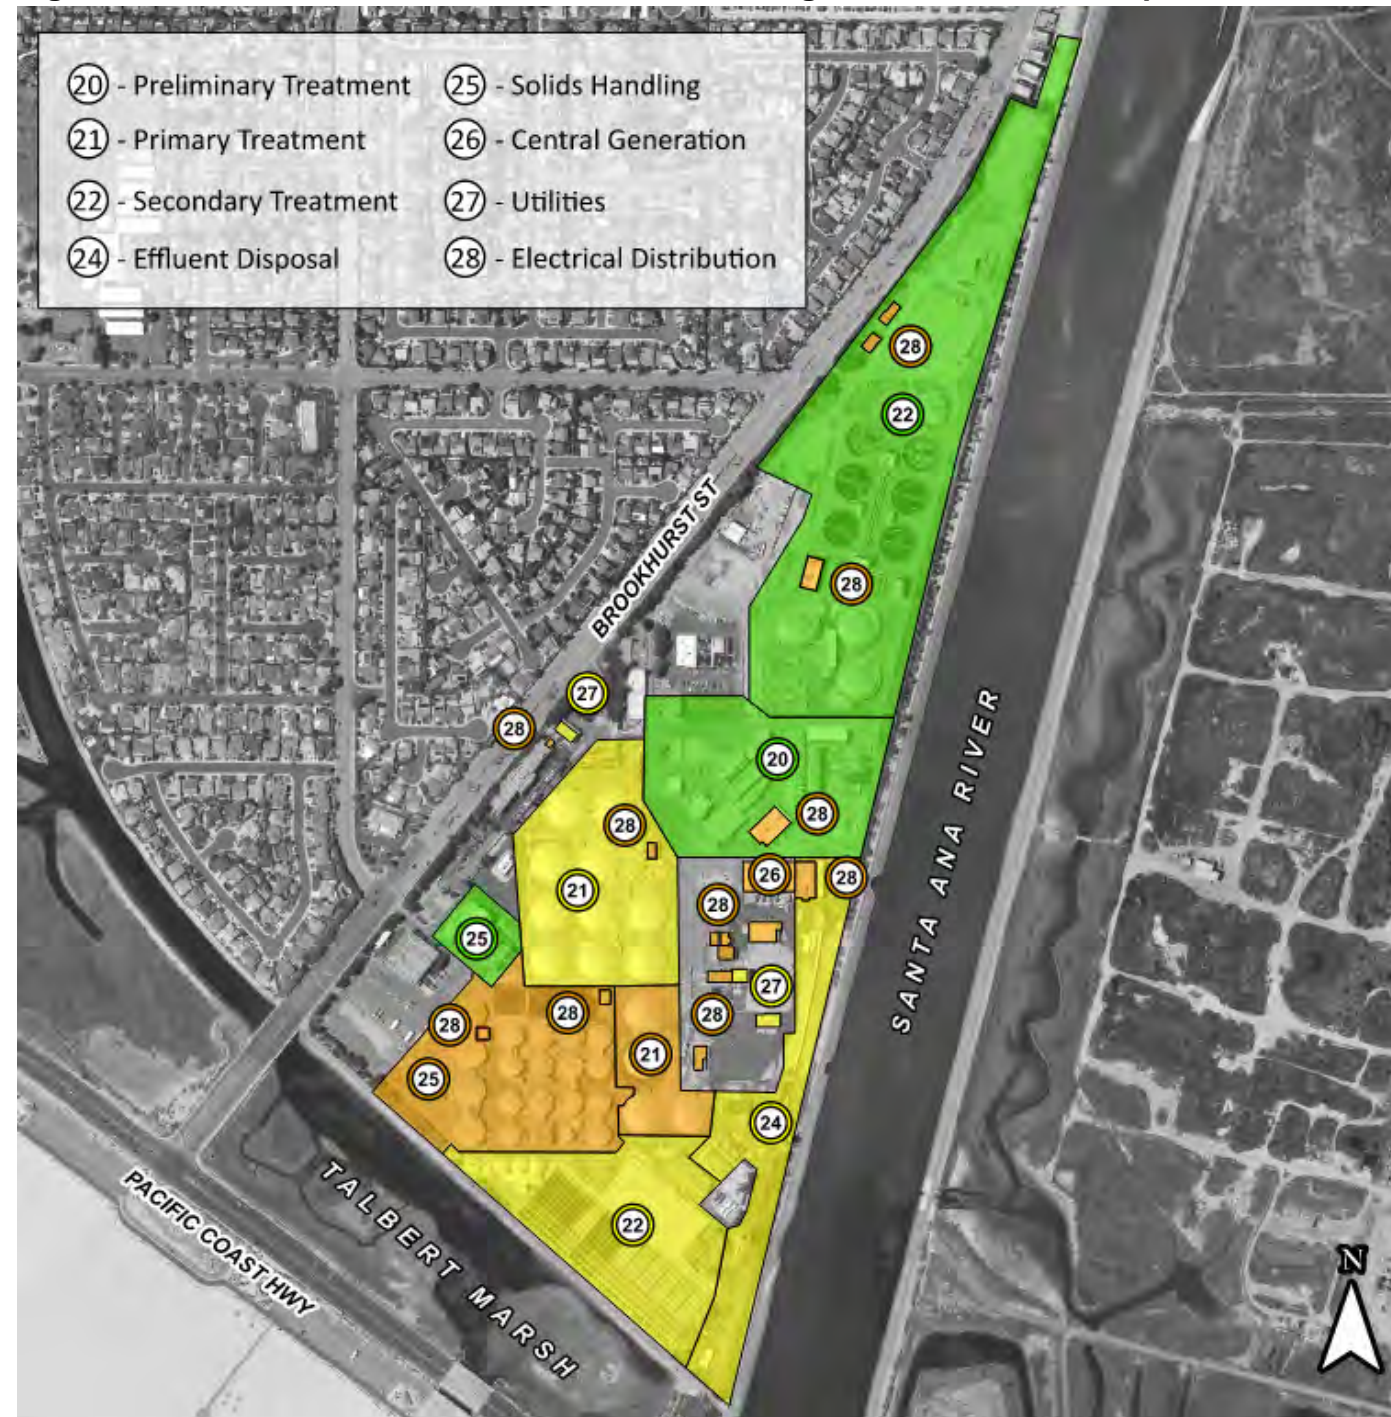
Figure ES-1-4. Plant No. 2 Process Area – Remaining Useful Life Score Map

Area No.	Area Name	Average Remaining Useful Life Score						Percentage of RUL Scores with 4s or 5s	Replacement Value (\$ Millions, in 2021 Dollars)	
		Civil	Structural	Mechanical	Electrical	Instrumentation	All Assets			
20	Preliminary Treatment	1	1	2	2	2	2	2%	\$357.6	
21	Primary Treatment - A-Side	5	4	4	3	3	4	57%	\$166.8	
21	Primary Treatment - B- & C-Side	3	3	3	3	3	3	4%	\$333.6	
22	Secondary Treatment - Activated Sludge	3	3	3	4	3	3	20%	\$612.6	
22	Secondary Treatment - DAFT	4	1	3	3	3	3	9%	\$57.7	
22	Secondary Treatment - Trickling Filter	2	1	2	3	3	2	5%	\$342.4	
24	Effluent Disposal	2	2	3	3	4	3	21%	\$900.2	
25	Solids Handling - Digesters	3	4	4	4	4	4	72%	\$355.5	
25	Solids Handling - Facilities	2	1	2	2	2	2	5%	\$184.6	
25	Solids Handling - Gas Handling	3	3	4	4	4	4	33%	\$37.3	
26	Central Generation ^a		3	4	4	4	4	70%	\$363.8	
27	Utilities	3	3	3	3	2	3	0%	\$108.3	
28	Electrical Distribution ^a				4		4	65%	\$80.1

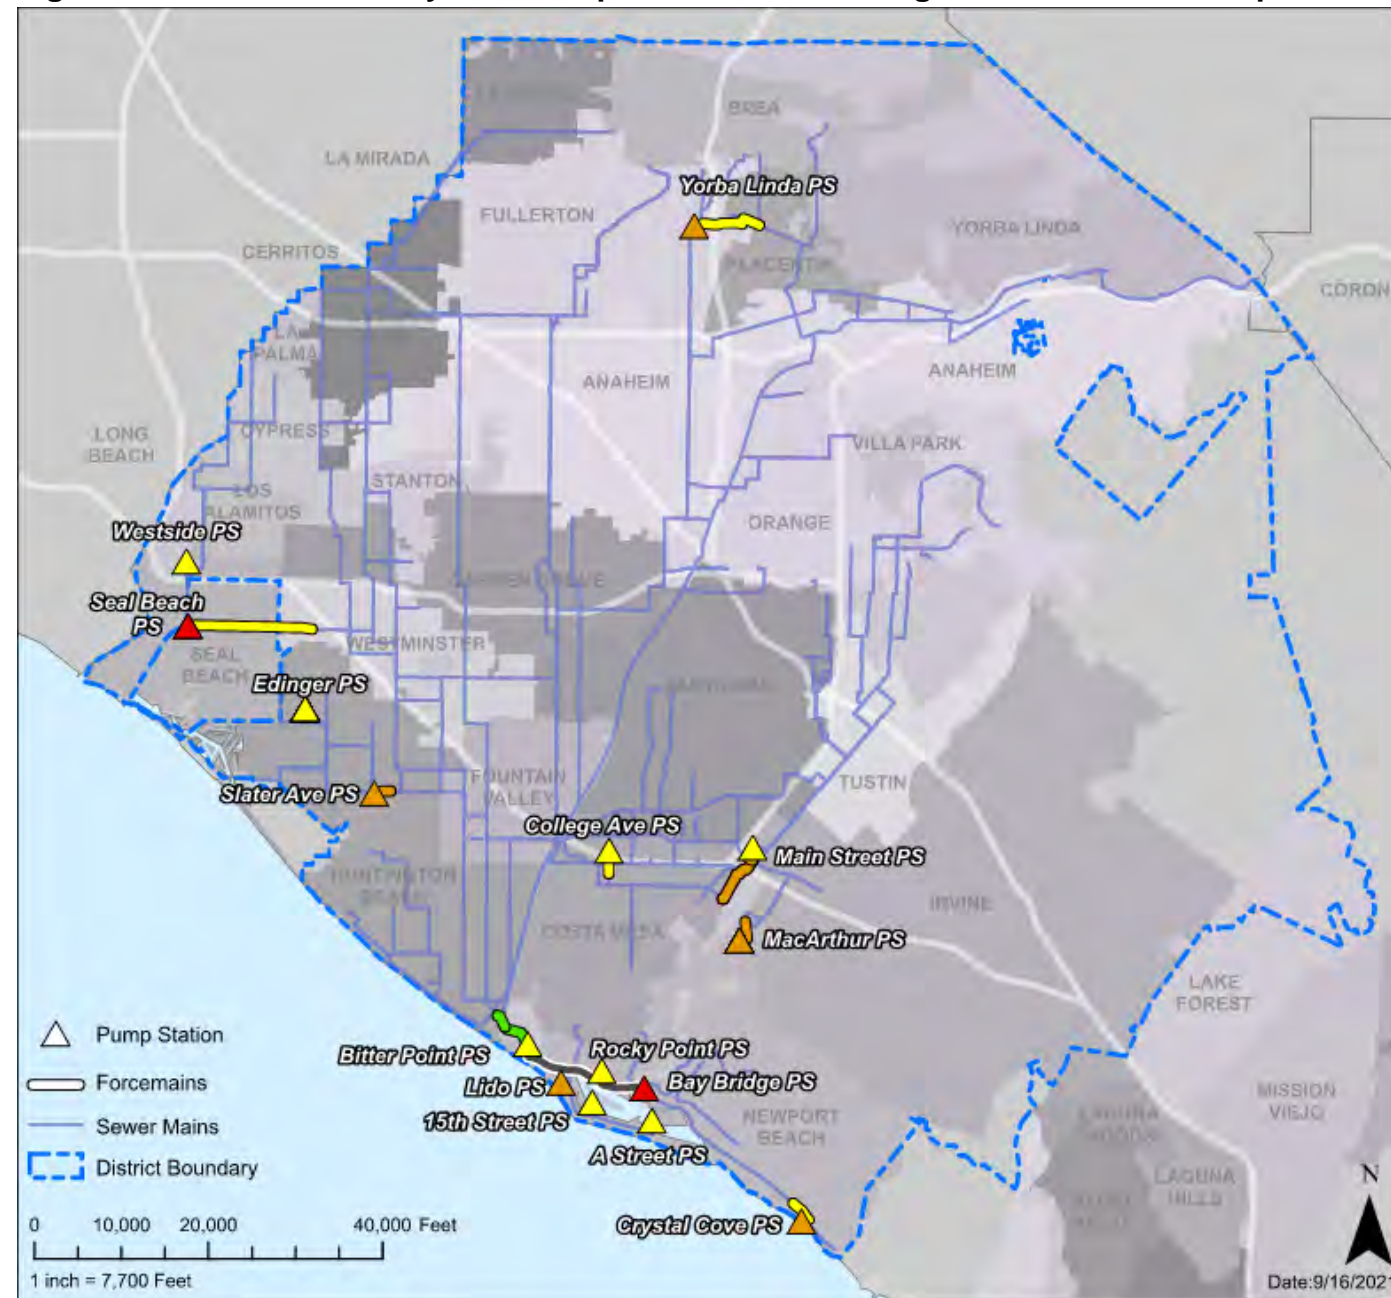
Figure ES-1-5. Collection System Pump Station – Remaining Useful Life Score Map

Service Area	Pump Station	Average Remaining Useful Life Score					Percentage of RUL Scores with 4s or 5s	Replacement Value (\$ Millions, in 2021 Dollars)	
		Civil	Structural	Mechanical	Electrical	Instrumentation			All Assets
5	15th Street	3	4	3	3	2	3	25%	\$14.8
5	A Street	3	4	4	3	2	3	25%	\$12.9
5	Bay Bridge	4	4	5	4	5	5	85%	\$37.5
5	Bitter Point	2	3	4	2	2	3	23%	\$35.5
6	College	3	3	3	2	2	3	8%	\$26.4
5	Crystal Cove	3	3	4	4	3	4	33%	\$2.8
11	Edinger	4	3	3	3	3	3	27%	\$14.2
5	Lido	1	4	4	4	4	4	50%	\$22.2
7	MacArthur	4	4	4	4	2	4	64%	\$18.0
7	Main Street	4	3	4	3	3	3	46%	\$48.4
5	Rocky Point	1	4	4	2	2	3	23%	\$17.6
11	Slater	4	4	4	3	3	4	31%	\$38.8
3	Seal Beach	3	4	5	5	4	5	83%	\$45.8
3	Westside	3	3	3	2	3	3	8%	\$33.7
2	Yorba Linda	3	4	4	3	3	4	36%	Not Valued
5	Newport Force Mains ^a	1	-	-	-	-	1	0%	-
Collection PS Total								38%	\$368.6

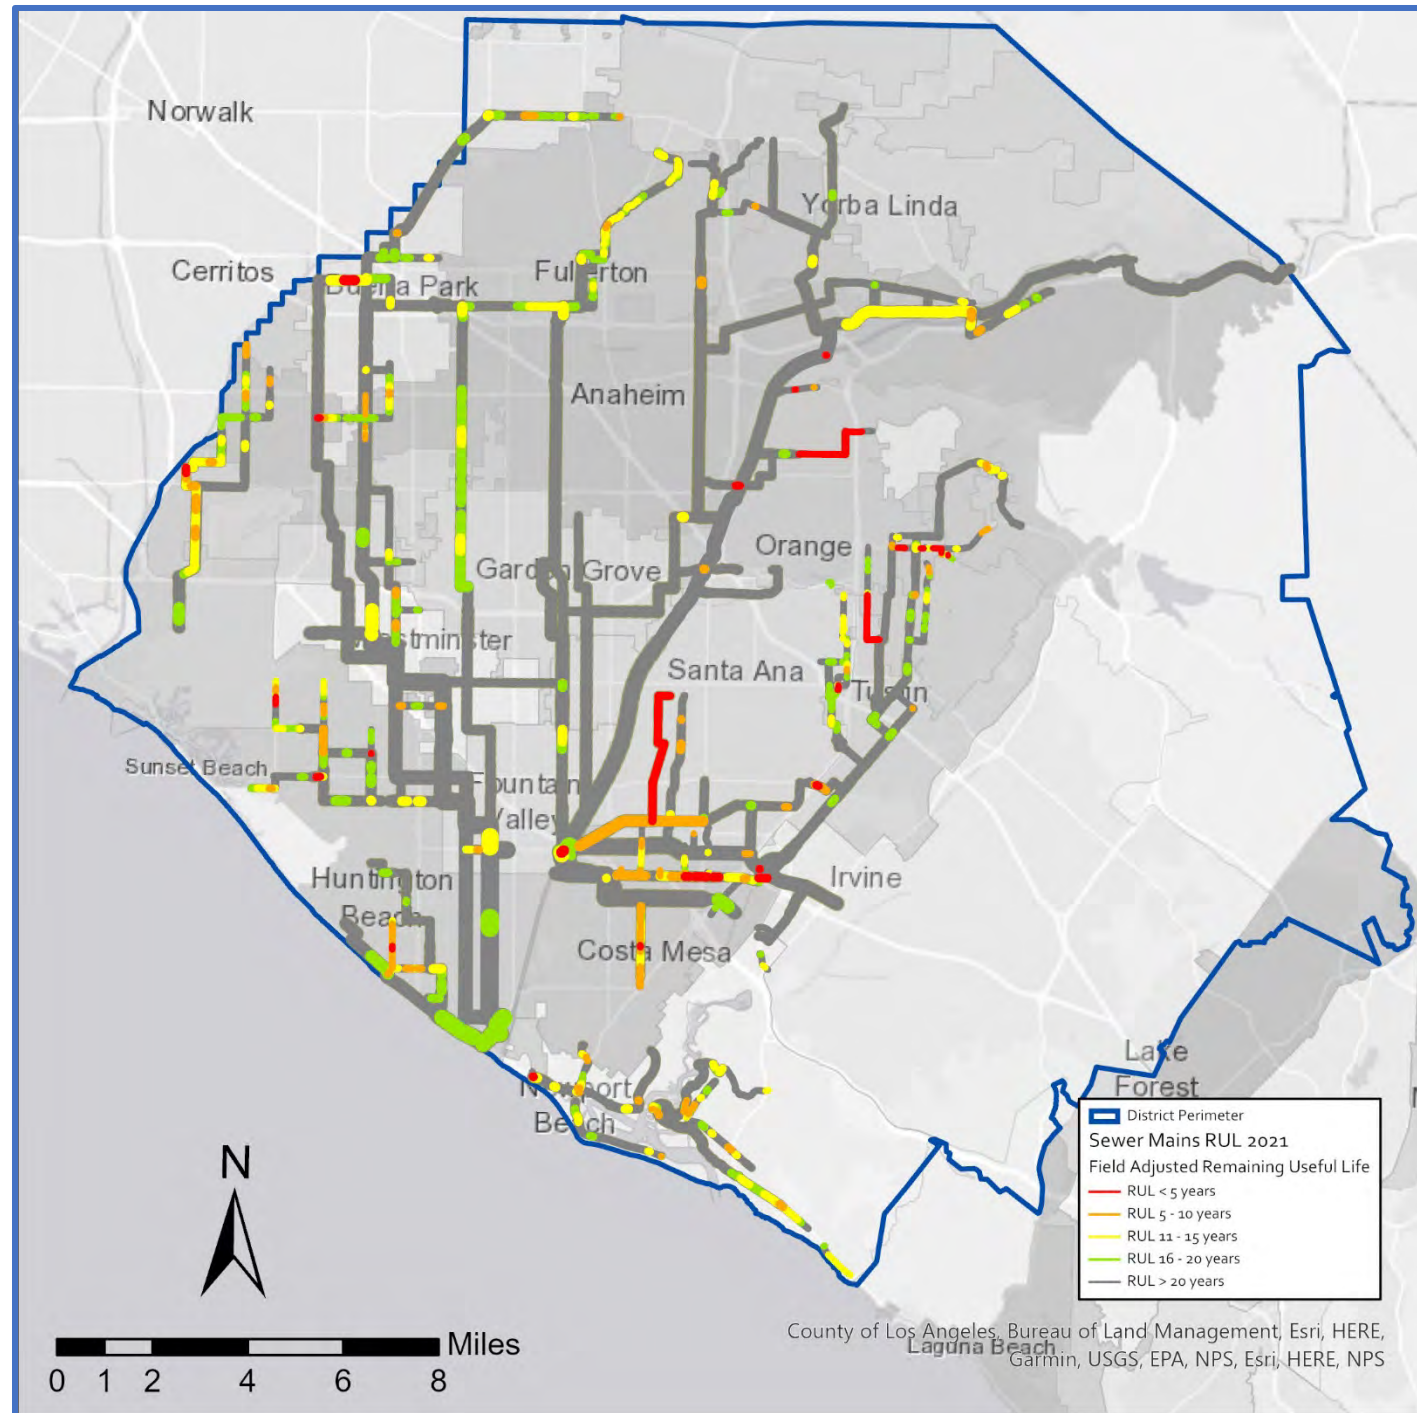
Figure ES-1-6. Collection System Pipelines – Remaining Useful Life Score Map

Trunklines	No. of Pipes with RUL Scores of 4 or 5	Miles of Pipes with RUL Scores of 4 or 5	Percentage of RUL Scores with 4s or 5s (By Length)	Replacement Value (\$ Millions, in 2021 Dollars) ^a
Baker-Main	74	5.62	14%	\$303.6
Bushard	0	0.00	0%	\$266.2
Coast	17	1.11	10%	\$108.6
Euclid	1	0.10	0%	\$297.4
Interplant	0	0.00	0%	\$127.1
Knott	37	3.23	5%	\$688.6
Miller-Holder	7	0.71	2%	\$326.3
Newhope	4	0.25	1%	\$230.3
Newport	17	0.82	4%	\$238.3
SARI	40	2.11	4%	\$568.6
Sunflower	12	0.72	2%	\$330.4
Talbert	74	5.86	70%	\$63.5
Total	283	20.53	6%	\$3,548.9

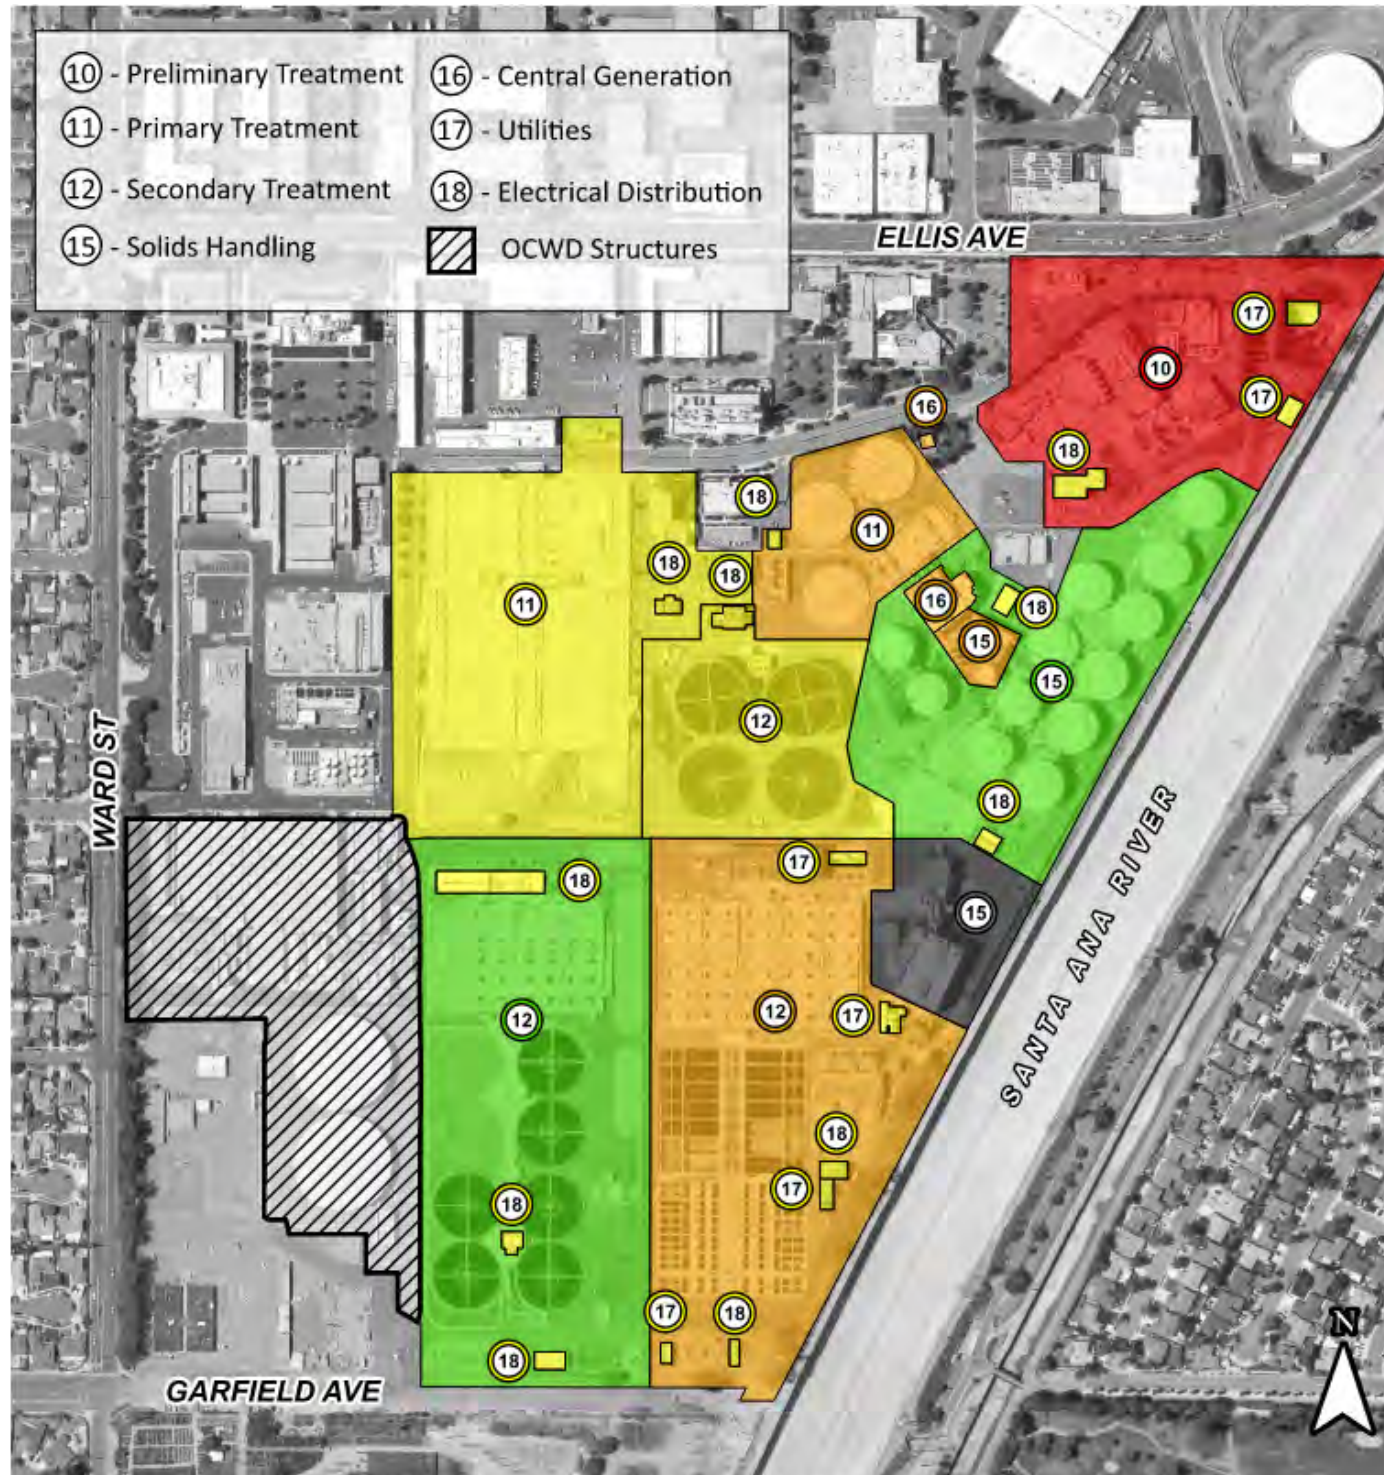
Figure 2-1. Plant No. 1 Process Area – Remaining Useful Life Score Map

Area No.	Area Name	Average Remaining Useful Life Score						Percentage of RUL Scores with 4s or 5s	Replacement Value (\$ Millions, in 2021 Dollars)
		Civil	Structural	Mechanical	Electrical	Instrumentation	All Assets		
10	Preliminary Treatment	2	3	5	5	5	5	67%	\$386.9
11	Primary Treatment - Basins (1-5)	4	2	4	5	5	4	67%	\$107.2
11	Primary Treatment - Basins (6-31)	4	2	3	3	3	3	20%	\$390.3
12	Secondary Treatment - Activated Sludge 1	3	3	4	4	5	4	51%	\$604.1
12	Secondary Treatment - Activated Sludge 2	1	1	2	3	2	2	13%	\$373.4
12	Secondary Treatment - Trickling Filter	1	1	3	4	3	3	7%	\$67.8
14	Interplant	2	2	2	2		2	17%	\$752.6
15	Solids Handling - Digesters	2	1	2	2	2	2	3%	\$254.7
15	Solids Handling - T&D Facilities	1	1	1	2	1	1	0%	\$190.2
15	Solids Handling - Gas Handling	3	4	4	4	5	4	67%	\$37.3
16	Central Generation ^a		3	3	4	4	4	46%	\$170.5
17	Utilities	3	3	3	2	2	3	0%	\$194.2
18	Electrical Distribution ^a				3		3	42%	\$81.6

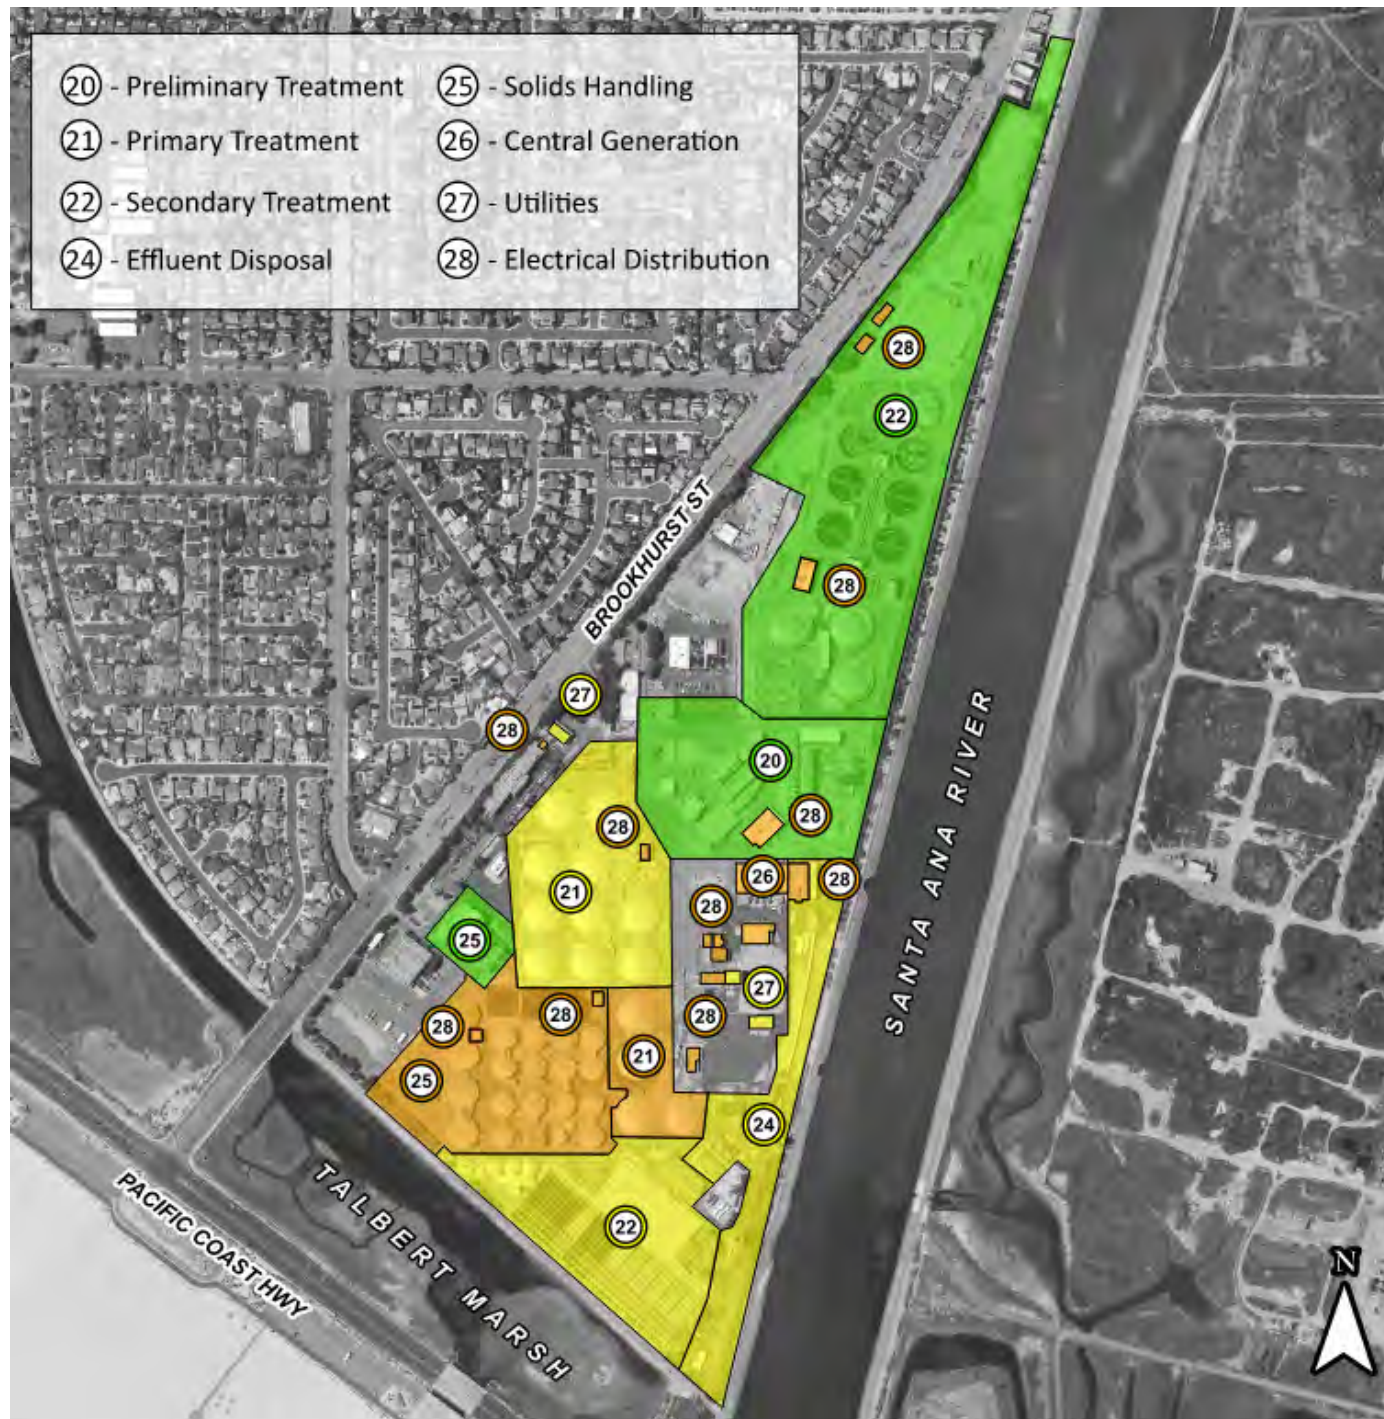
Figure 2-2. Plant No. 2 Process Area – Remaining Useful Life Score Map

Area No.	Area Name	Average Remaining Useful Life Score						Percentage of RUL Scores with 4s or 5s	Replacement Value (\$ Millions, in 2021 Dollars)	
		Civil	Structural	Mechanical	Electrical	Instrumentation	All Assets			
20	Preliminary Treatment	1	1	2	2	2	2	2%	\$357.6	
21	Primary Treatment - A-Side	5	4	4	3	3	4	57%	\$166.8	
21	Primary Treatment – B- & C-Side	3	3	3	3	3	3	4%	\$333.6	
22	Secondary Treatment - Activated Sludge	3	3	3	4	3	3	20%	\$612.6	
22	Secondary Treatment - DAFT	4	1	3	3	3	3	9%	\$57.7	
22	Secondary Treatment - Trickling Filter	2	1	2	3	3	2	5%	\$342.4	
24	Effluent Disposal	2	2	3	3	4	3	21%	\$900.2	
25	Solids Handling - Digesters	3	4	4	4	4	4	72%	\$355.5	
25	Solids Handling - Facilities	2	1	2	2	2	2	5%	\$184.6	
25	Solids Handling - Gas Handling	3	3	4	4	4	4	33%	\$37.3	
26	Central Generation ^a		3	4	4	4	4	70%	\$363.8	
27	Utilities	3	3	3	3	2	3	0%	\$108.3	
28	Electrical Distribution ^a				4		4	65%	\$80.1

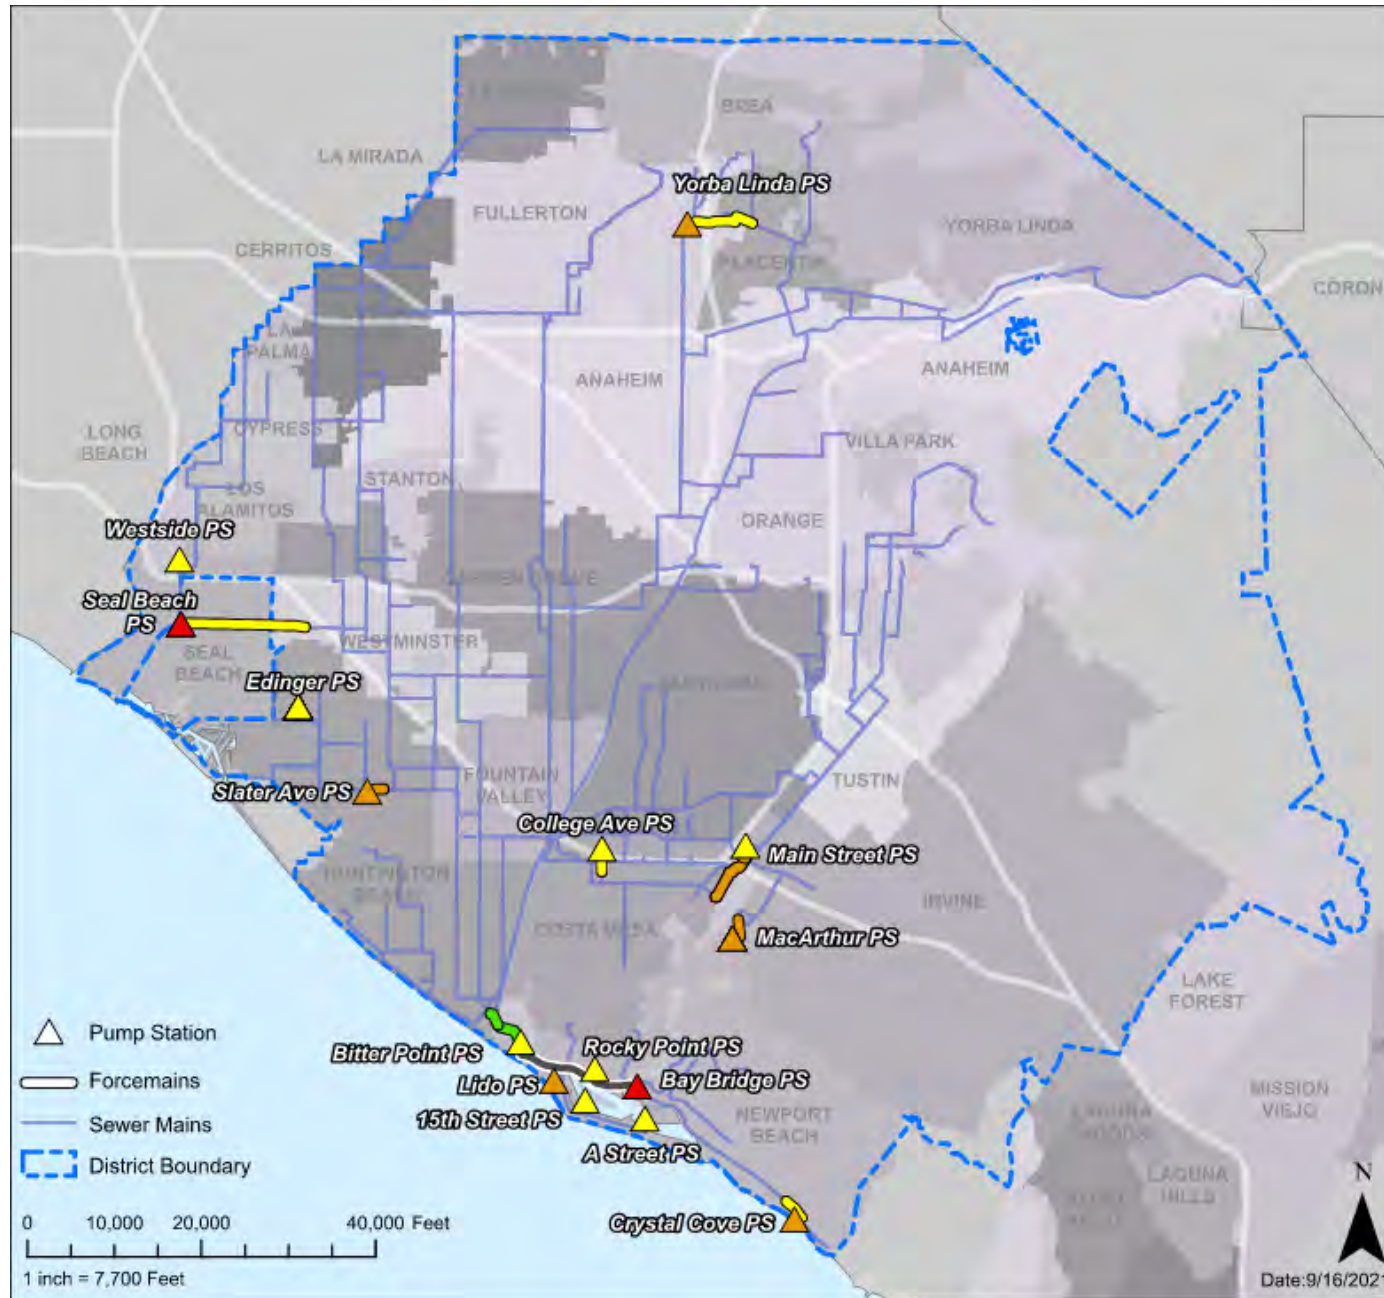
Figure 2-3. Collection System Pump Station – Remaining Useful Life Score Map

Service Area	Pump Station	Average Remaining Useful Life Score					Percentage of RUL Scores with 4s or 5s	Replacement Value (\$ Millions, in 2021 Dollars)	
		Civil	Structural	Mechanical	Electrical	Instrumentation			All Assets
5	15th Street	3	4	3	3	2	3	25%	\$14.8
5	A Street	3	4	4	3	2	3	25%	\$12.9
5	Bay Bridge	4	4	5	4	5	5	85%	\$37.5
5	Bitter Point	2	3	4	2	2	3	23%	\$35.5
6	College	3	3	3	2	2	3	8%	\$26.4
5	Crystal Cove	3	3	4	4	3	4	33%	\$2.8
11	Edinger	4	3	3	3	3	3	27%	\$14.2
5	Lido	1	4	4	4	4	4	50%	\$22.2
7	MacArthur	4	4	4	4	2	4	64%	\$18.0
7	Main Street	4	3	4	3	3	3	46%	\$48.4
5	Rocky Point	1	4	4	2	2	3	23%	\$17.6
11	Slater	4	4	4	3	3	4	31%	\$38.8
3	Seal Beach	3	4	5	5	4	5	83%	\$45.8
3	Westside	3	3	3	2	3	3	8%	\$33.7
2	Yorba Linda	3	4	4	3	3	4	36%	Not Valued
5	Newport Force Mains ^a	1	-	-	-	-	1	0%	-
Collection PS Total								38%	\$368.6

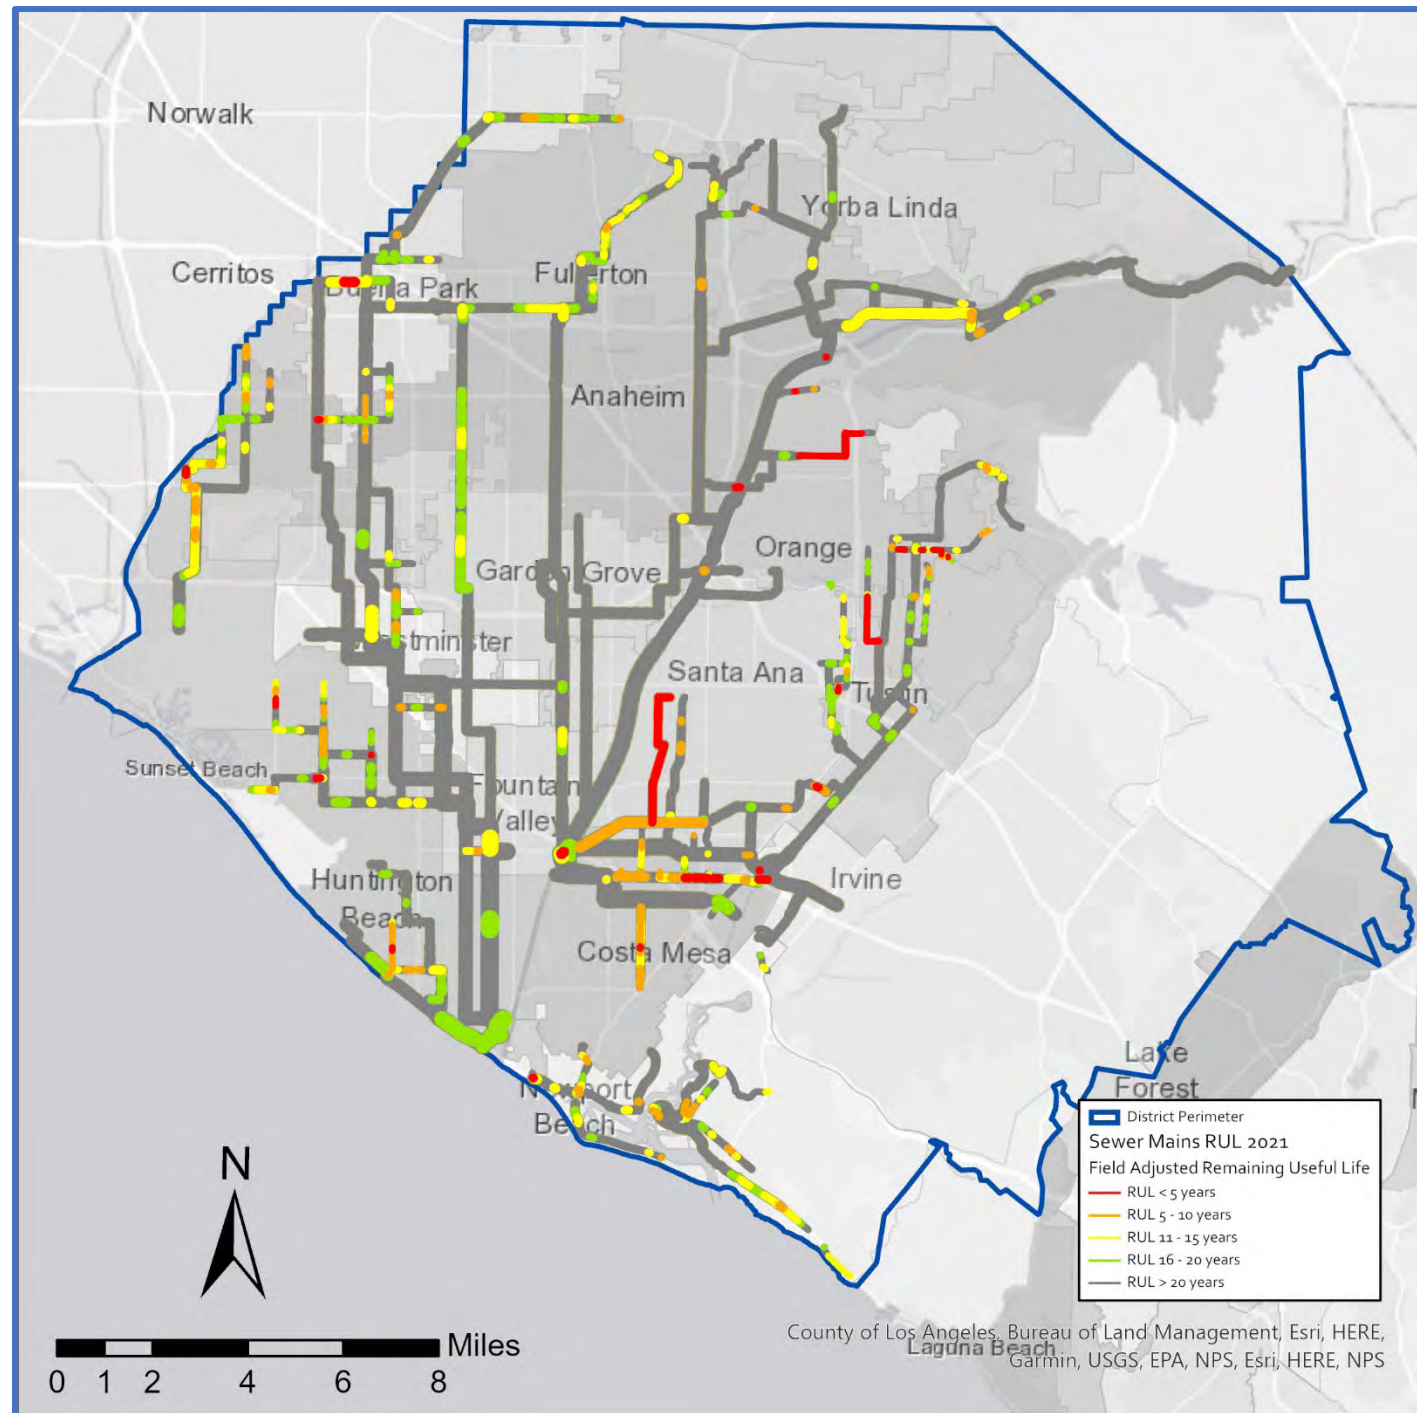
Figure 2-4. Collection System Pipelines – Remaining Useful Life Score Map

Trunklines	No. of Pipes with RUL Scores of 4 or 5	Miles of Pipes with RUL Scores of 4 or 5	Percentage of RUL Scores with 4s or 5s (By Length)	Replacement Value (\$ Millions, in 2021 Dollars) ^a
Baker-Main	74	5.62	14%	\$303.6
Bushard	0	0.00	0%	\$266.2
Coast	17	1.11	10%	\$108.6
Euclid	1	0.10	0%	\$297.4
Interplant	0	0.00	0%	\$127.1
Knott	37	3.23	5%	\$688.6
Miller-Holder	7	0.71	2%	\$326.3
Newhope	4	0.25	1%	\$230.3
Newport	17	0.82	4%	\$238.3
SARI	40	2.11	4%	\$568.6
Sunflower	12	0.72	2%	\$330.4
Talbert	74	5.86	70%	\$63.5
Total	283	20.53	6%	\$3,548.9
