Primary Clarifiers F and G Rotating Mechanism Rehabilitation at Plant No. 2, Project No. FE23-09, Specification No. S-2024-612BD

Project Scope

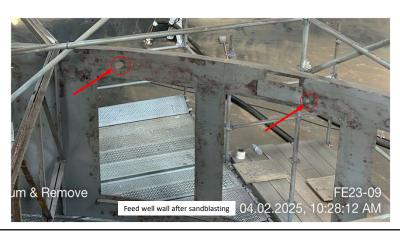
- Both Clarifiers F and G are not operational due to corrosion
- P2 does not have a redundancy for the clarifiers at this time
- Contractor sandblasted the corroded steel

More damage to the steel than what was initially anticipated (feed well area, rake arm, center column)
