# Ocean Outfall Condition Assessment and Scoping Study, Project No. PS18-09

Valerie Ratto  
Engineering  
Supervisor

Operations  
Committee

February 1, 2023

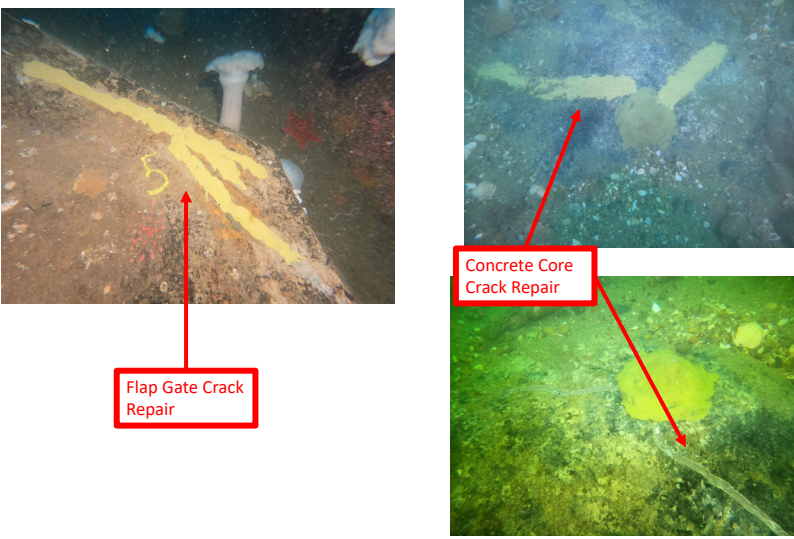
Flap Gate Crack Repair

Concrete Core Crack Repair

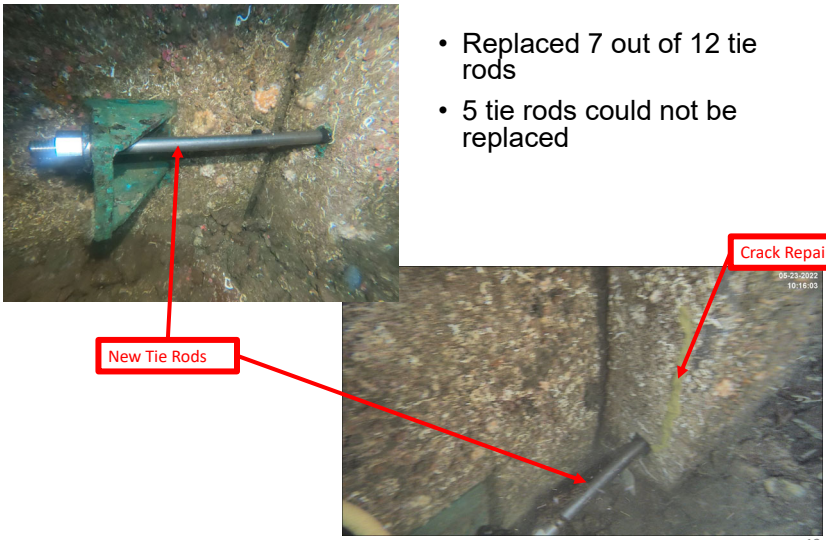
- Replaced 7 out of 12 tie rods
- 5 tie rods could not be replaced

New Tie Rods

Crack Repair

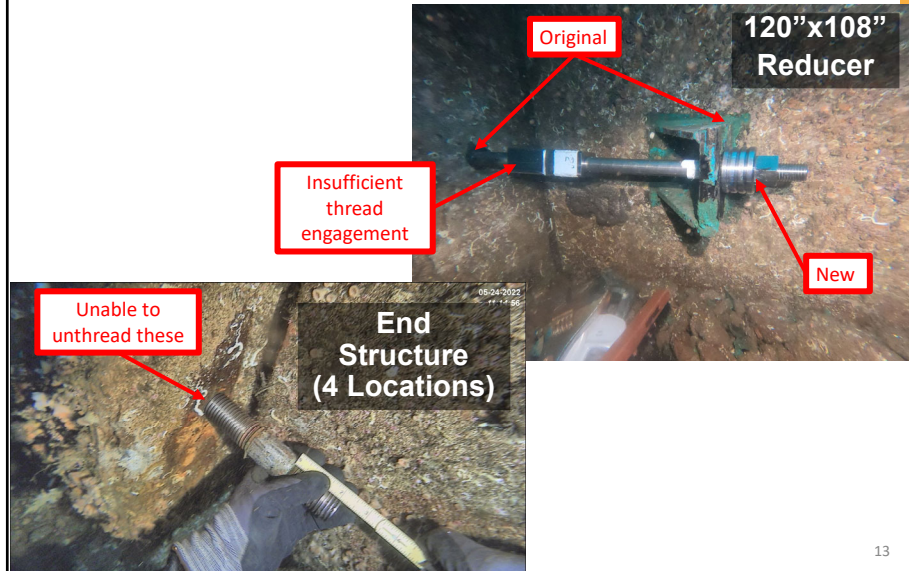
## Stuck Tie Rod Repair Plan
