**LEGISTAR NO. 2023-2772
SUPPLEMENTAL ATTACHMENT
ACTIVATED SLUDGE CLARIFIER ENTRY IMPROVEMENTS AT PLANT NO. 2, PROJECT
NO. FR2-0023**

Secondary Clarifier Safety Improvements

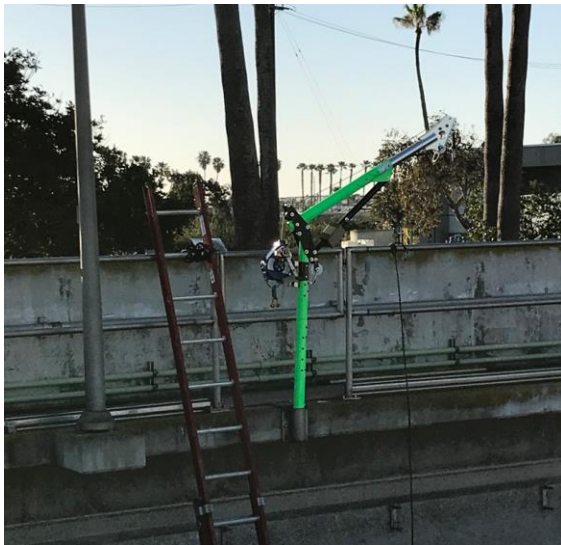
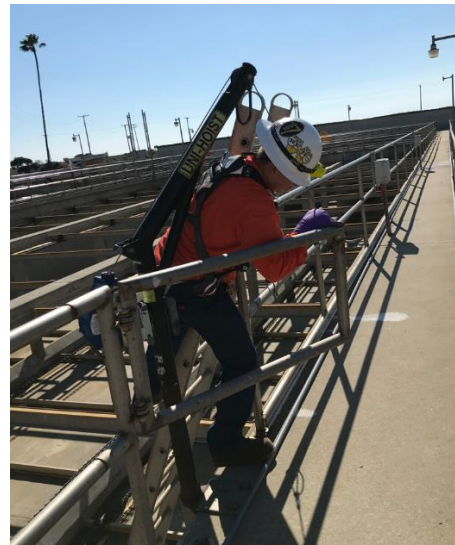
Figure 1 – Existing Problem:

Difficult ingress/egress at the secondary clarifiers due to inconvenient placement of ladder and davit crane.

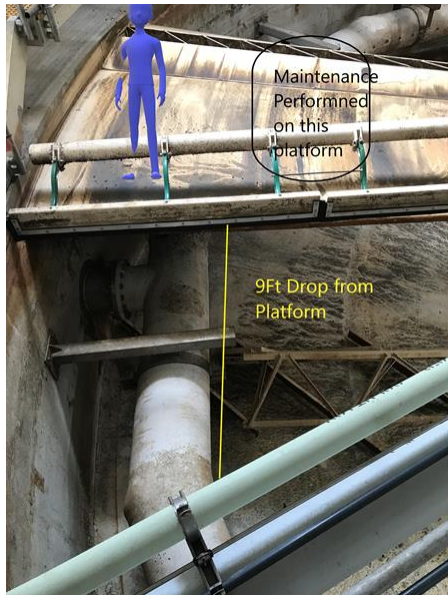
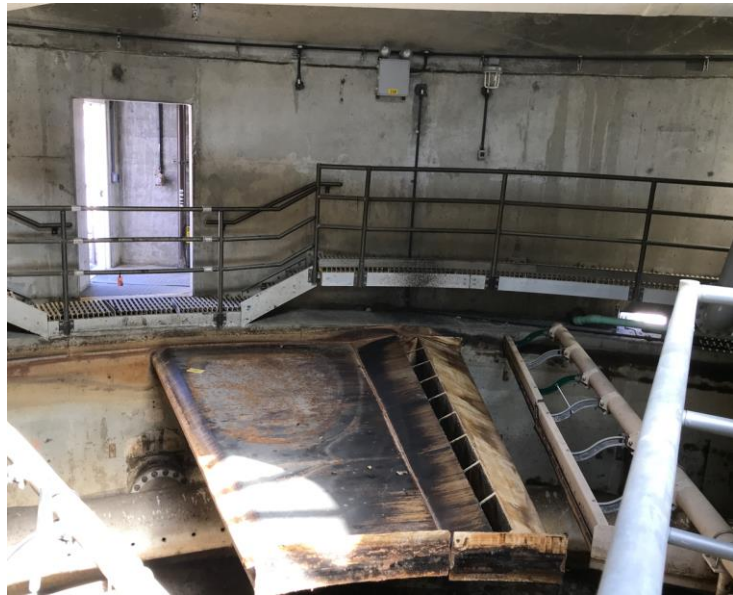
Figure 3 – Existing Problem:

Existing platform over the DAFT basin (similar layout in all four DAFTs) without fall protection.
