**LEGISTAR NO. 2023-2772  
SUPPLEMENTAL ATTACHMENT  
ACTIVATED SLUDGE CLARIFIER ENTRY IMPROVEMENTS AT PLANT NO. 2, PROJECT  
NO. FR2-0023**

**Secondary Clarifier Safety Improvements**

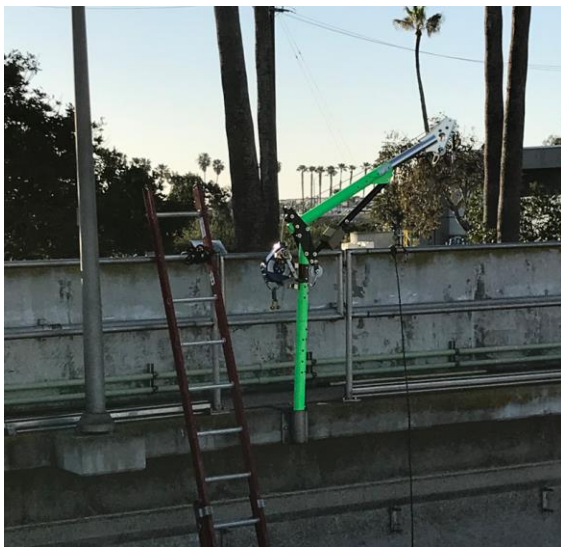
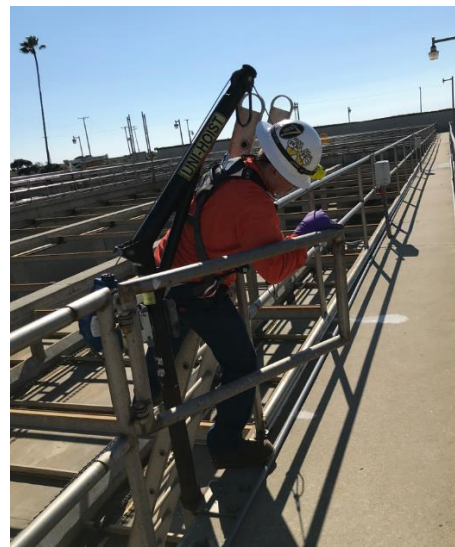
**Figure 1 – Existing Problem:**

Difficult ingress/egress at the secondary clarifiers due to inconvenient placement of ladder and davit crane.
