Seismic Evaluation of Structures at Plant Nos. 1 and 2

Project PS15-06

Kathy Millea, Director of Engineering
Administration Committee
May 13, 2020

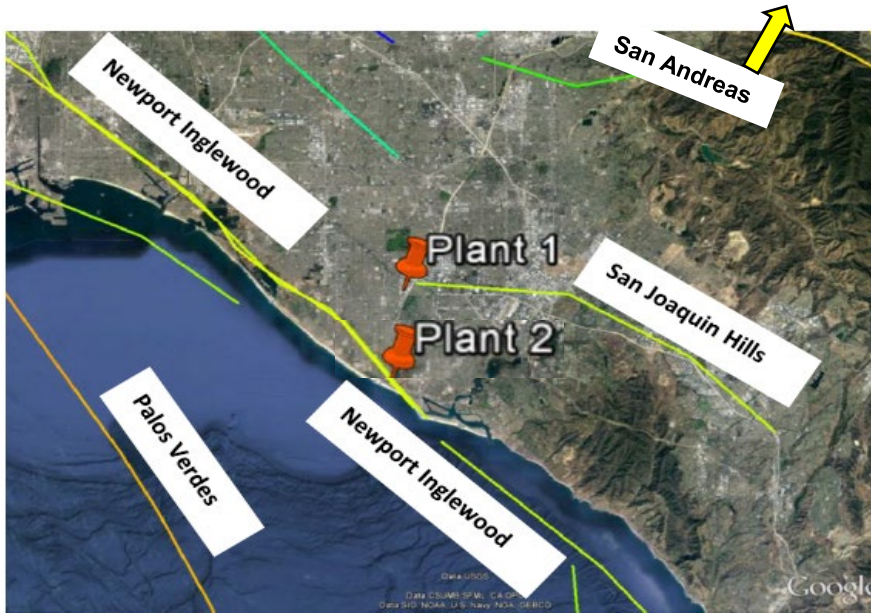
Several Local Faults Impact Seismic Hazards

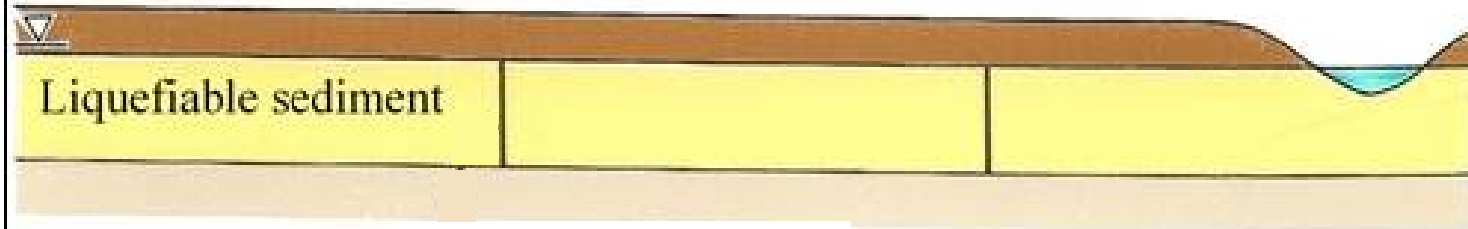
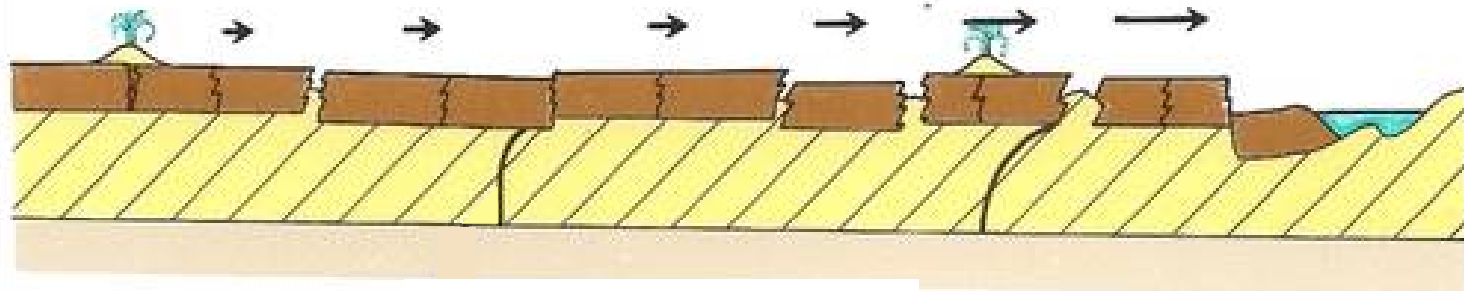
LATERAL SPREAD

Before earthquake:

After earthquake:

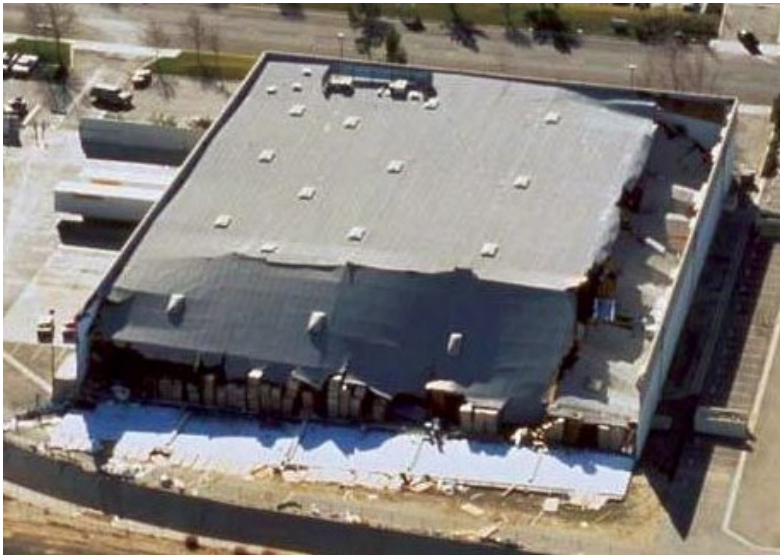
Separation of the roof element from the wall caused roof to collapse

Ref: 1994 Northridge Earthquake. EERI, Earthquake Engineering Research Institute

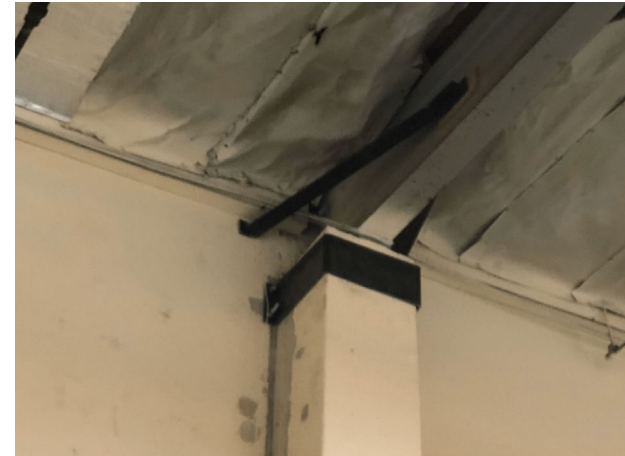
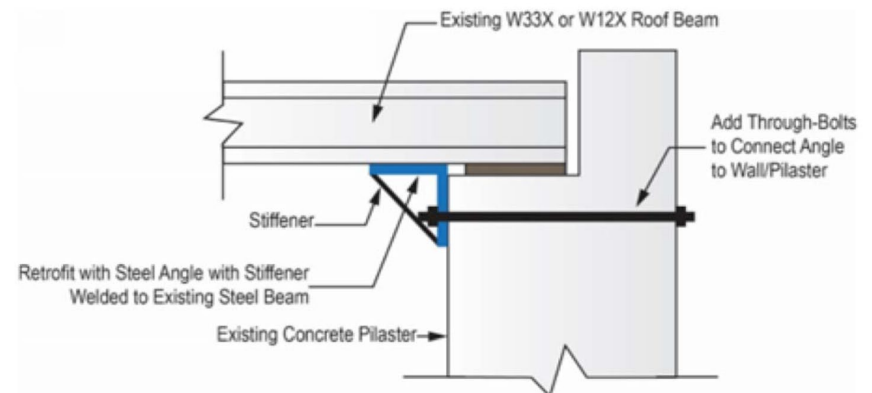
Installation of wall anchorage

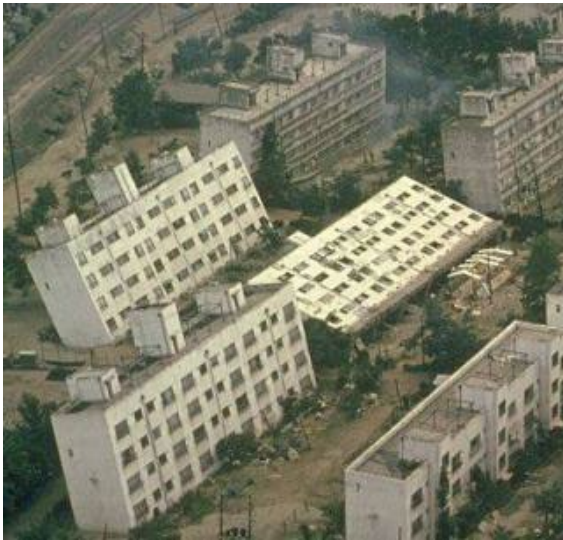
Soils became liquified during a seismic event, reducing the ground's ability to support loads

Niigata Japan, June 16, 1964
Photo Credit: National Geophysical Data Center

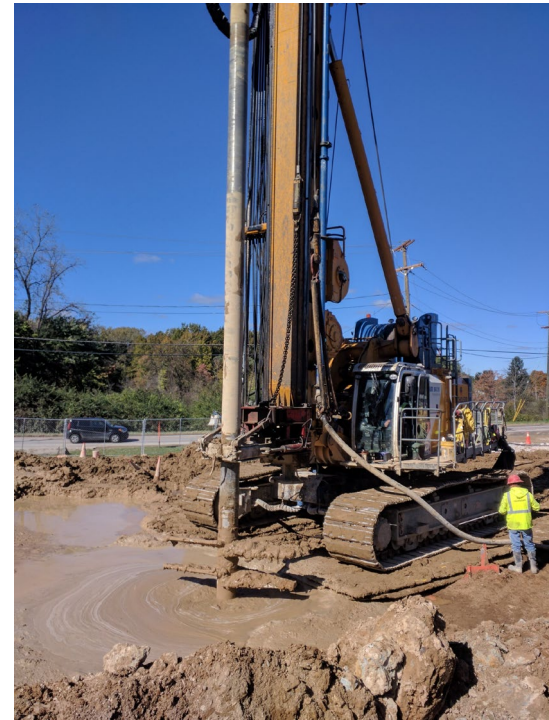
Deep soil mixing is one alternative to stabilize soil by “cementing” the sand particles together

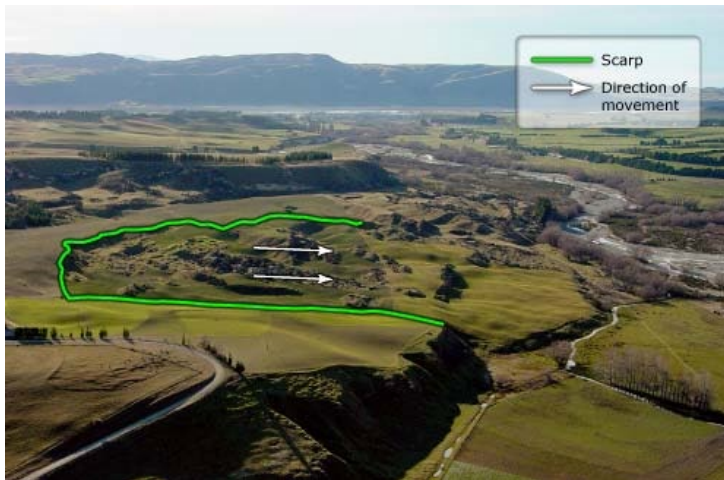
Seismic event causes soil to move laterally towards a free surface of lower elevation (river bed)

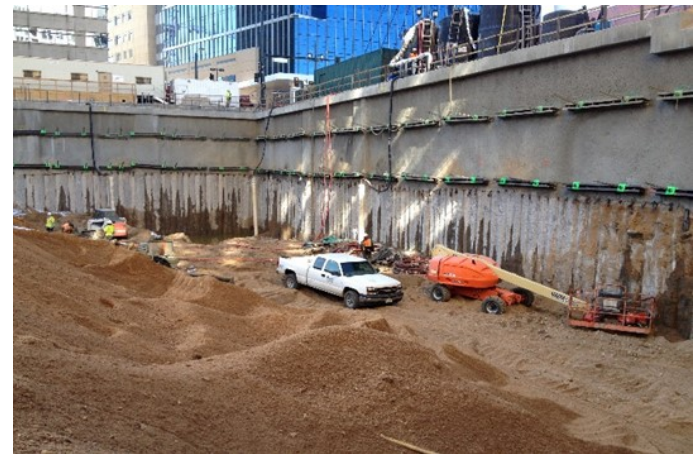
Installation of closely spaced piles effectively creates a “wall” that is designed to resist lateral soil movement
