**LEGISTAR NO. 2022-2459
SUPPLEMENTAL ATTACHMENT
RETURN ACTIVATED SLUDGE DISCHARGE PIPING REPLACEMENT AT
ACTIVATED SLUDGE PLANT NO. 1, PROJECT NO. FE20-03**

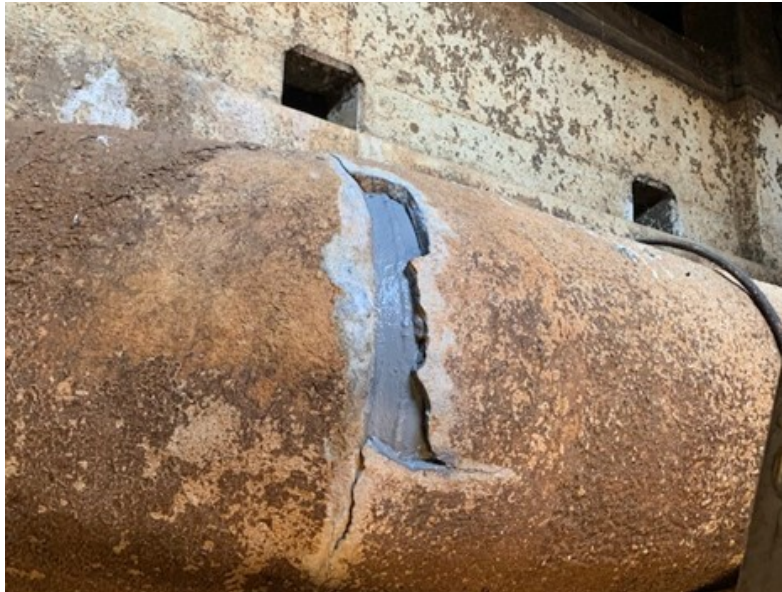
Figure 1:

The Return Activated Sludge (RAS) pipelines are deteriorating, with the outer layer broken off in sections of pipe.

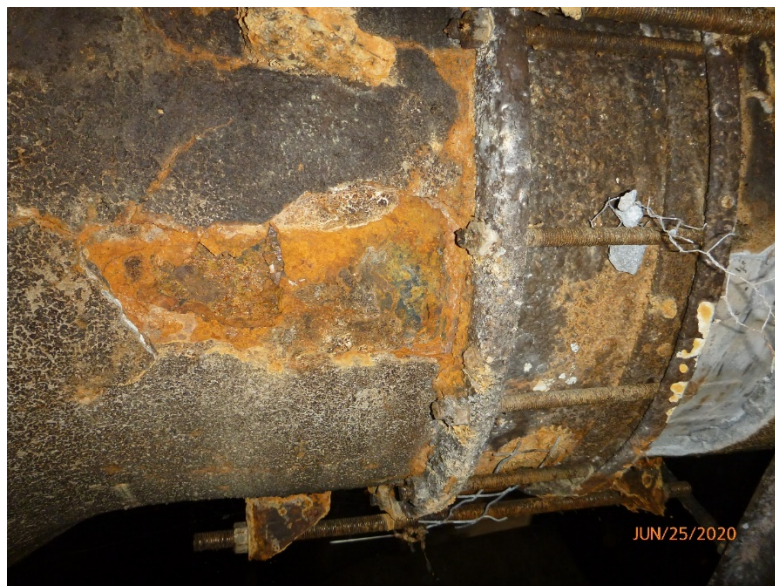
Figure 2:

The RAS pipelines are showing signs of heavy corrosion and are in need of rehabilitation.
