Seismic Evaluation of Structures at Plant Nos. 1 and 2

Project PS15-06

Kathy Millea, Director of Engineering **Operations Committee**

May 6, 2020

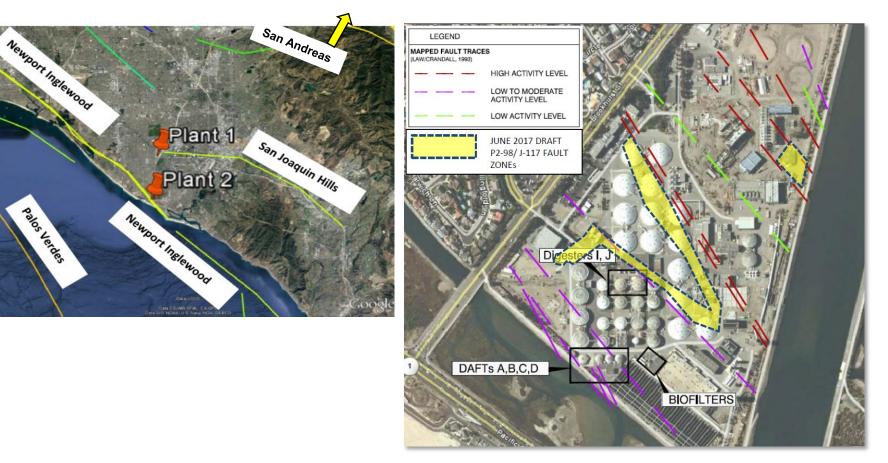
Several Local Faults Impact Seismic Hazards

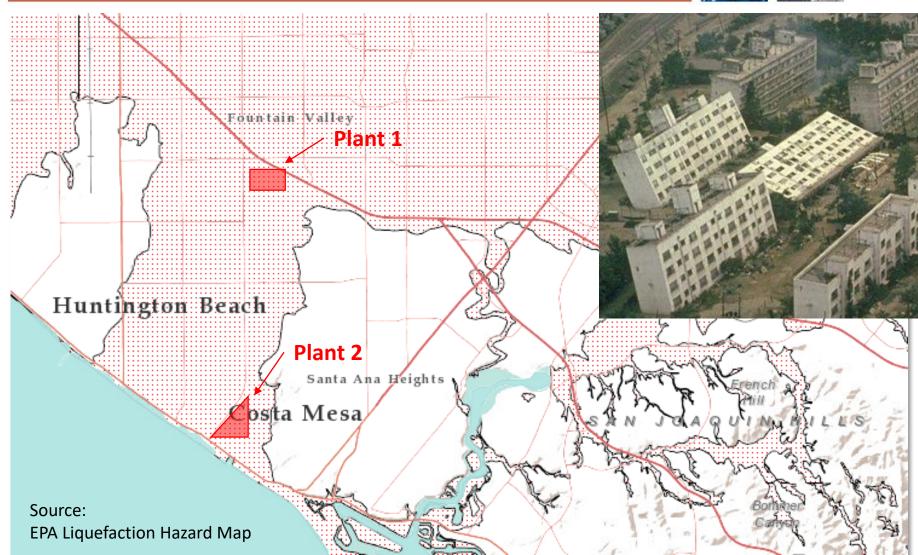
Potential Liquefaction Hazard Zone

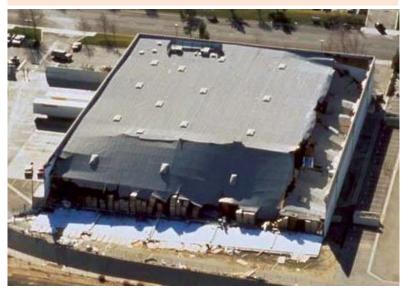
Separation of the roof element from the wall caused roof to collapse

Installation of wall anchorage

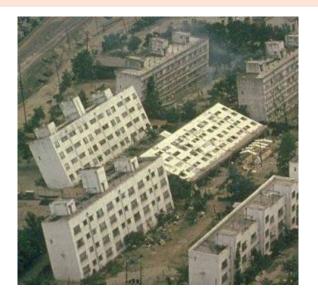
Soils became liquified during a seismic event, reducing the ground's ability to support loads

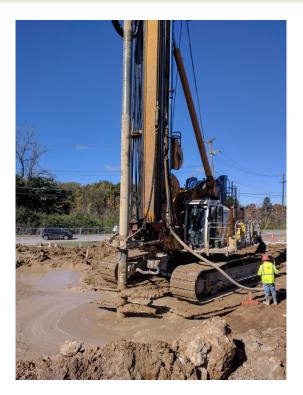
Deep soil mixing is one alternative to stabilize soil by "cementing" the sand particles together

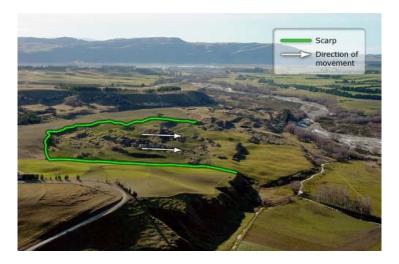
Seismic event causes soil to move laterally towards a free surface of lower elevation (river bed)

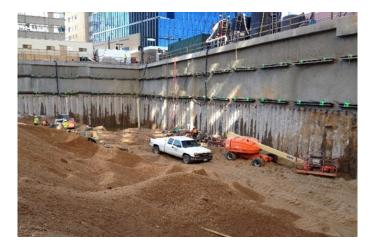
Installation of closely spaced piles effectively creates a "wall" that is designed to resist lateral soil movement
