Project Report

PS15-06 Seismic Evaluation of Structures at Plants 1 and 2

Seismic Evaluation Criteria

Excerpt From Technical Memorandum 1

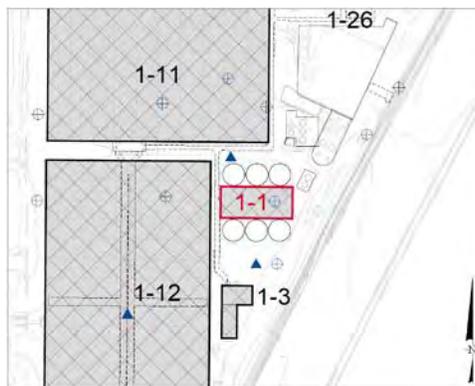
Plan View

PFM and Description ¹	Tier ²	Assessment Results
PFM 2: Wall anchorage to the roof at east and west walls of the north building	T1	Check of the eave beam to span horizontally across the width of the building. The actual roof connections will have DCR's > 1.0. It is recommended that wall anchorage be added to the east and west walls.
PFM 3: Roof diaphragm shear at the north building	T2	Excessive shear demands at the north building, which has a 4.5-inch deep steel deck (low shear capacity).
PFM 4: Discontinuous shear walls at the interior of the south building in the north-south direction (@ grid lines 3 and 5)	T1	The transverse CMU walls at grid lines 4 and 5 of the north building and walls at grid lines 3 and 5 of the south building are discontinuous. Provide ties to adjacent concrete walls that occur between grids C and D.

PFM 7: Bending/shear failure of piles due to lateral spread (surface PGD = 27-inches) T1/2 23.3" (estimate of spread at pile head) lateral spread toward the Santa Ana River. DCR is the near pile top displacement over pile top displacement at yield (3.5").

Recommended Geotechnical Mitigation ¹	Cost ²	Comments
PFM 7: Standard Geotechnical Mitigation A2	See Note 3	Mitigation is required to reduce lateral spread by 70% (surface PGD = 8-inches).
Recommended Structural Mitigation ¹	Cost ²	Comments
PFM 2: Standard Structural Mitigation A1	\$150,000	N/A
PFM 3: Standard Structural Mitigation B1	\$560,000	Existing roof deck is 4.5-inch deep diaphragm with no concrete topping. Replace entire roof diaphragm.
PFM 4: Provide steel beam or channel ties for the full width of the building (40-ft) that are epoxied into the bottom side of the first floor to drag loads into the existing shear walls between grid lines C and D.	\$130,000	N/A

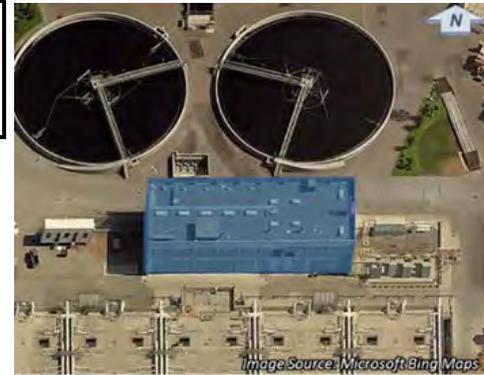
Plan View

PFM and Description ¹	Tier ²	Assessment Results
PFM 2: Wall anchorage to the roof at the north and south walls of the Blower Building	T1	Check of the W33x connections at pilasters (10 locations). Transfer of wall anchorage force relies on a 1" weld (not clear what kind of weld) every 12 inches. For mitigation, it is assumed the load path in the diaphragm is deficient as well.
PFM 3: Wall anchorage to the roof at the north and south walls of the PEPS Building	T1	The north and south walls of PEPS were retrofit as part of the P1-44-4 project (22 locations).
PFM 4: Wall anchorage to the roof at the east and west walls of the PEPS Building	T1	Check of the W27x connections at pilasters (4 locations). Transfer of loads into the diaphragm appear to be minimal.

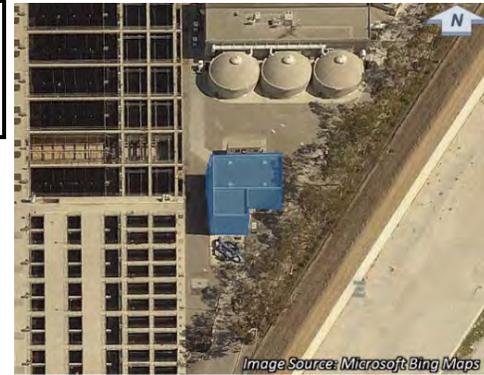
Plan View

PFM 6: Bending/shear failure of piles due to lateral spread (surface PGD = 40-inches) T1/2 32" (estimate at pile head) lateral spread toward Santa Ana River. DCR is the near pile top displacement over pile top displacement at yield (3.5").

Recommended Geotechnical Mitigation ¹	Cost ²	Comments
PFM 6: Standard Geotechnical Mitigation A2	See Note 3	Mitigation is required to reduce lateral spread by 80% (surface PGD = 8-inches).

Recommended Structural Mitigation ¹	Cost ²	Comments
PFM 2: Standard Structural Mitigation A2 (Medium)	\$300,000	Wall anchorage mitigation at W24x94 roof beams (8 locations).
