Sole Source for Bar Screens

Headworks Rehabilitation
Project No. P1-105

Kathy Millea, Director of Engineering
Operations Committee
July 1, 2020

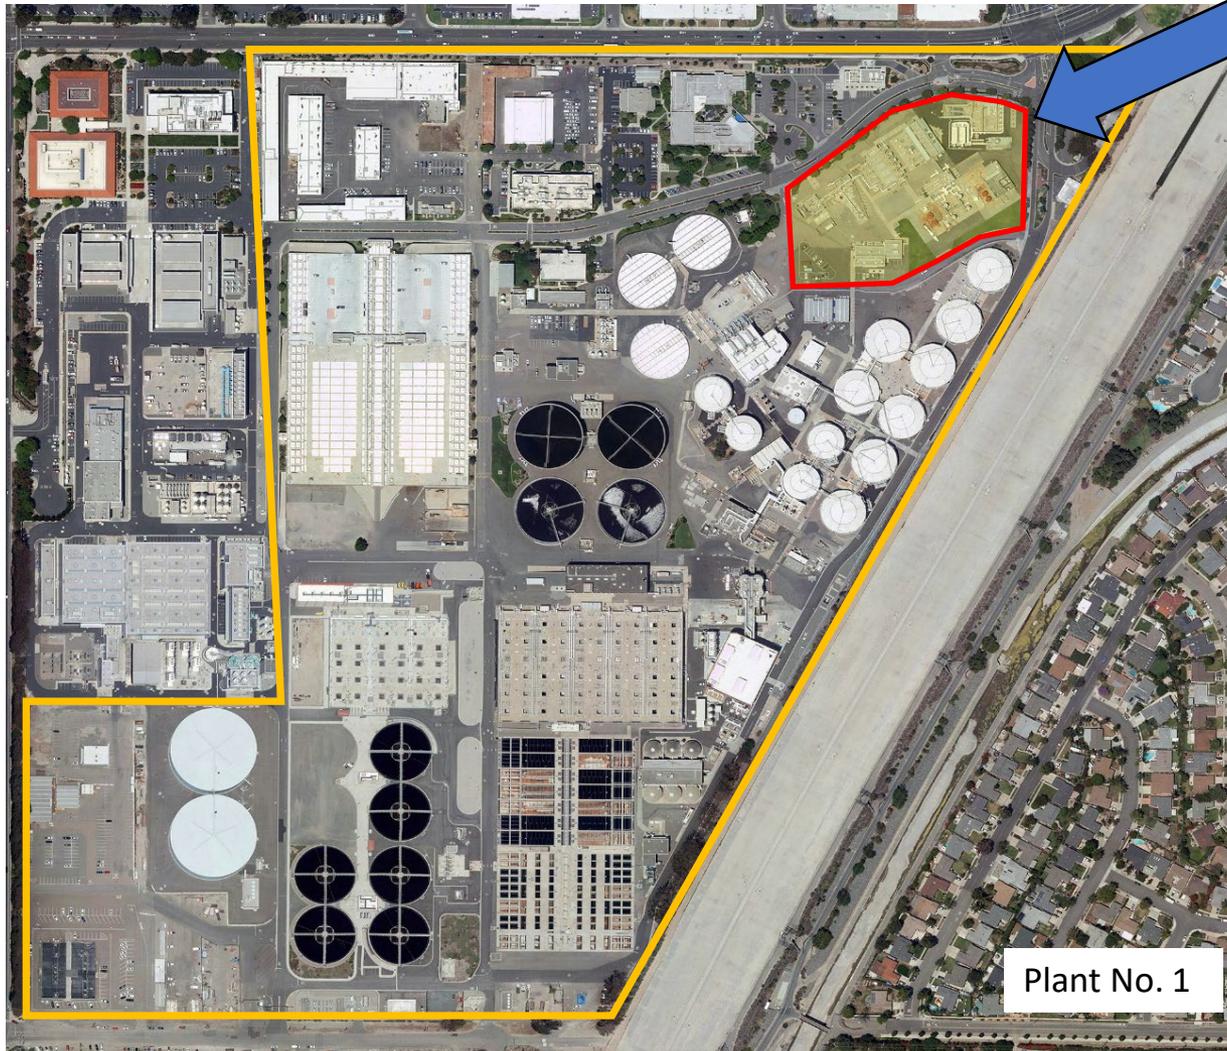
Headworks is where treatment begins

Headworks Rehabilitation at Plant No. 1

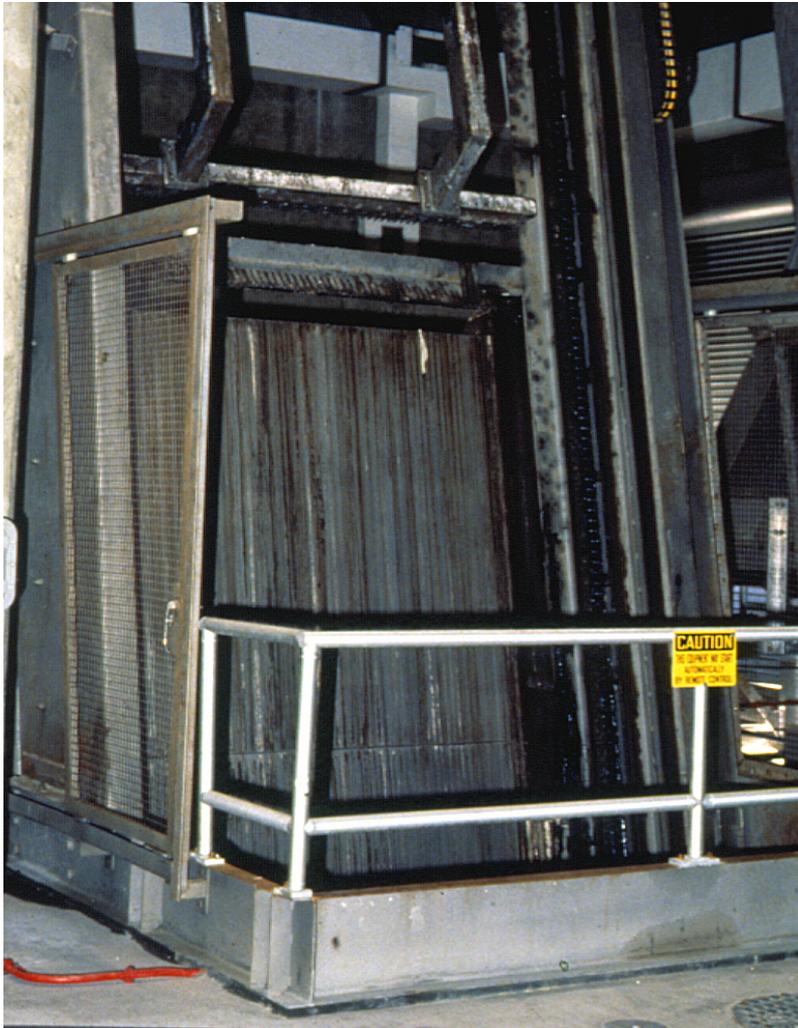
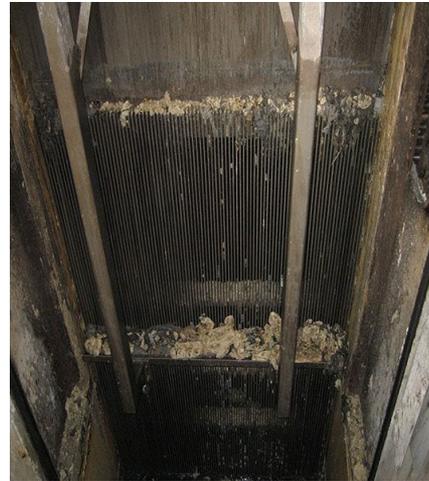
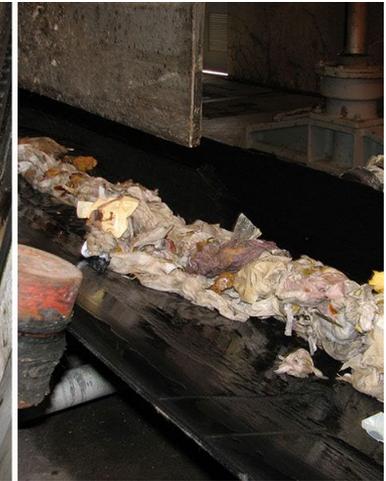
Existing Bar Screens

5/8" Spacing

1" Spacing

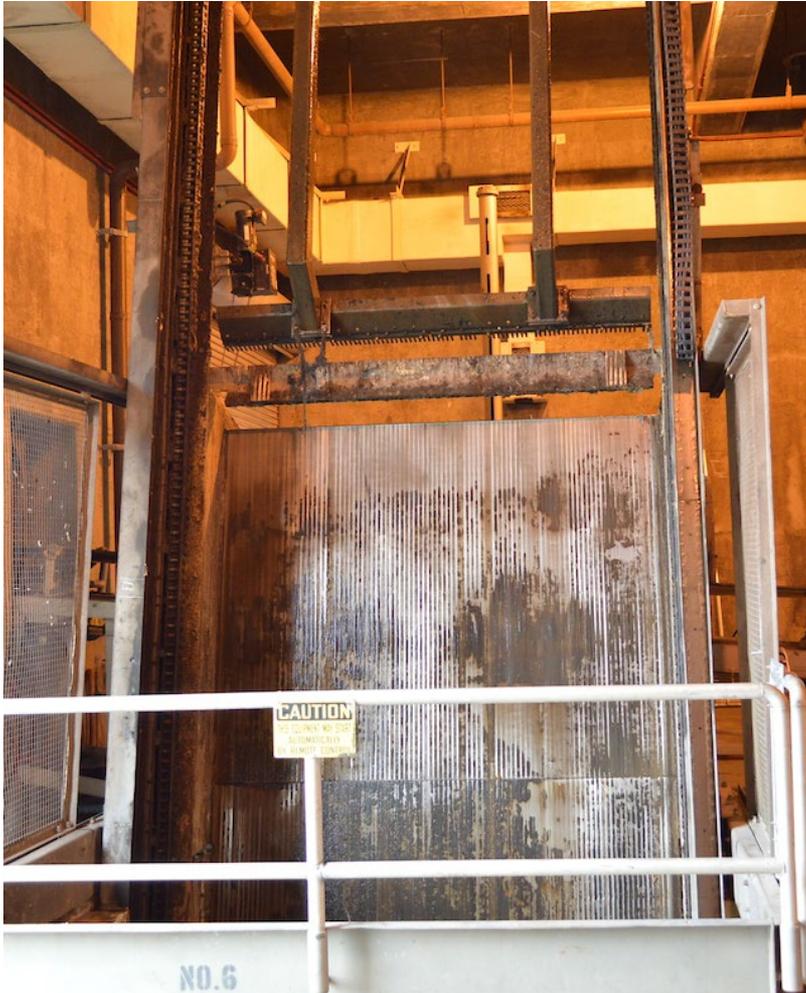
Bar Screen Evaluation

Extensive studies performed:

- Type of screening mechanisms
- Bar screen spacing
- Hydraulic capacity

Pilot testing of 5/8-inch screen for Plant No. 2 Headworks project

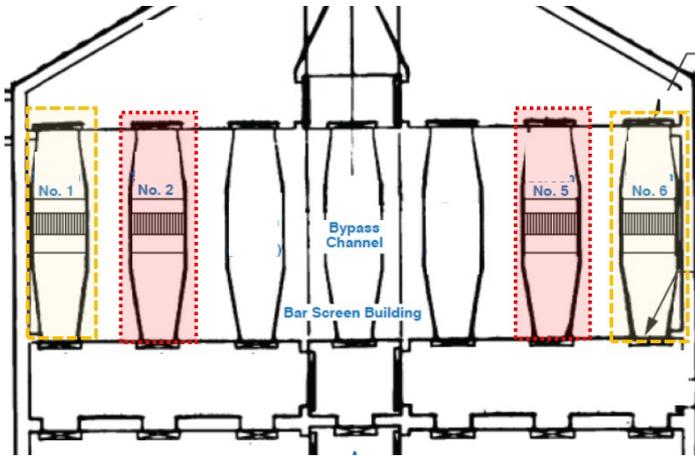
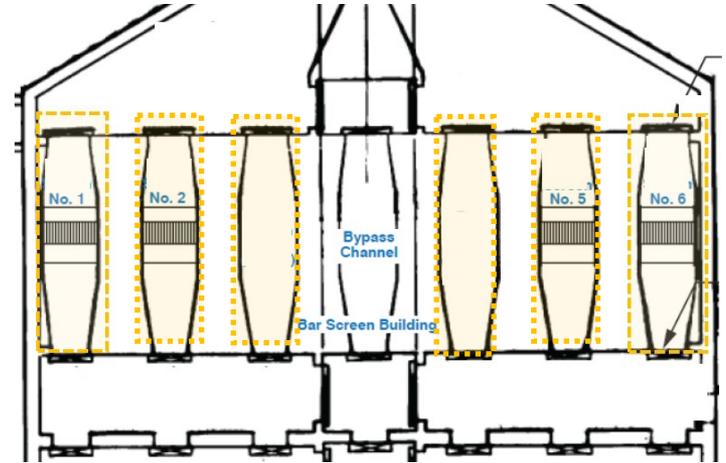
Evaluation Results

5/8" Spacing

1" Spacing

- Refurbish 4 existing bar screens
- Add 2 new bar screens
- Keep climber screens
- All bar screens to have 5/8" spacing
 - Better removal
 - Reliability
 - Hydraulic Capacity
 - Fit within existing structure

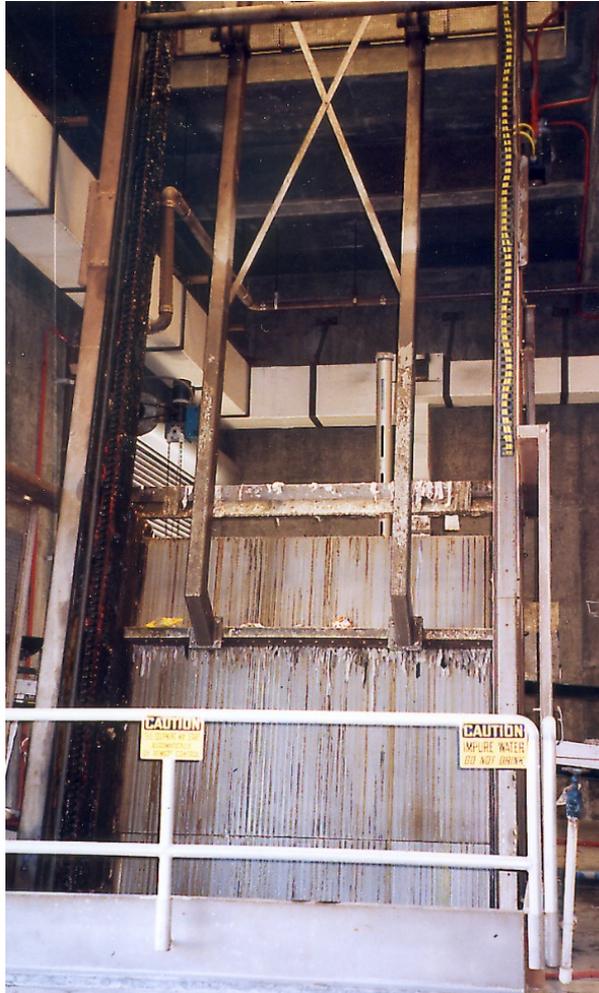
Existing Climber Technology by Suez WTS

- \$2 million lower equipment cost to rehab vs. replace 4 bar screens
- Only SUEZ WTS can supply parts and material to refurbish existing bar screens
- All bar screens would be the same design
- \$3.8 million pricing commitment from supplier. Verified as reasonable based on pricing for similar installations.
