Lido Pump Station Sewage Spill

Operations
Committee

December 7, 2022

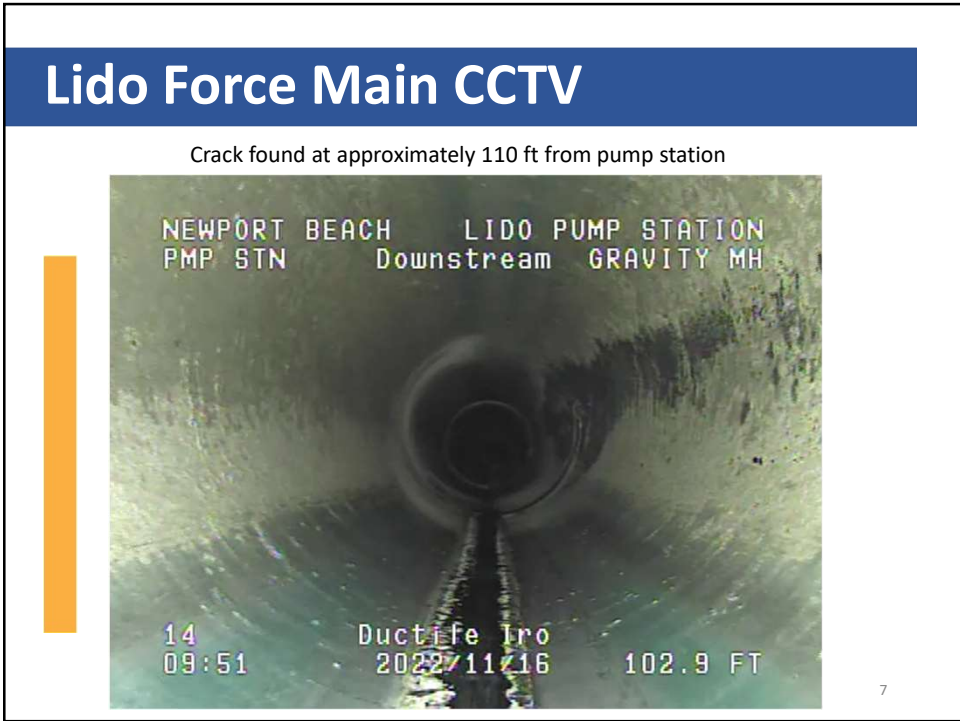
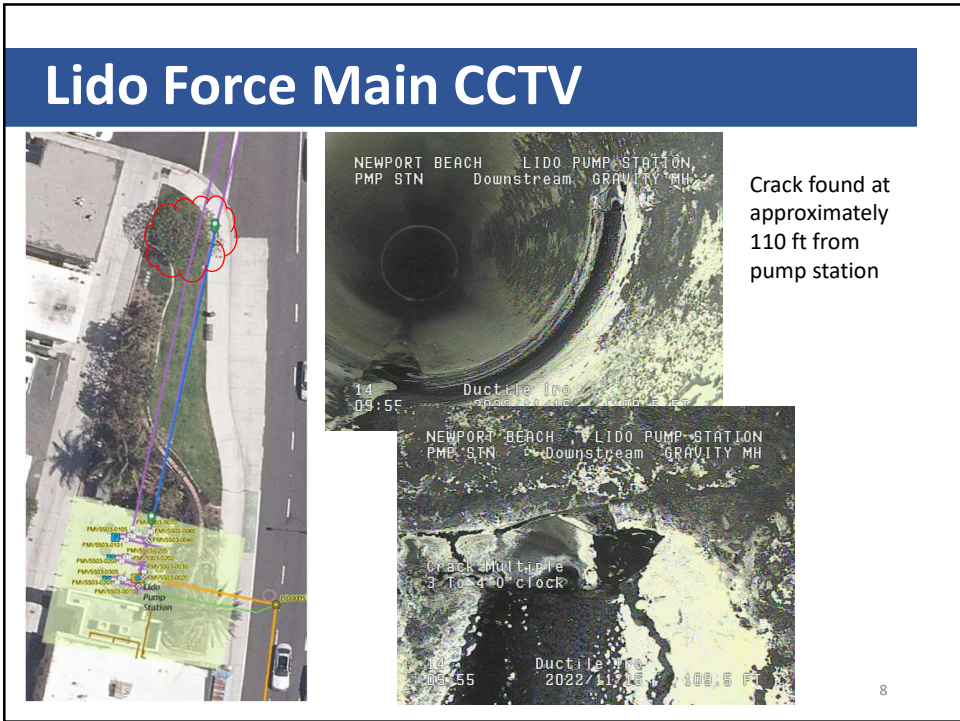
- Initial CCTV was performed on 11/16/22 to locate break
- Approximately 142 feet of East force main was inspected
- Inspection stops at a junction joint
- Additional 416 feet of CCTV was performed from where pipe was excavated and removed

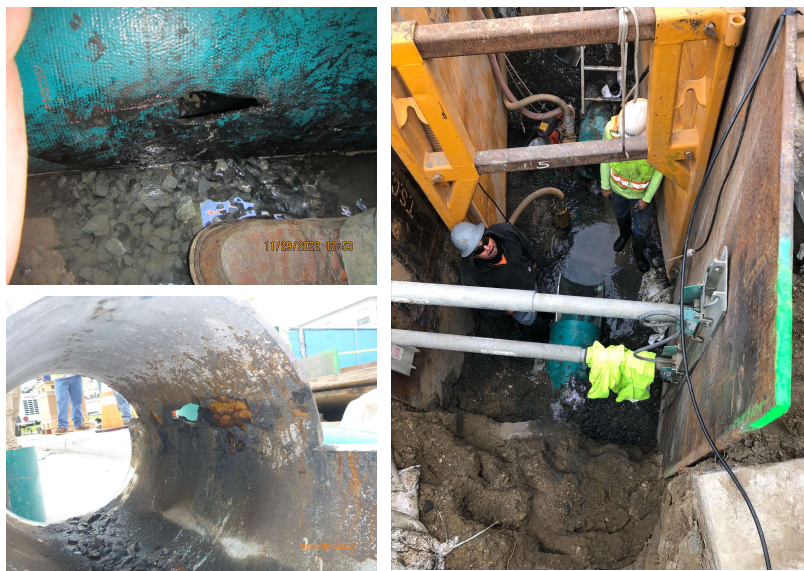
Excavation and Repairs

- Damaged pipe was cutout and replaced
- Couplings were concrete encased, pipe exterior wax-taped
- Force main was pressure tested
- Excavation site being restored

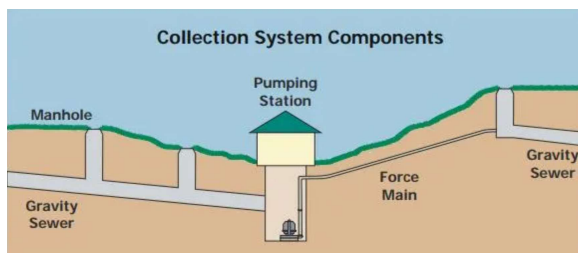
Asset Management - Force Main Condition

Current force main remaining useful life scores are theoretical and adjusted per condition assessment(s)

5	• RUL: < 5 years
4	• RUL: 5 – 10 years
3	• RUL: 11 – 15 years
2	• RUL: 16 – 20 years
1	• RUL: > 20 years
