Primary Clarifiers F and G Rotating Mechanism Rehabilitation at Plant No. 2, Project No. FE23-09, Specification No. S-2024-612BD

Project Scope

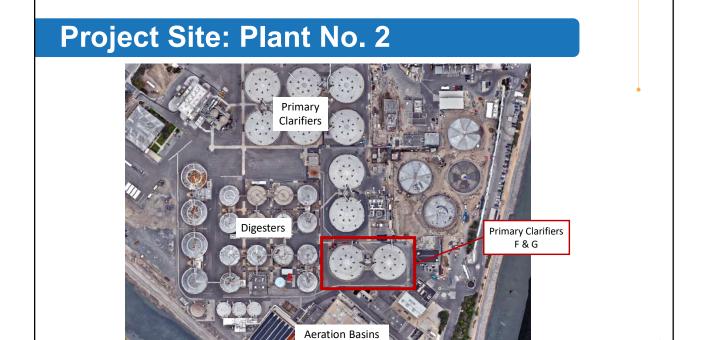
Current Condition

- Both Clarifiers F and G are not operational due to corrosion
- P2 does not have a redundancy for the clarifiers at this time
- Contractor sandblasted the corroded steel
