# Asset Management Plan 2024

***OC San will know the condition of assets we own and will have a plan to operate and maintain these assets to deliver the required level of service, at the lowest life cycle cost, with an acceptable level of risk.***

OC San owns and operates wastewater collection system infrastructure, as well as two resource recovery and wastewater treatment facilities located in Fountain Valley and Huntington Beach. Our collection system infrastructure includes over 380 miles of regional trunk sewer pipelines and 15 pump stations throughout the OC San service area (Figure ES-1). Wastewater is conveyed to Reclamation Plant Number (No.) 1 in Fountain Valley and Reclamation Plant No. 2 in Huntington Beach. These facilities treat an average daily wastewater flow of more than 190 million gallons per day, serving over 2.6 million people in central and northern Orange County, California.

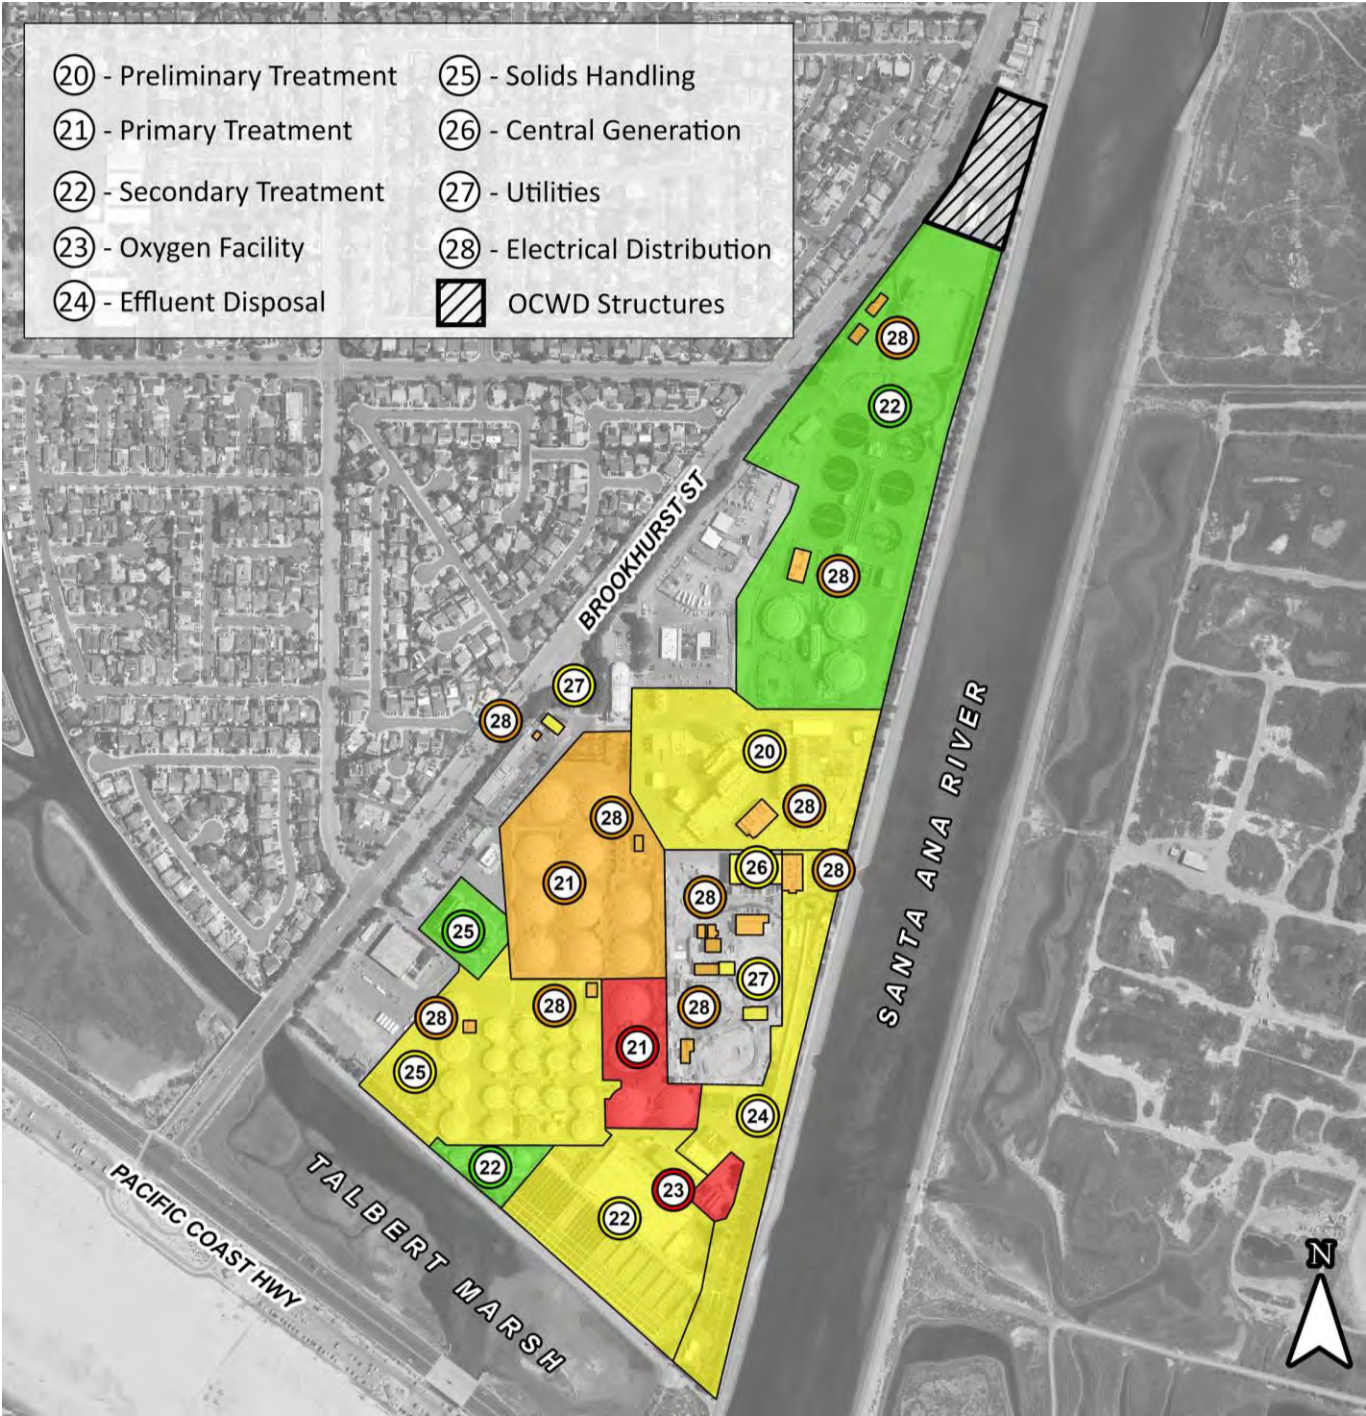
Figure ES-4. Plant No. 2 Process Area – Remaining Useful Life Score Map

Note: Area 29 is excluded from the map. The colored process areas reflect the average RUL score as shown on the respective table.

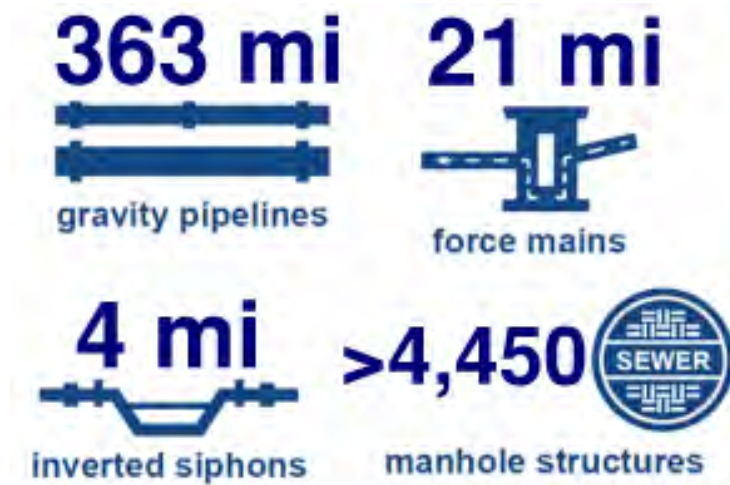
OC San's collection system serves as a regional conveyance system, collecting and conveying wastewater flows from 20 cities, 4 special districts, and various unincorporated areas, and accommodates dry weather urban runoff. OC San's more than 380 miles of collection system pipelines and 15 pump stations are spread throughout northern Orange County and include 363 miles of gravity pipelines, 21 miles of force mains, 4 miles of inverted siphons, and more than 4,450 manhole structures.

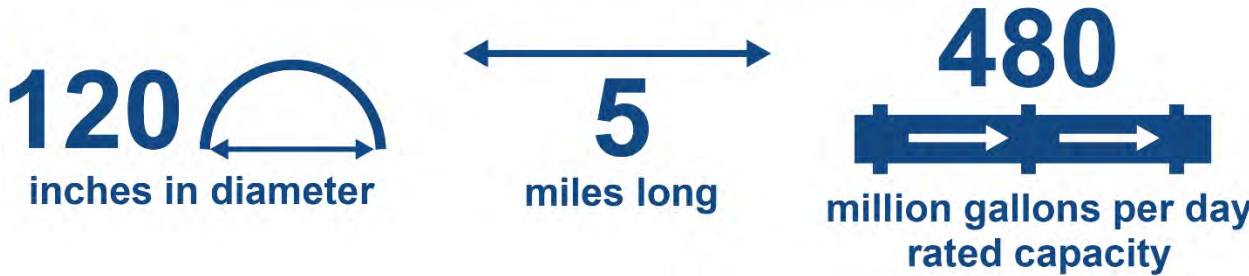
OUTFALL NO. 2 PRIMARY OCEAN OUTFALL

**Outfall No. 2** serves as the primary ocean outfall, discharging treated wastewater approximately 5 miles offshore at a depth of approximately 200 feet. It began service in 1971. Based on the findings of a comprehensive assessment study completed in 2022, a rehabilitation project is in progress to ensure the outfall’s reliability for many years to come.

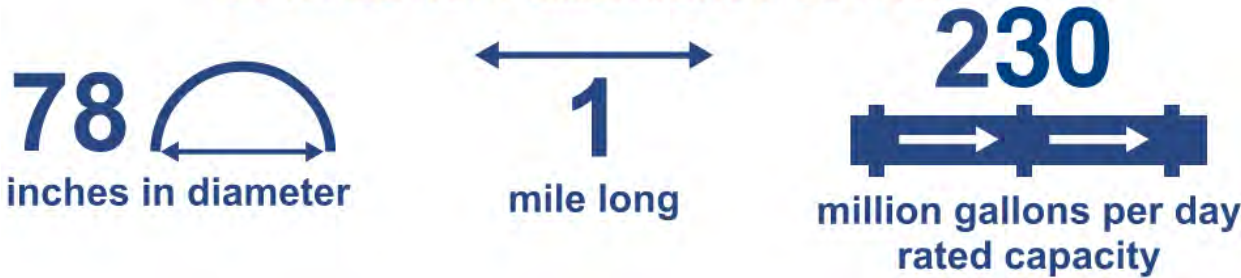
OUTFALL NO. 1 EMERGENCY OUTFALL

**Outfall No. 1** serves as an emergency outfall and primary backup to Outfall No. 2, discharging treated wastewater over a mile offshore at a depth of approximately 65 feet. It was originally constructed in 1954 and was later modified in 1965. OC San’s NPDES permit specifies that this outfall can be used only in the case of an emergency or during planned maintenance activities.

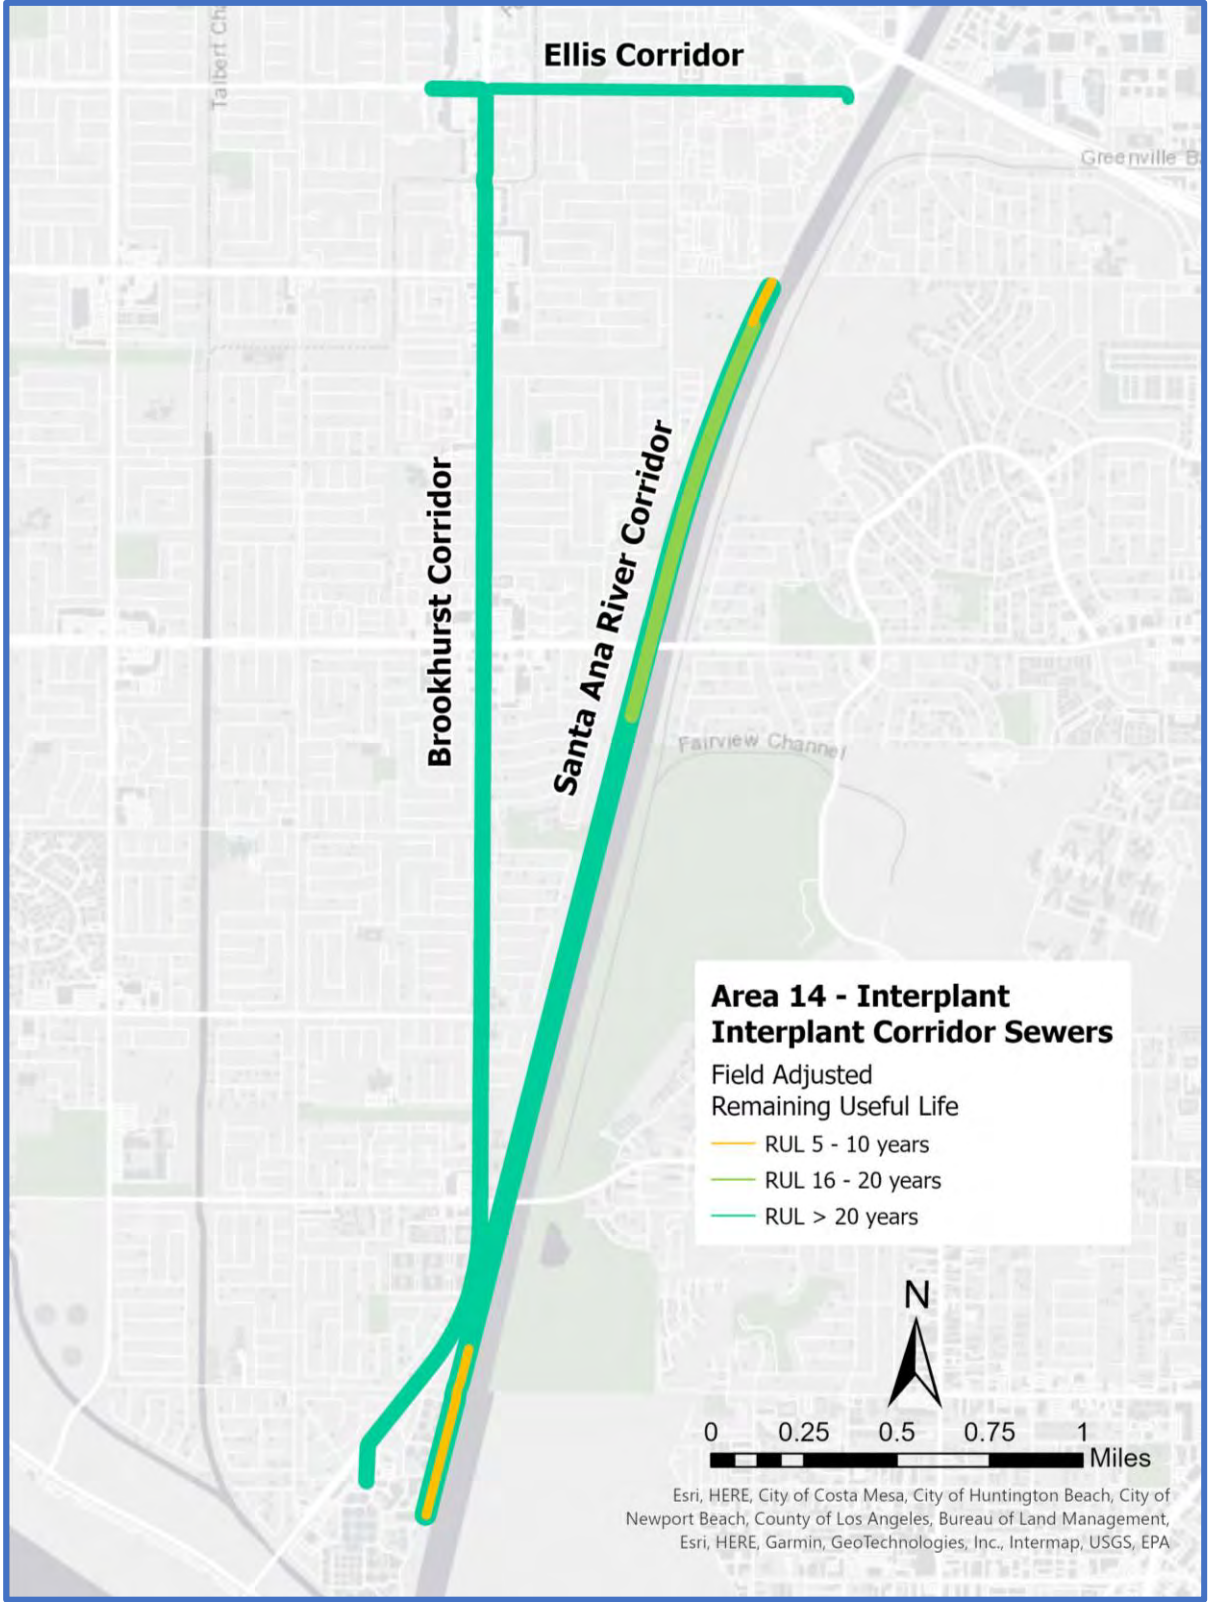
Remaining Useful Life Maps

AREA 14 ASSET MANAGEMENT SUMMARY – PLANT NO. 1 INTERPLANT

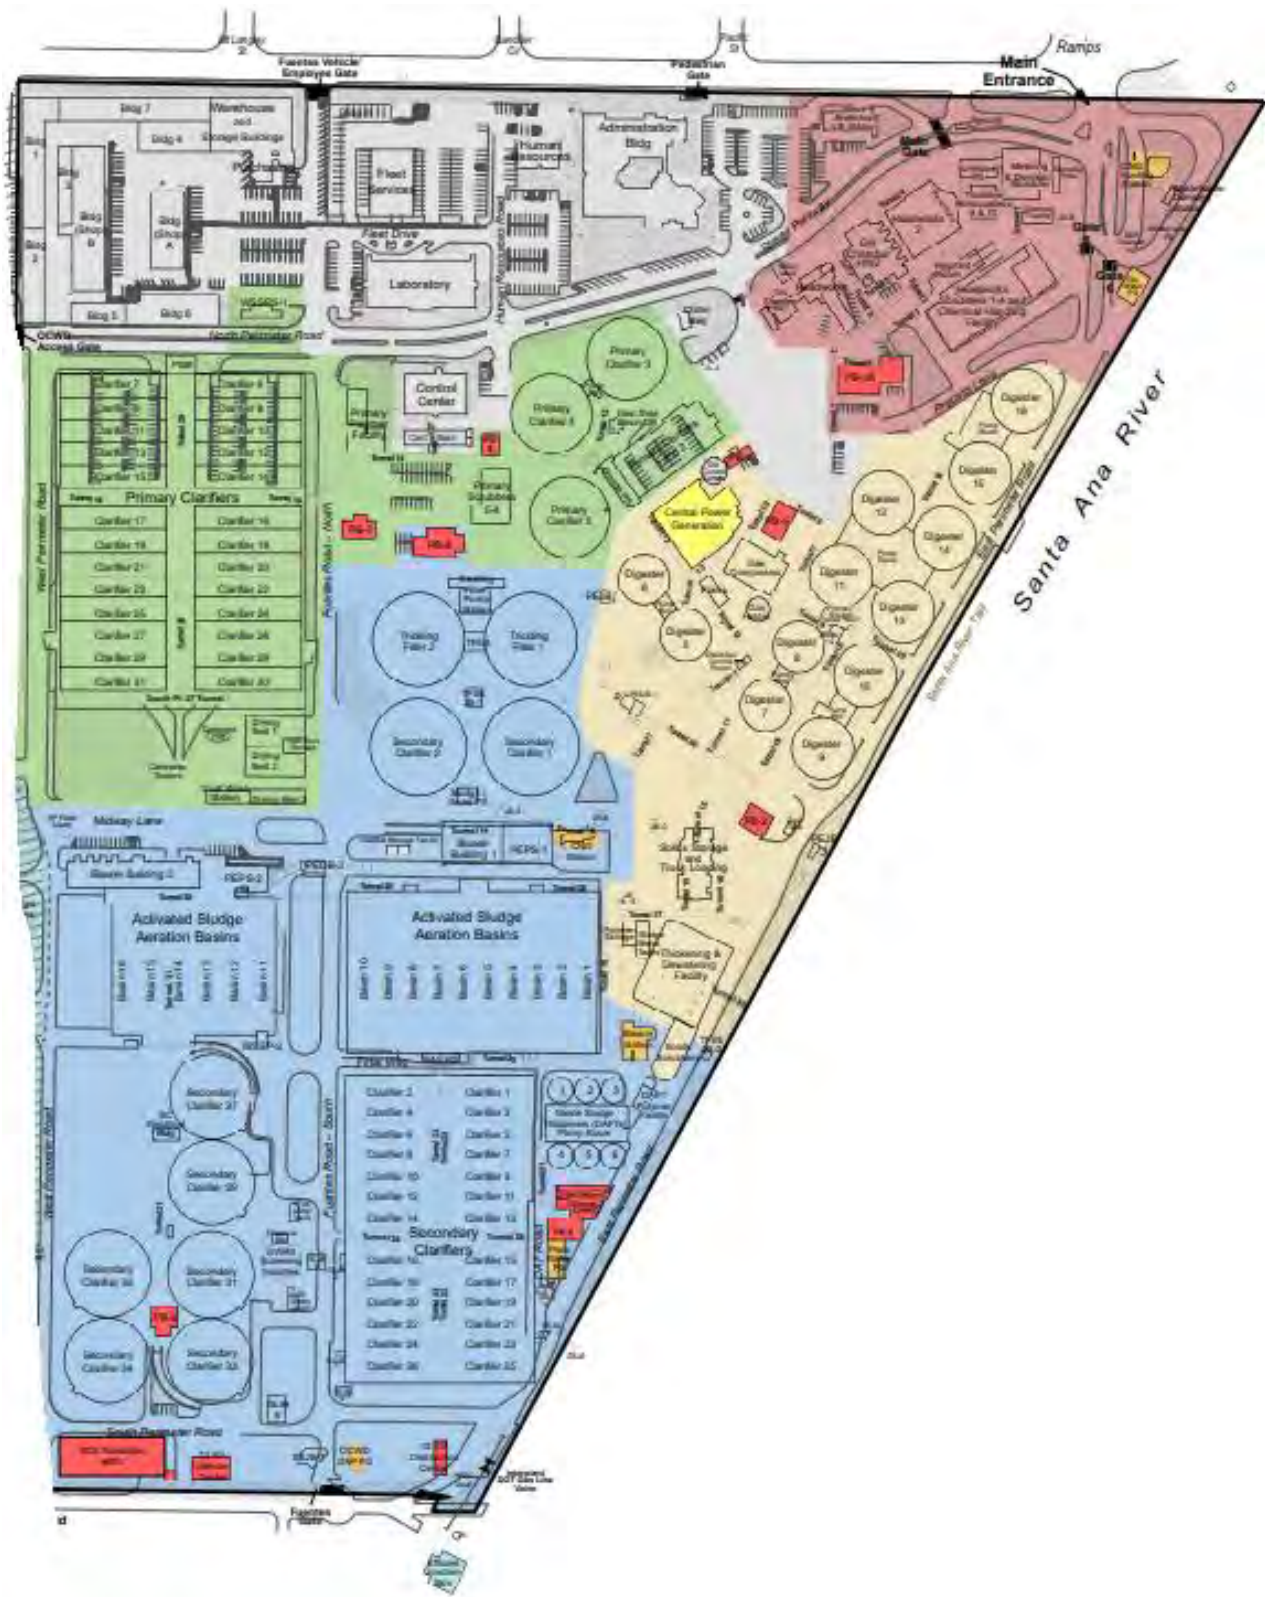
Occupied and Power Building Site Plan at Plant No. 1

AREA 19 ASSET MANAGEMENT SUMMARY – PLANT NO. 1 OCCUPIED & POWER BUILDINGS

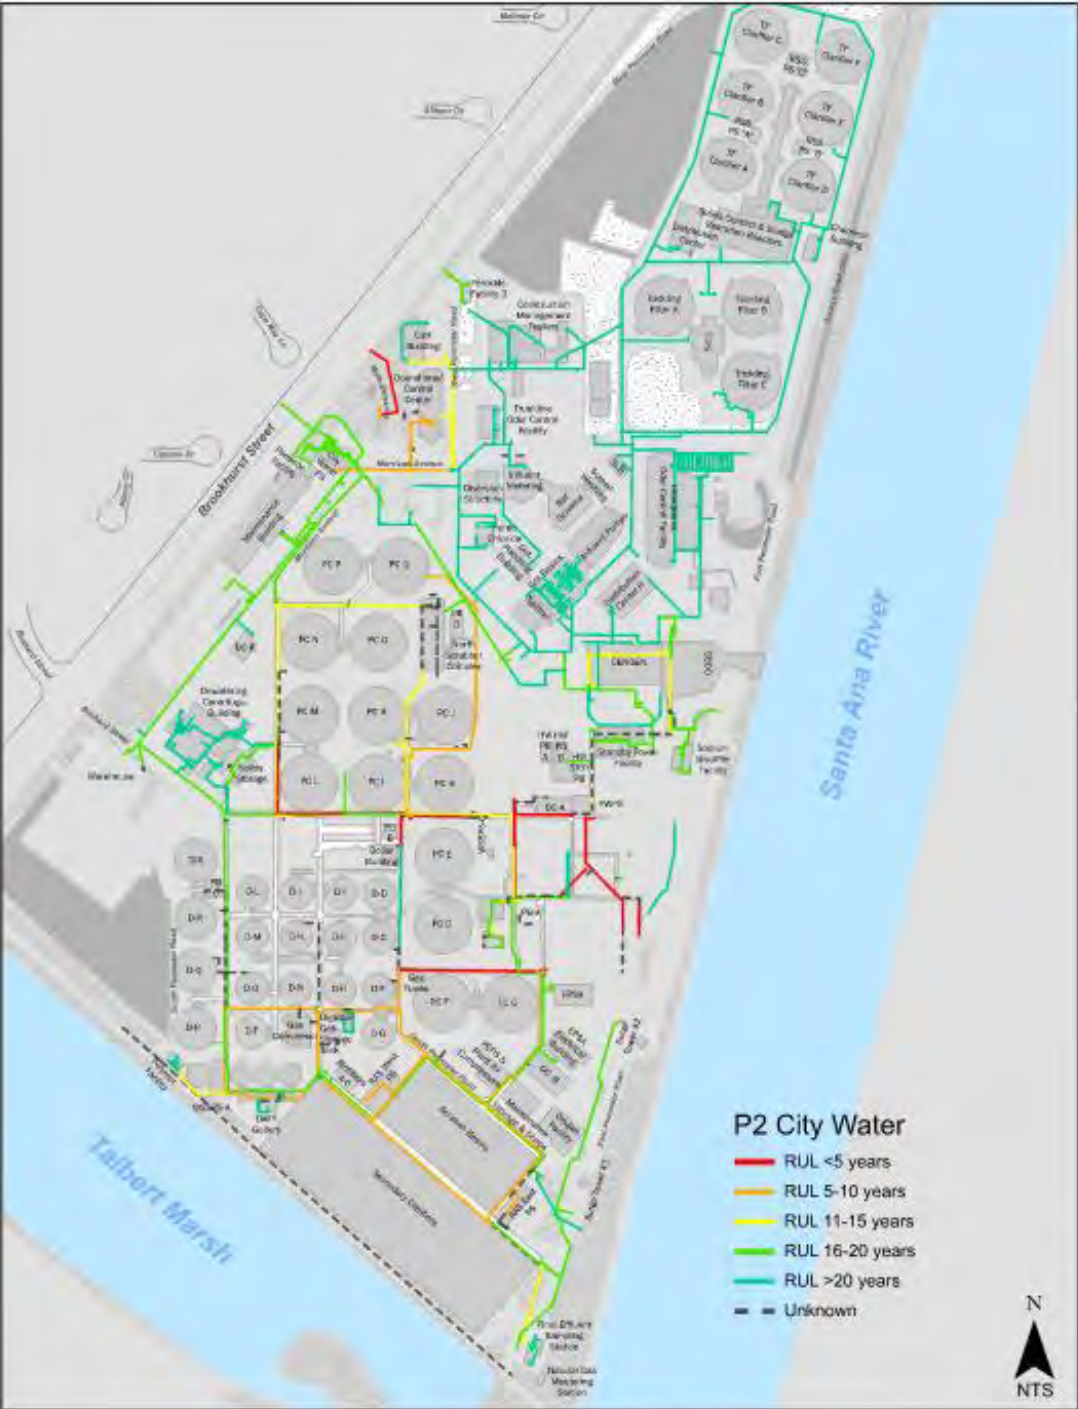
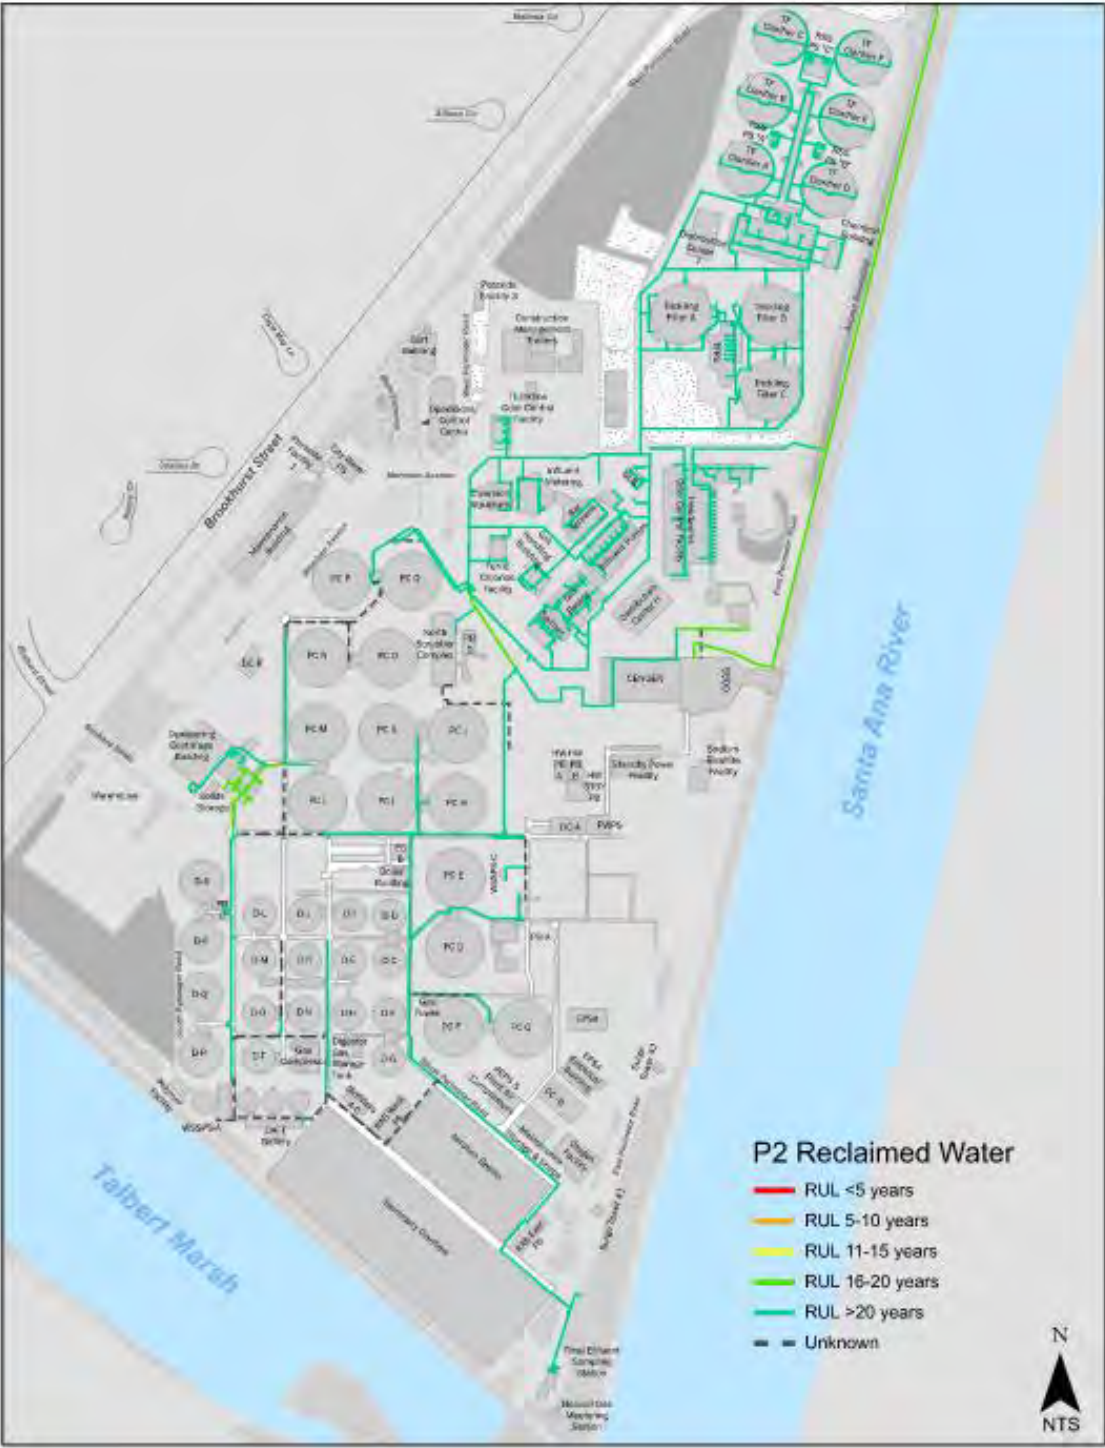
Remaining Useful Life of Utility Infrastructure

AREA 27 ASSET MANAGEMENT SUMMARY – PLANT NO. 2 UTILITIES

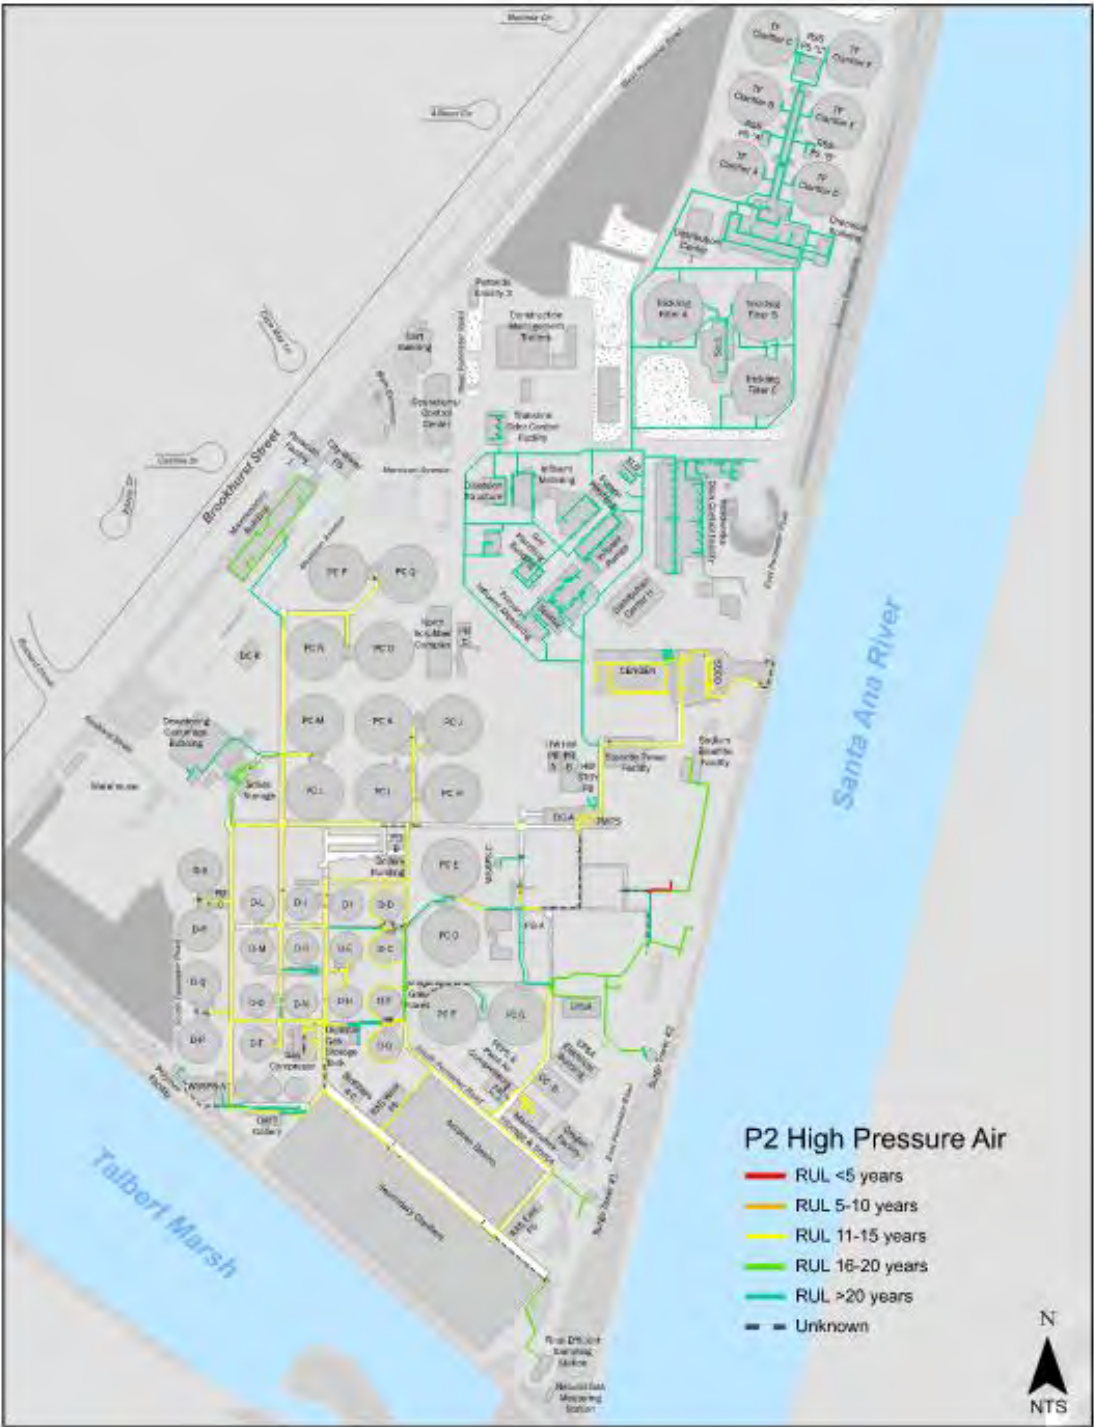
Remaining Useful Life of Utility Infrastructure

AREA 27 ASSET MANAGEMENT SUMMARY – PLANT NO. 2 UTILITIES

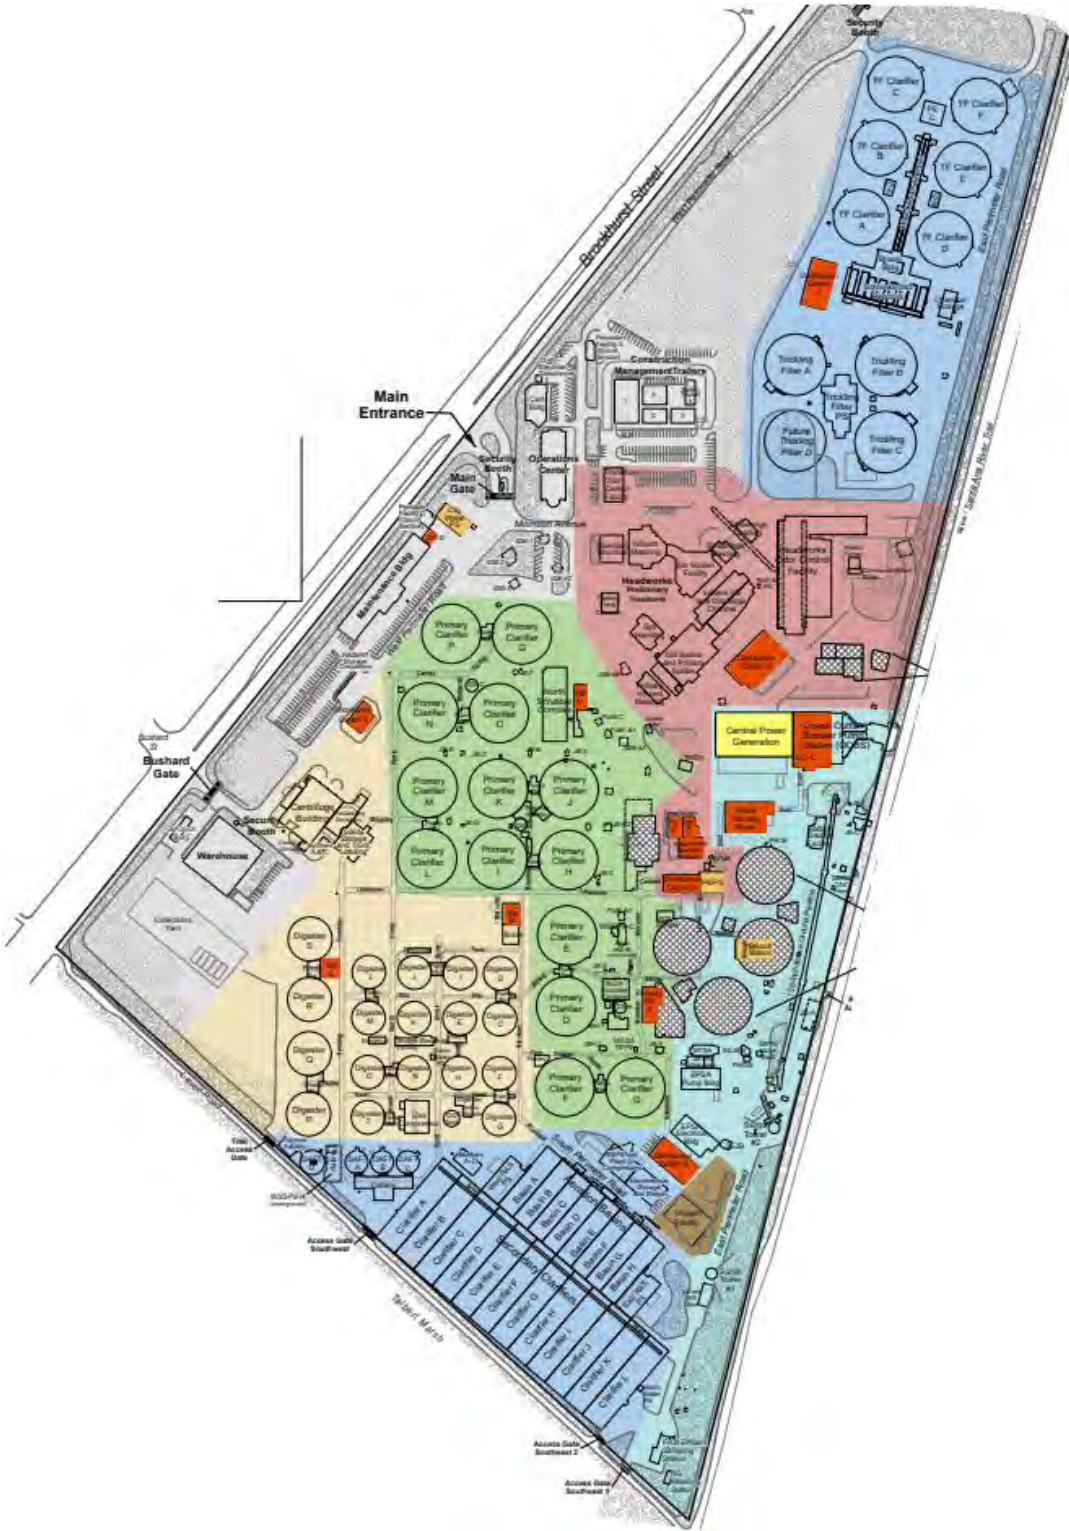
Occupied and Power Building Site Plan at Plant No. 2

AREA 29 ASSET MANAGEMENT SUMMARY – PLANT NO. 2 OCCUPIED & POWER BUILDINGS
