Asset Management Plan

2025

OC San owns and operates wastewater collection system infrastructure, as well as two resource recovery and wastewater treatment facilities located in Fountain Valley and Huntington Beach. Its collection system infrastructure includes over 380 miles of regional sewer pipelines and 15 pump stations throughout the OC San service area (Figure ES-1). Wastewater is conveyed to Reclamation Plant Number (No.) 1 in Fountain Valley and Reclamation Plant No. 2 in Huntington Beach. These facilities treat an average daily wastewater flow of 184 million gallons per day, serving approximately 2.6 million people in central and northwest Orange County, California.

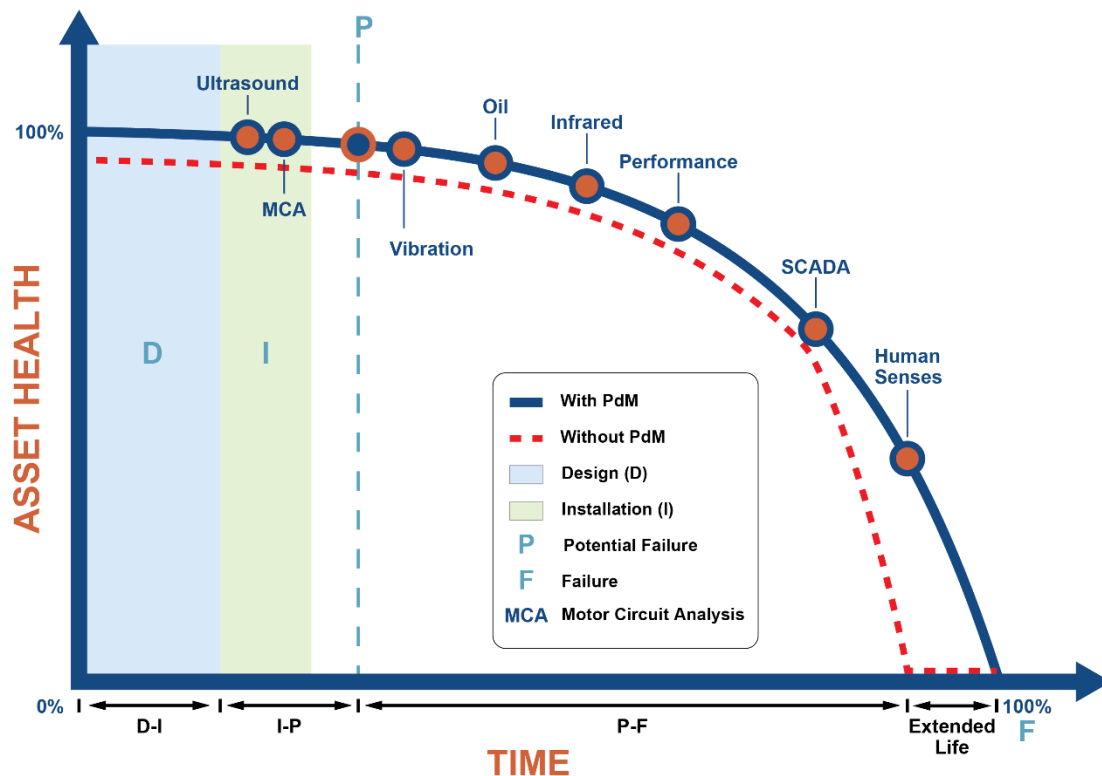
Figure 1-3. D-I-P-F Curve and PdM Summary

The ‘P-F’ curve is a concept that identifies the intervals between Potential Failure ‘P’ and Functional Failure ‘F’ and was first introduced by Stan Nowland and Howard Heap in 1978. The curve has since been extended to include Design ‘D’ and Installation ‘I’ by Doug Plucknette and is called the ‘D-I-P-F’ curve, also known as the Asset Life Cycle Curve (Figure 1-3).

which collects data through condition monitoring to provide real-time performance evaluation of assets. PdM is a proactive approach that minimizes unexpected breakdowns and extends the mean time between failures. It reduces not only the likelihood of failure but also overall equipment downtime and repair costs by monitoring the actual equipment health through quantifiable means and performing advanced analysis and failure detection to identify condition degradation in its early phase (Figure 1-3).

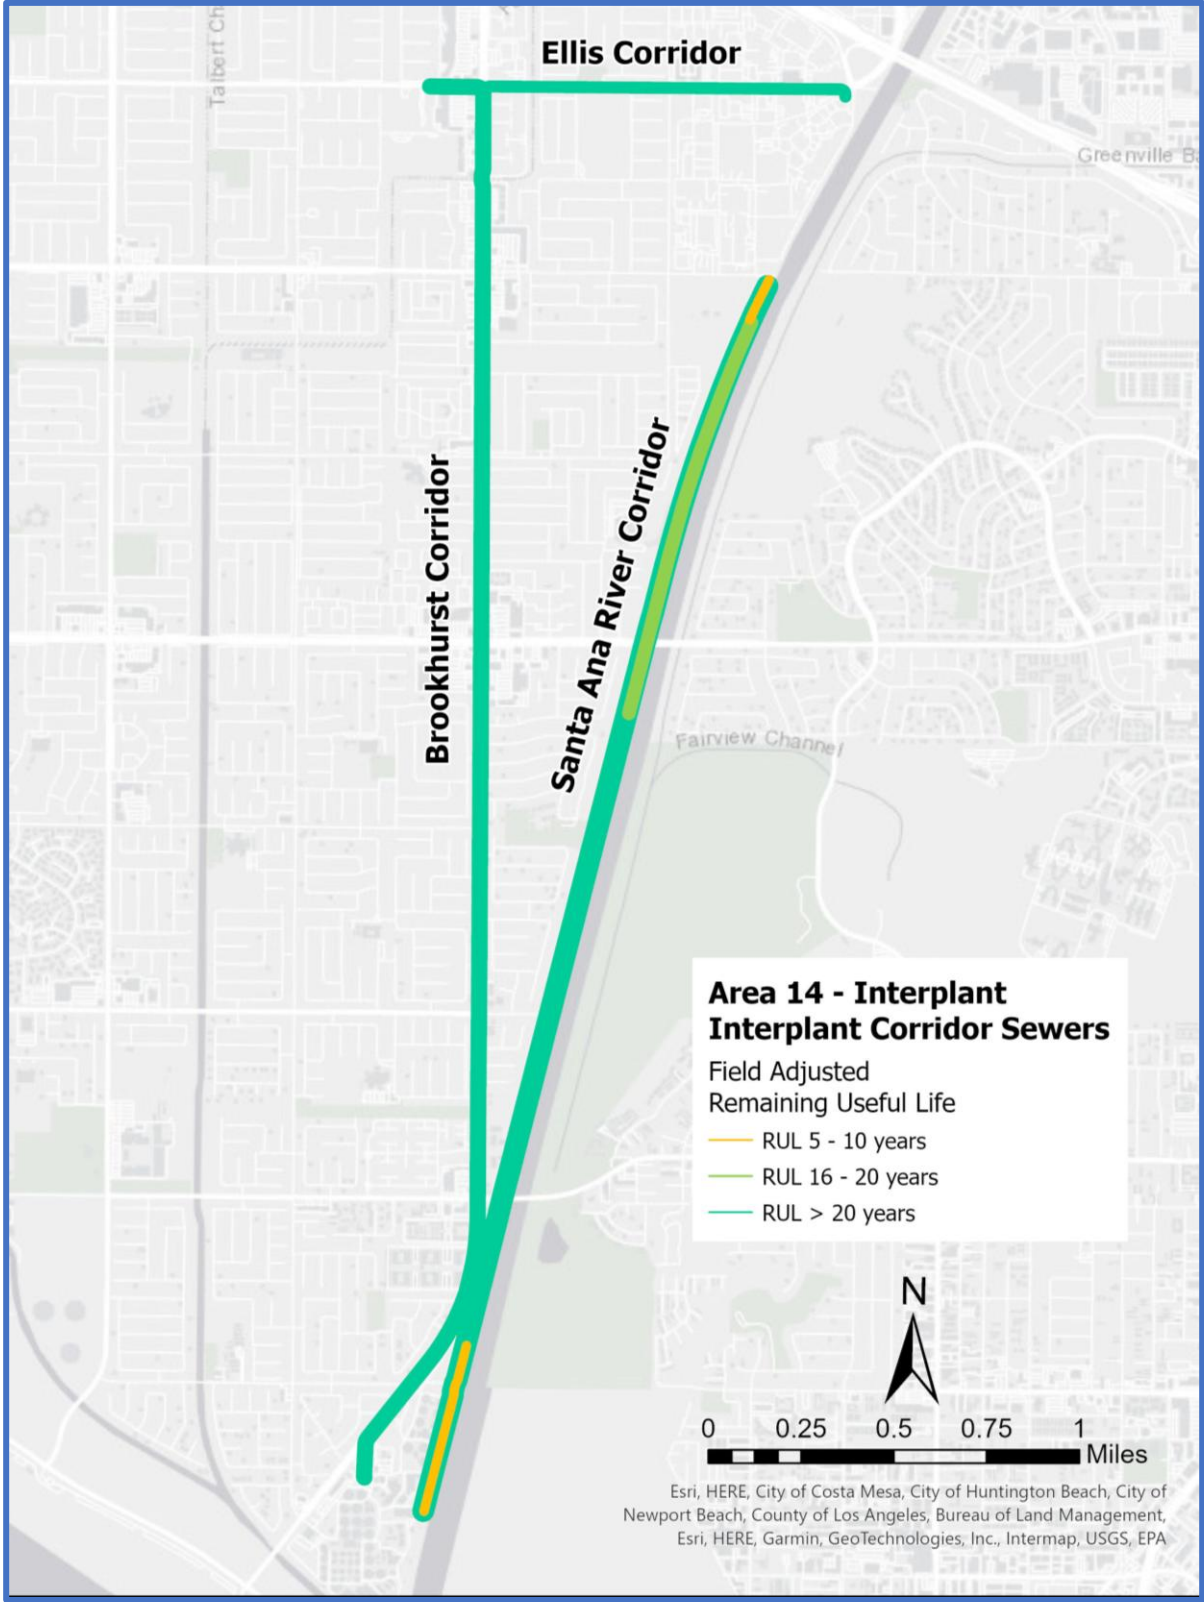
Remaining Useful Life Maps

AREA 14 ASSET MANAGEMENT SUMMARY – PLANT NO. 1 INTERPLANT

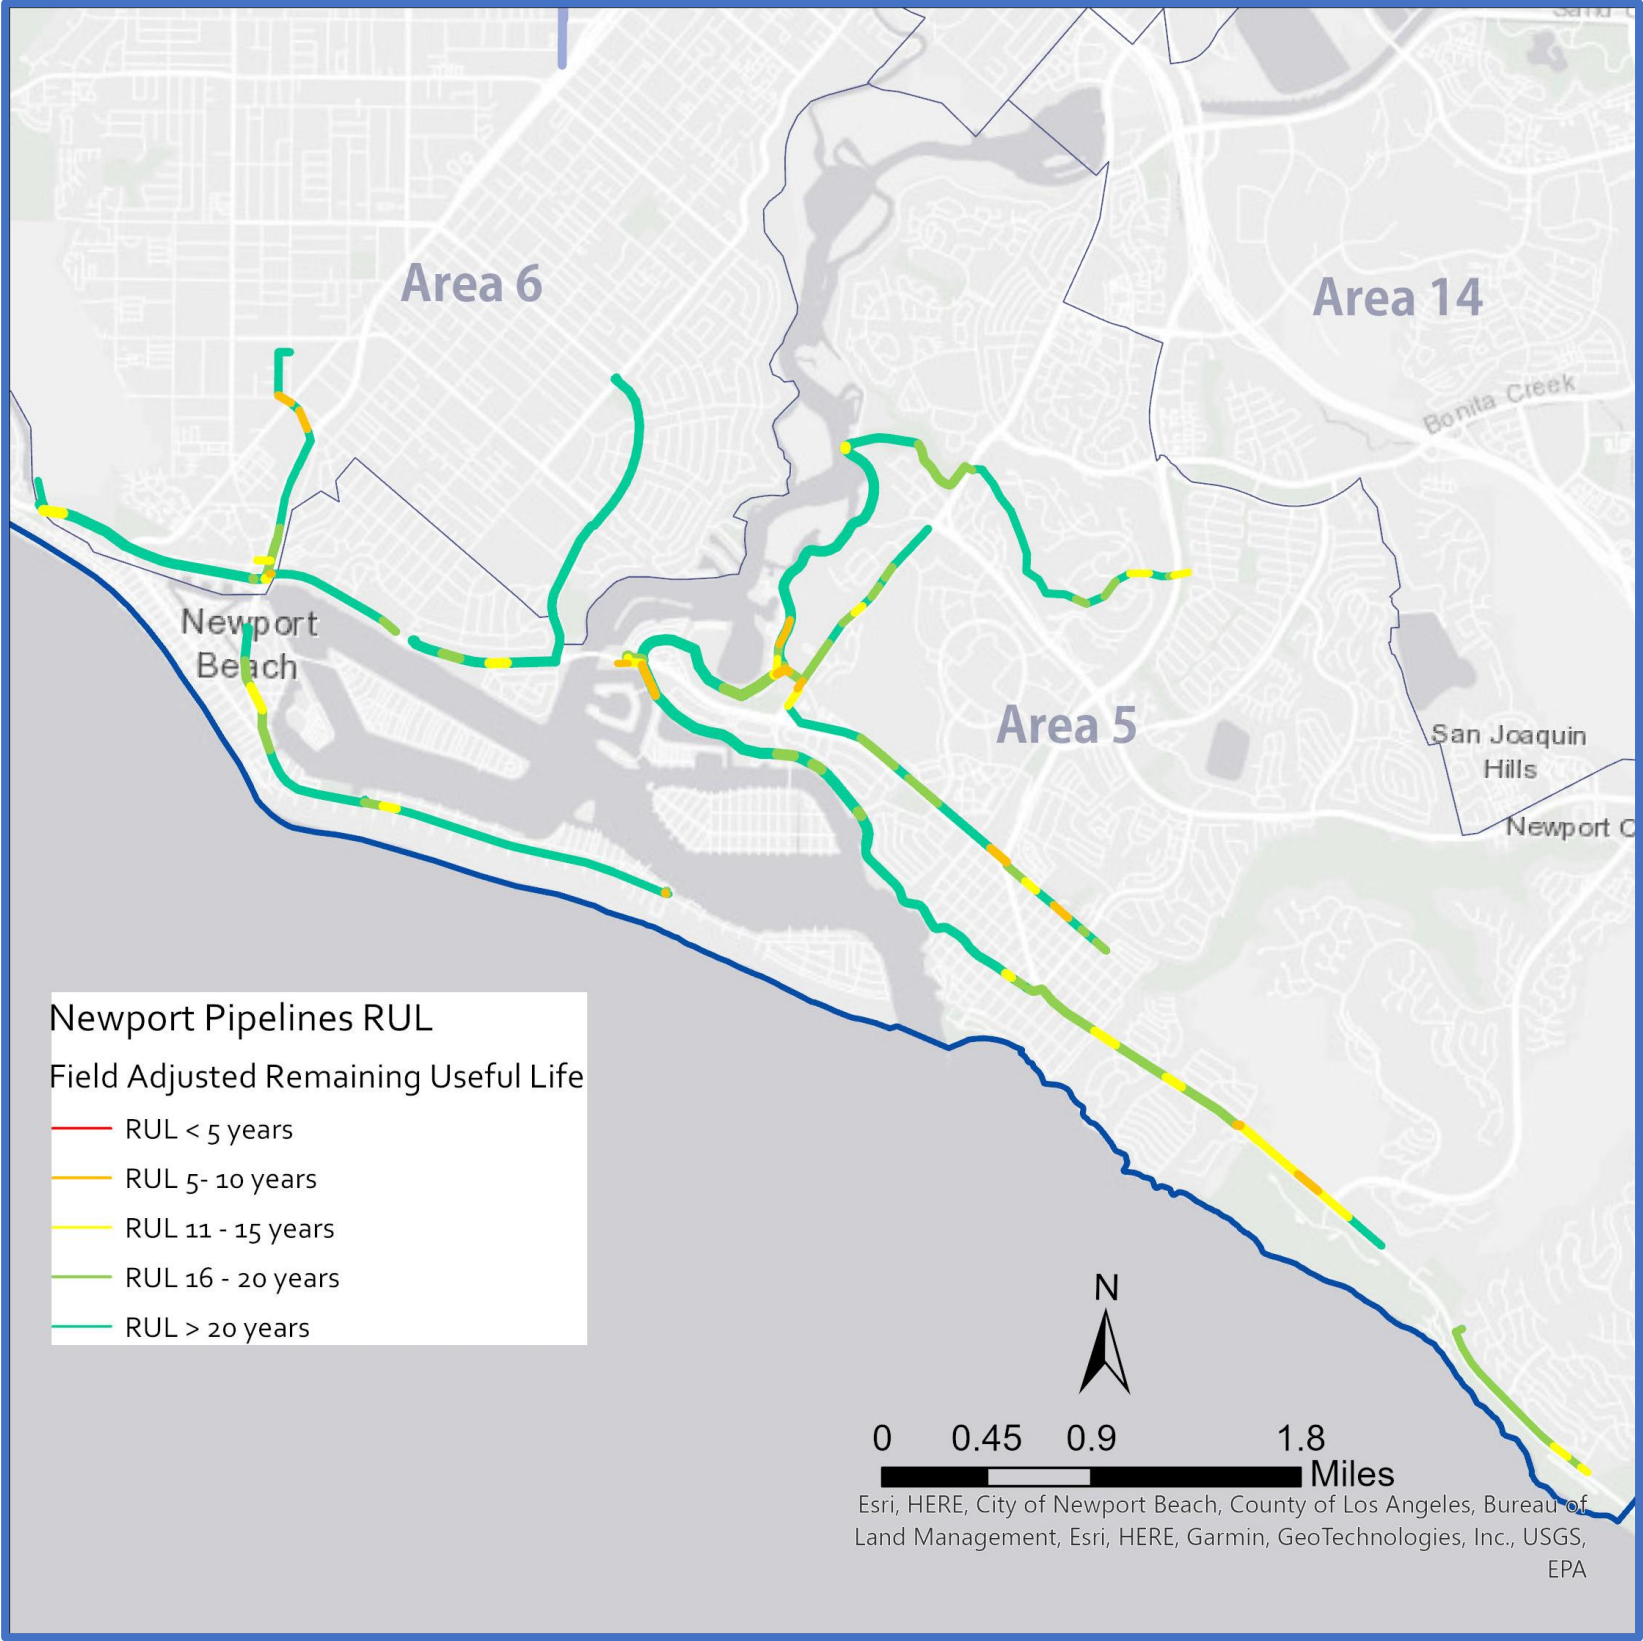
System Overview - Newport Pipelines

Major Assets and Condition Information - Newport Pipelines

Asset Type	Total Length (miles)	No. of Pipes	Average Age (years)	No. of Pipes with RUL Score of 5	No. of Pipes with RUL Score of 4
Vitrified Clay					
≤ 18" Ø	5.7	113	53	-	12
> 18" Ø	8.2	176	40	-	6
Ductile Iron					
≤ 18" Ø	1.3	18	32	-	1
> 18" Ø	2.6	35	36	-	1
Polyvinyl Chloride					
≤ 18" Ø	0.13	3	12	-	-
> 18" Ø	2.6	36	25	-	-
High-Density Polyethylene					
≤ 18" Ø	0.13	2	33	-	-
> 18" Ø	0.66	14	31	-	-
Cast Iron					
≤ 18" Ø	0.12	2	50	-	-
Reinforced Concrete					
48" Ø	0.02	1	13	-	-
