Asset Management Plan 2024

OC San will know the condition of assets we own and will have a plan to operate and maintain these assets to deliver the required level of service, at the lowest life cycle cost, with an acceptable level of risk.

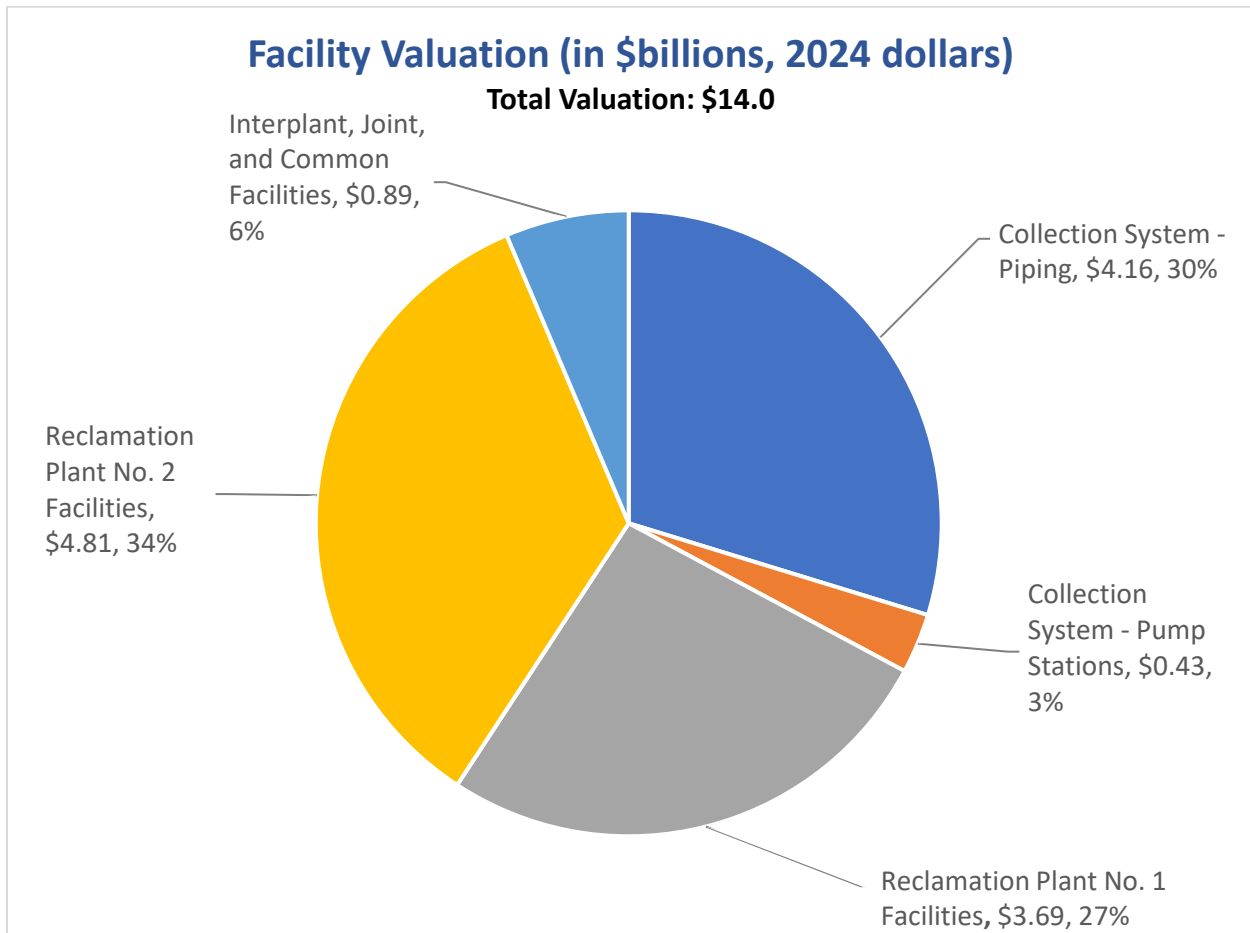
Figure ES-2. Facility Valuation by Location

Figure ES-2 shows the facility valuation by asset system for OC San’s wastewater infrastructure. The original valuation was prepared as part of the 2017 Facilities Master Plan. The estimated replacement value in Fiscal Year (FY) 2024–2025 is \$14.0 billion based on the Engineering News-Record Construction Cost Index increases since the 2017 Facilities Master Plan.

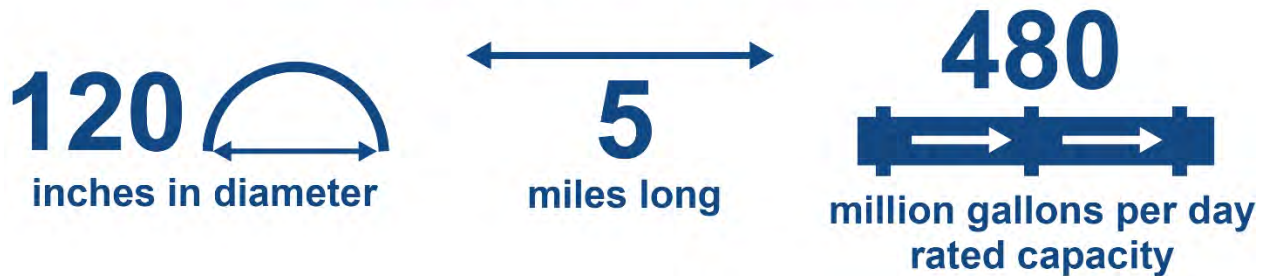
OUTFALL NO. 2 PRIMARY OCEAN OUTFALL

Outfall No. 2 serves as the primary ocean outfall, discharging treated wastewater approximately 5 miles offshore at a depth of approximately 200 feet. It began service in 1971. Based on the findings of a comprehensive assessment study completed in 2022, a rehabilitation project is in progress to ensure the outfall’s reliability for many years to come.

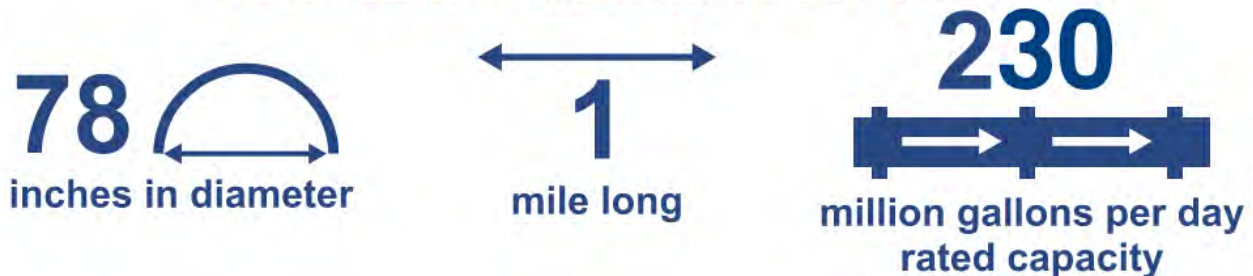
OUTFALL NO. 1 EMERGENCY OUTFALL

Outfall No. 1 serves as an emergency outfall and primary backup to Outfall No. 2, discharging treated wastewater over a mile offshore at a depth of approximately 65 feet. It was originally constructed in 1954 and was later modified in 1965. OC San’s NPDES permit specifies that this outfall can be used only in the case of an emergency or during planned maintenance activities.

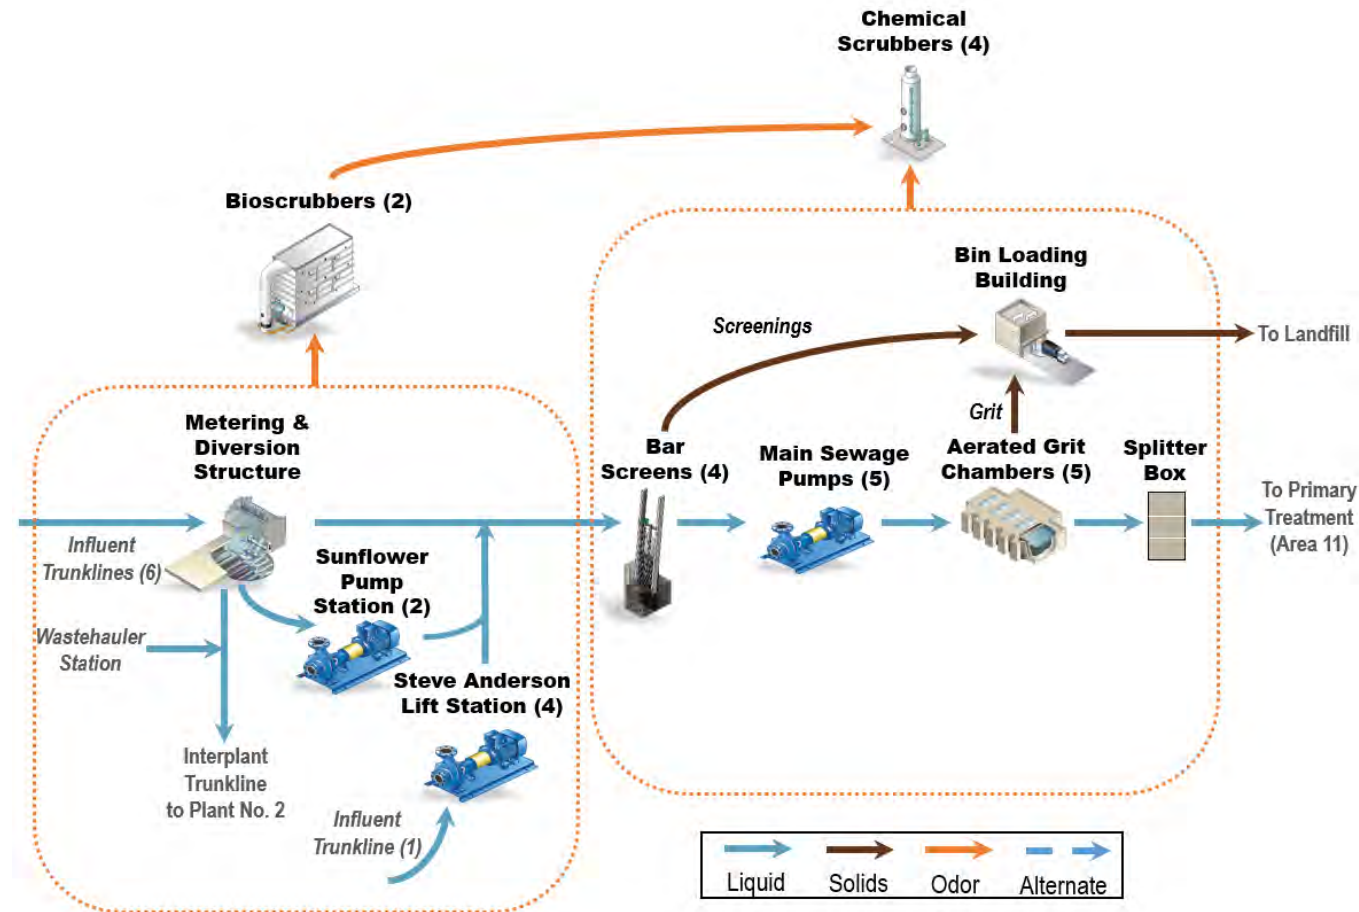
Process Schematic

AREA 10 ASSET MANAGEMENT SUMMARY – PLANT NO. 1 PRELIMINARY TREATMENT

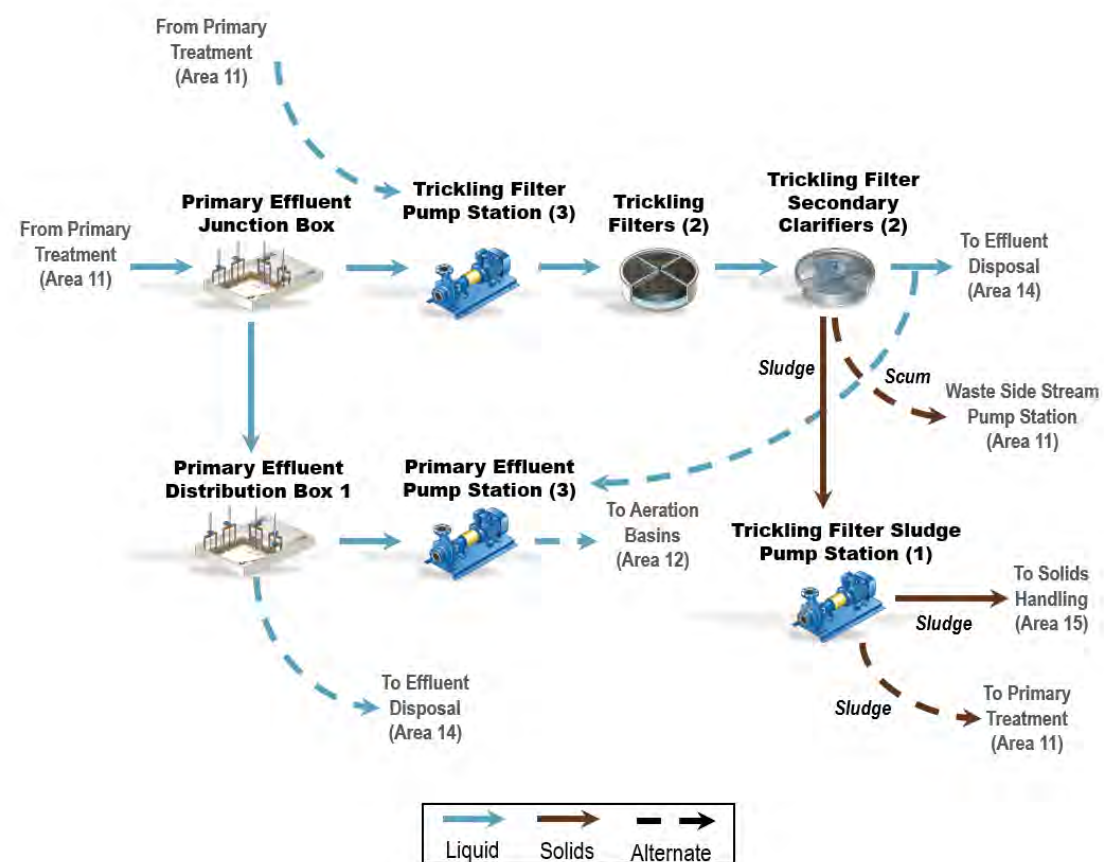
Process Schematic

AREA 12 ASSET MANAGEMENT SUMMARY – PLANT NO. 1 SECONDARY TREATMENT – TRICKLING FILTERS

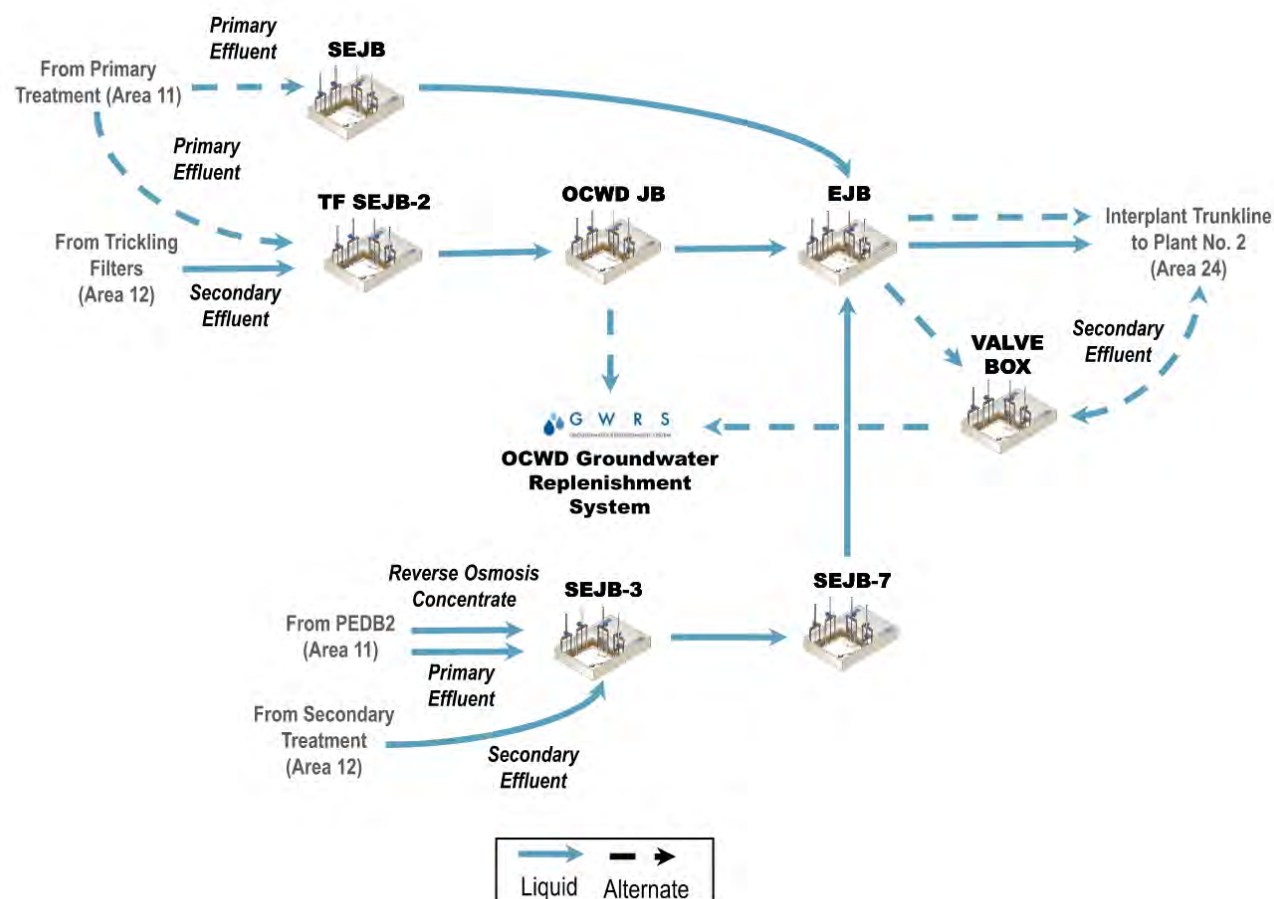
Process Schematic

AREA 14 ASSET MANAGEMENT SUMMARY – PLANT NO. 1 INTERPLANT

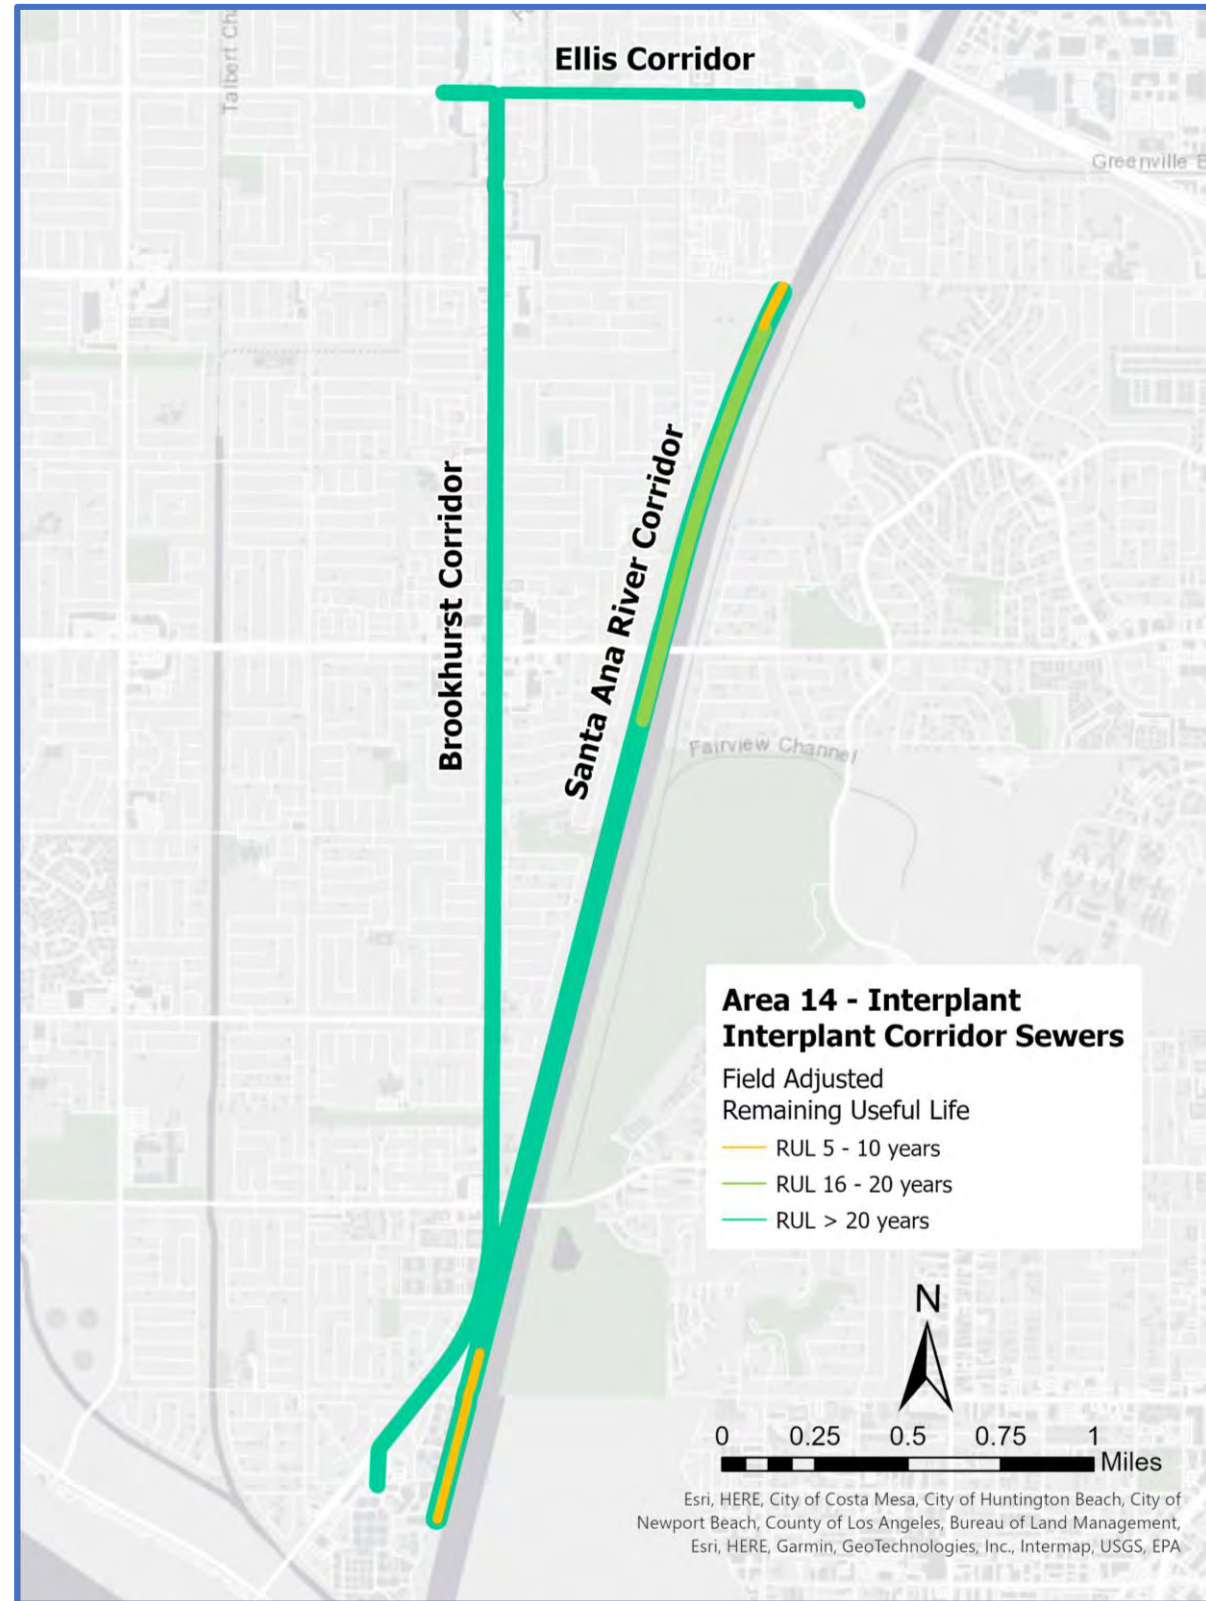
Remaining Useful Life Maps

AREA 14 ASSET MANAGEMENT SUMMARY – PLANT NO. 1 INTERPLANT

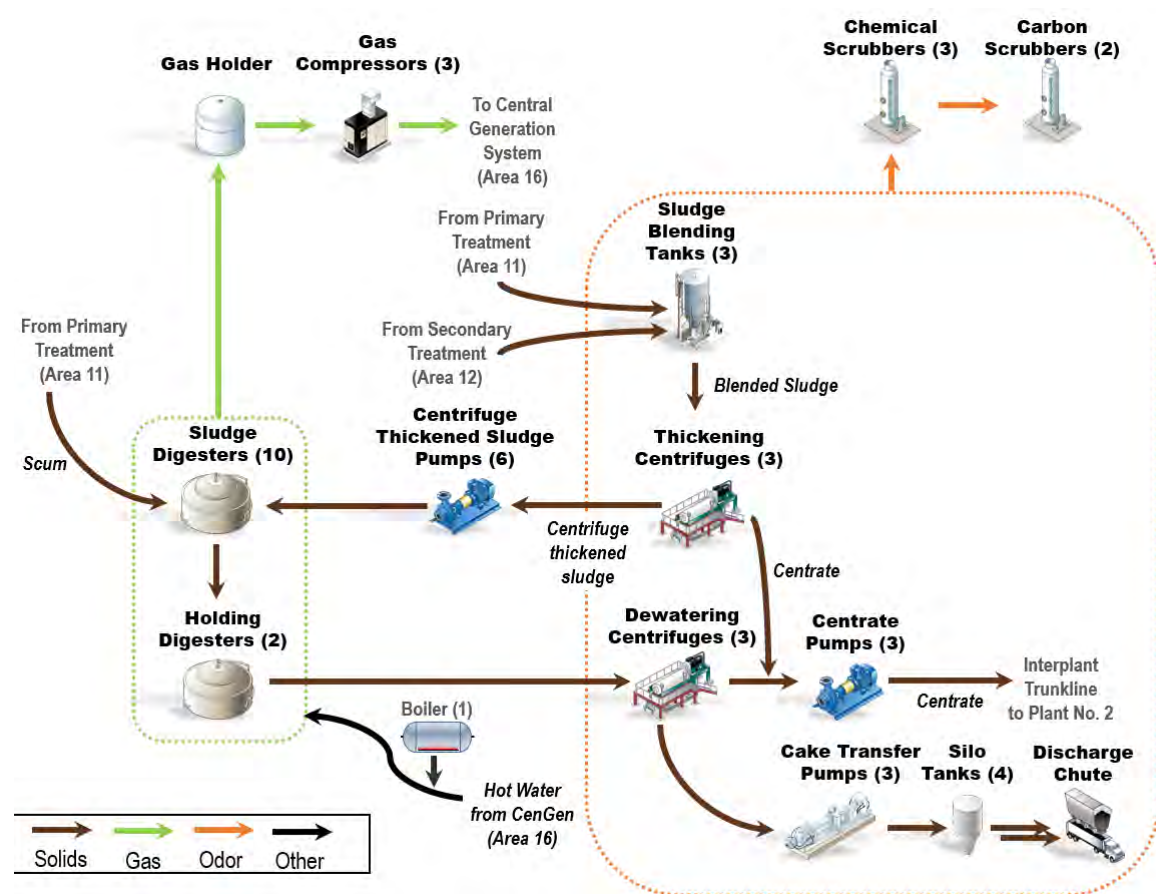
AREA 15 ASSET MANAGEMENT SUMMARY – PLANT NO. 1 SOLIDS HANDLING – DIGESTERS

Note: Process Schematic shows entire Area 15 Solids Handling Facility.

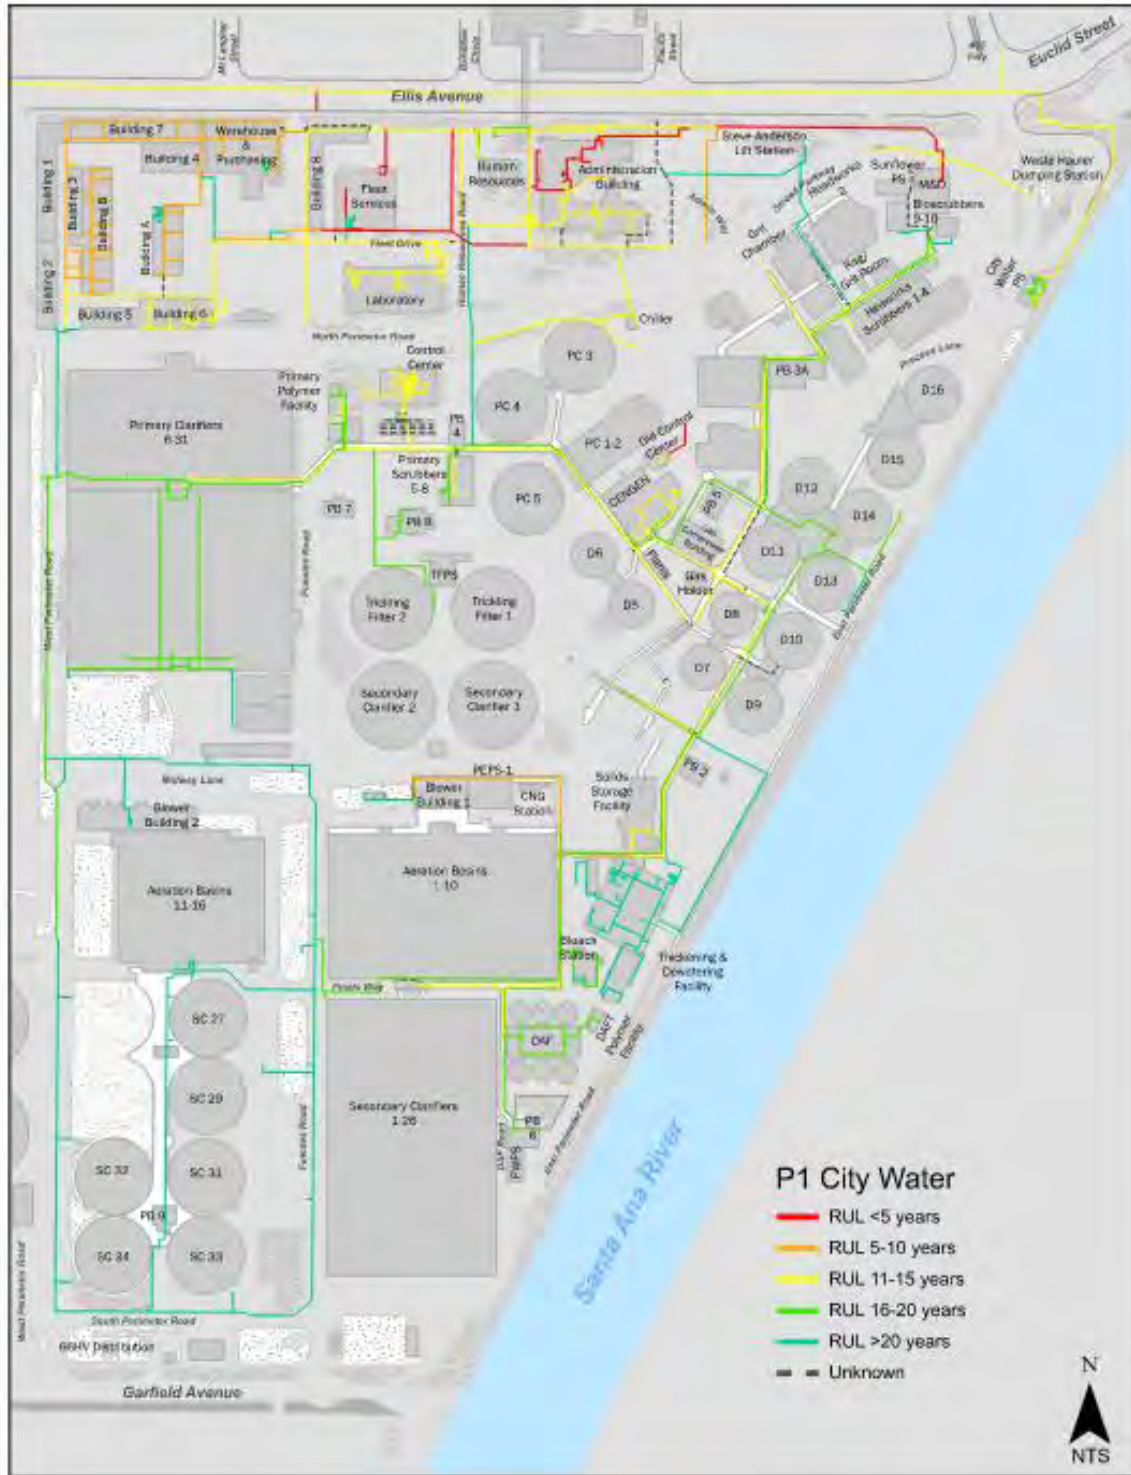
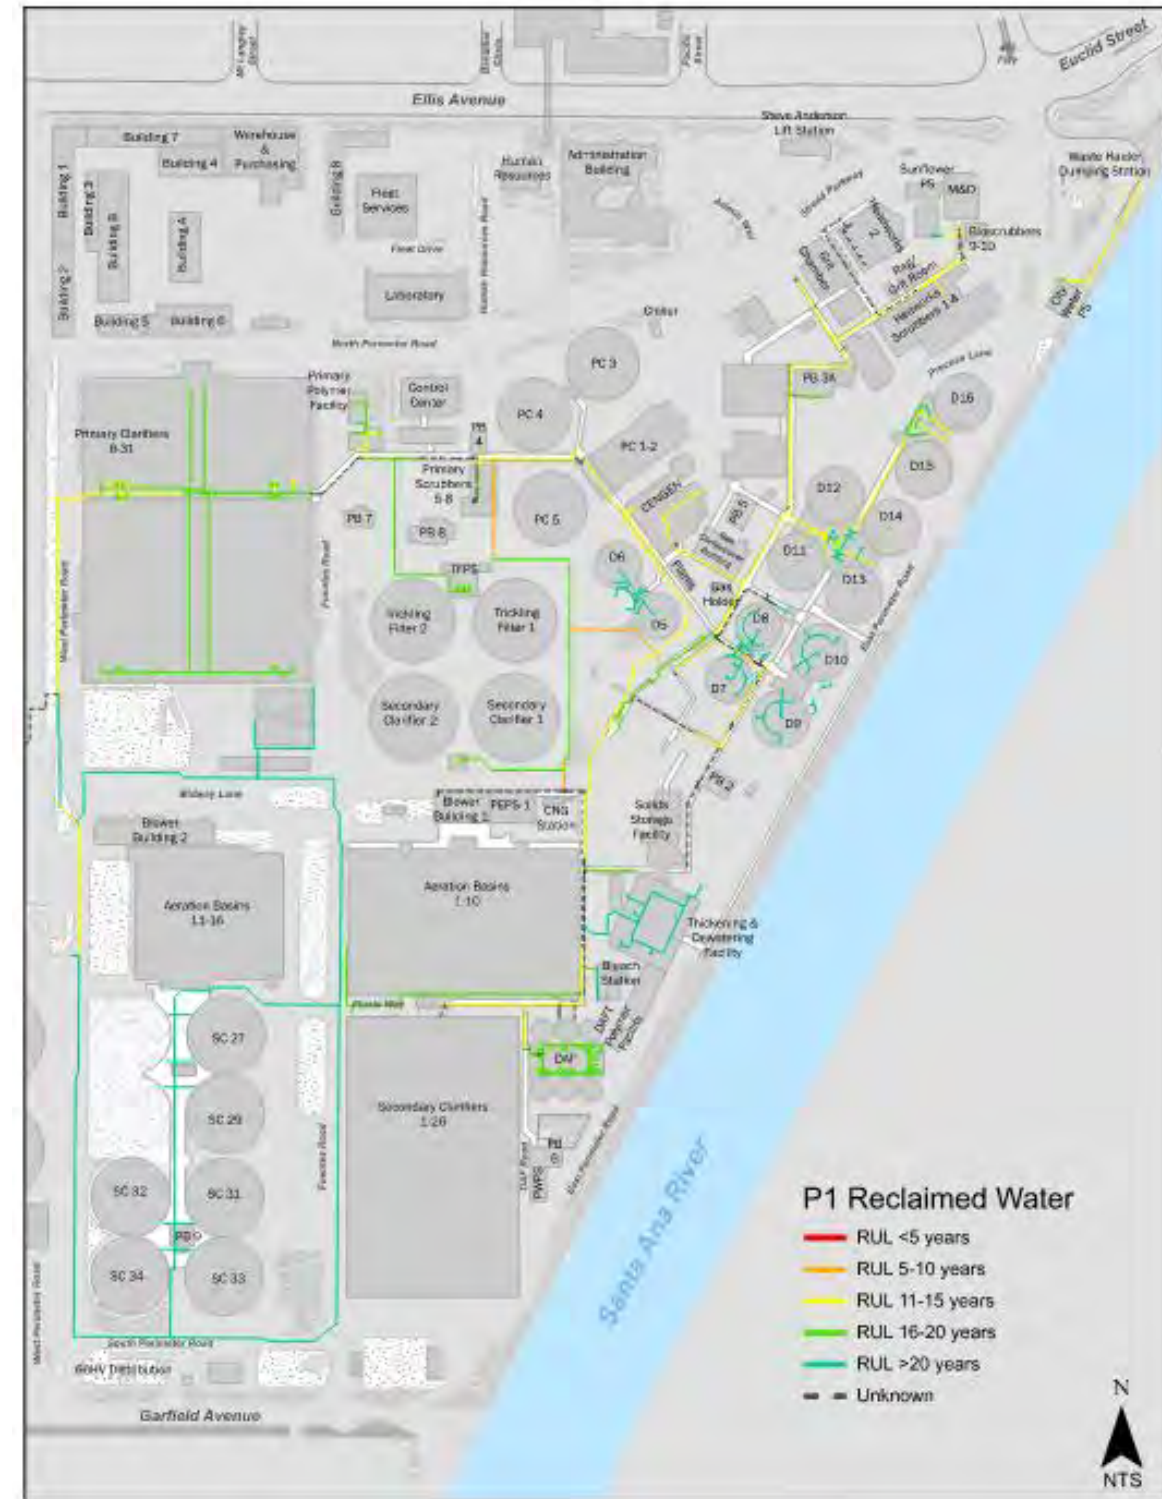
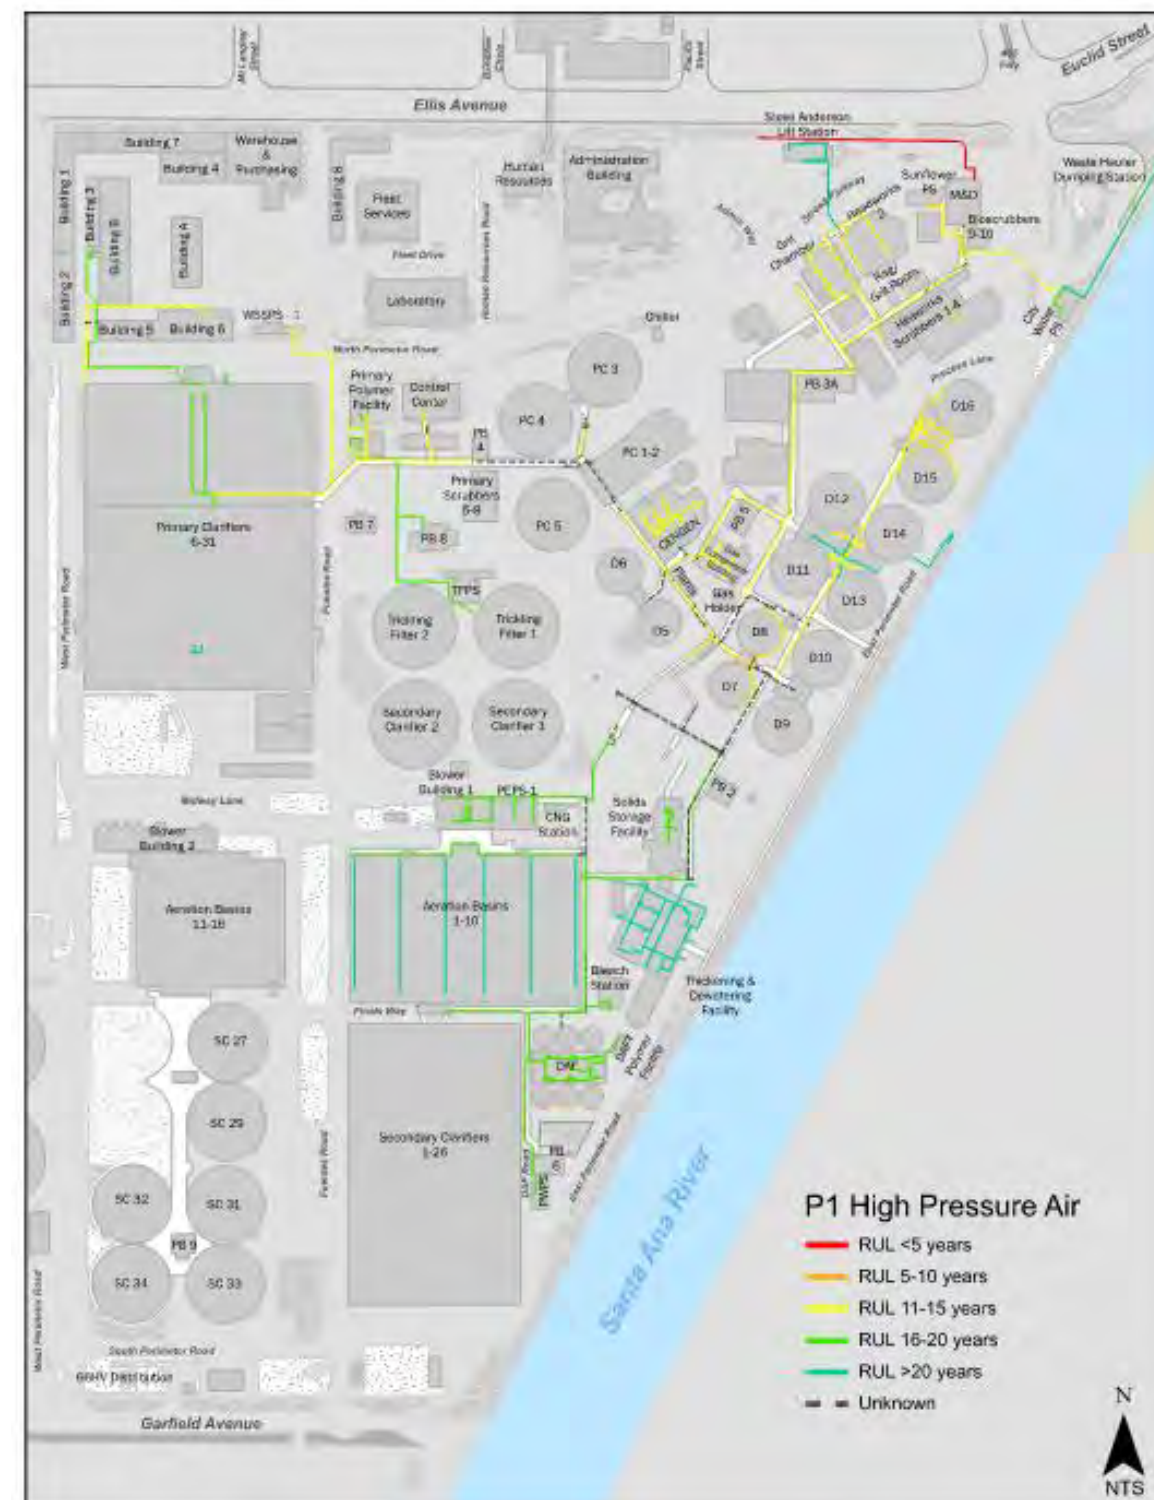
Remaining Useful Life of Utility Infrastructure

AREA 17 ASSET MANAGEMENT SUMMARY – PLANT NO. 1 UTILITIES

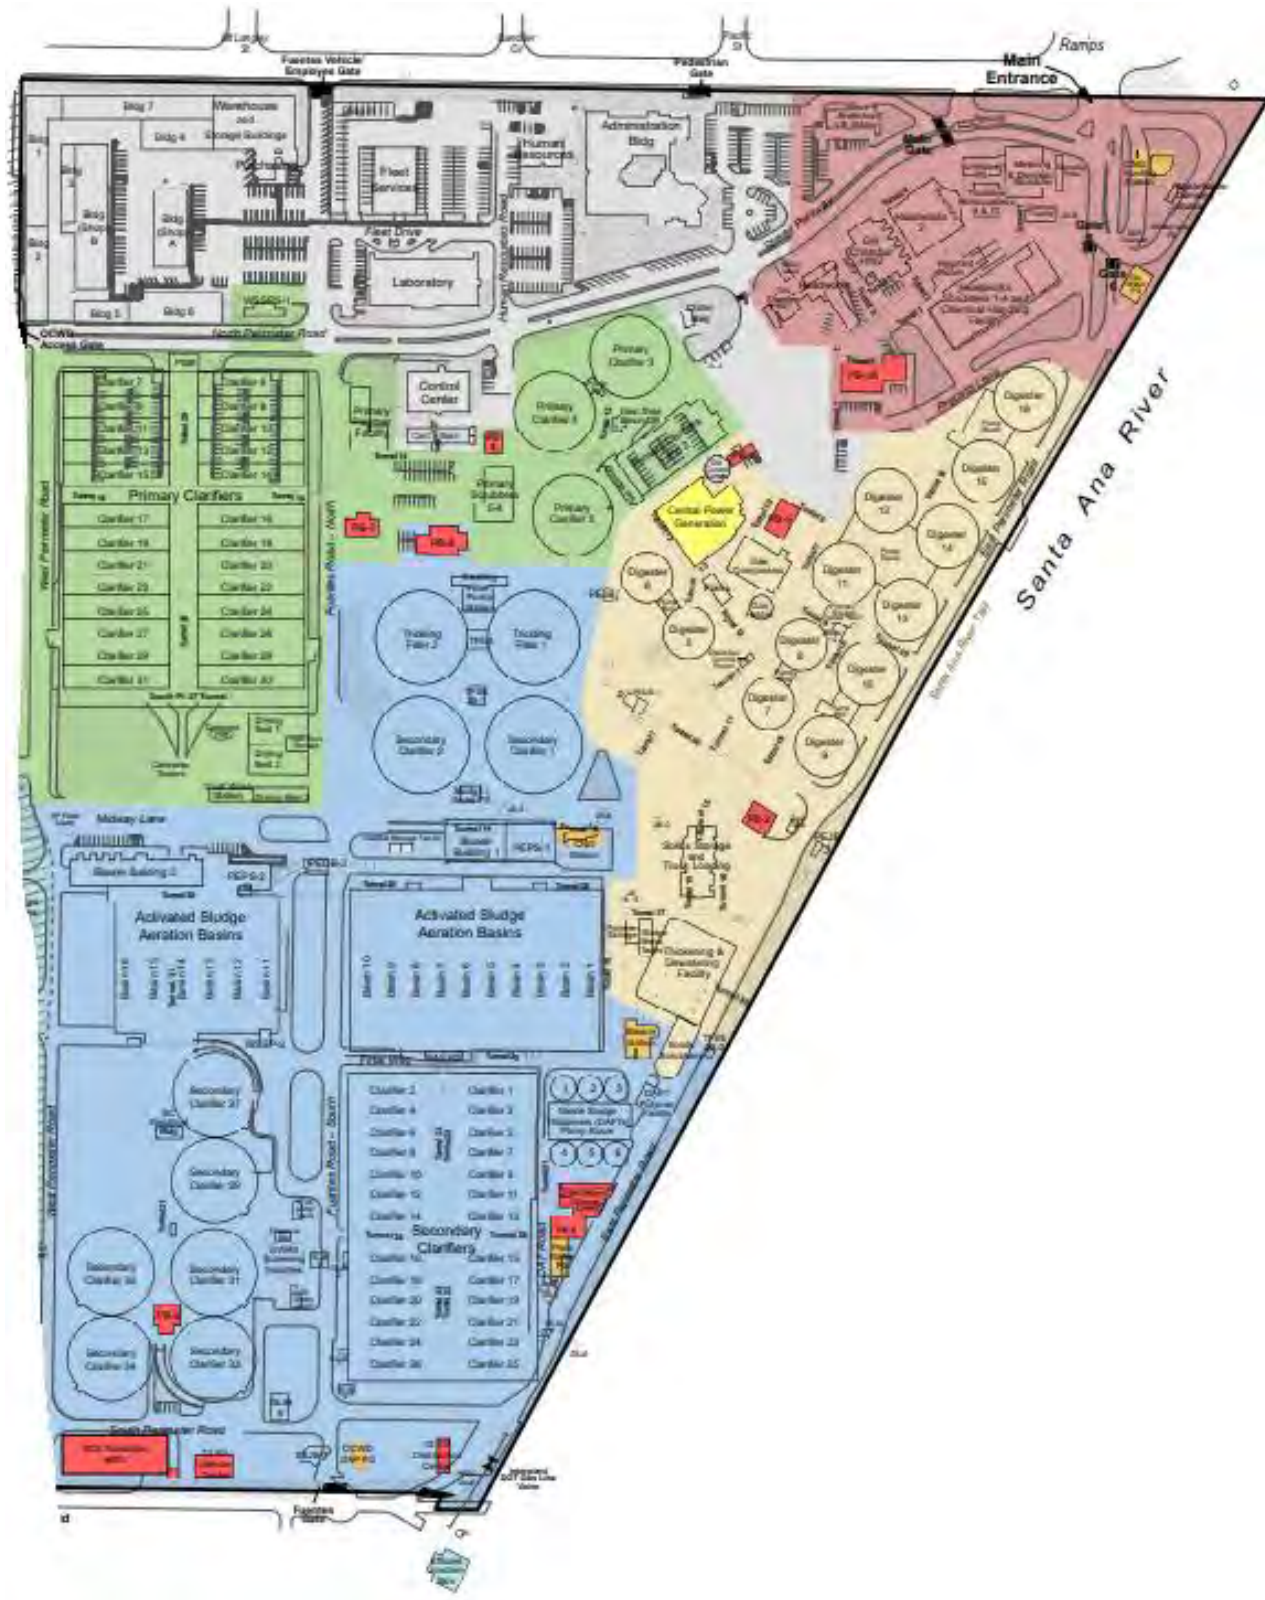
Occupied and Power Building Site Plan at Plant No. 1

AREA 19 ASSET MANAGEMENT SUMMARY – PLANT NO. 1 OCCUPIED & POWER BUILDINGS

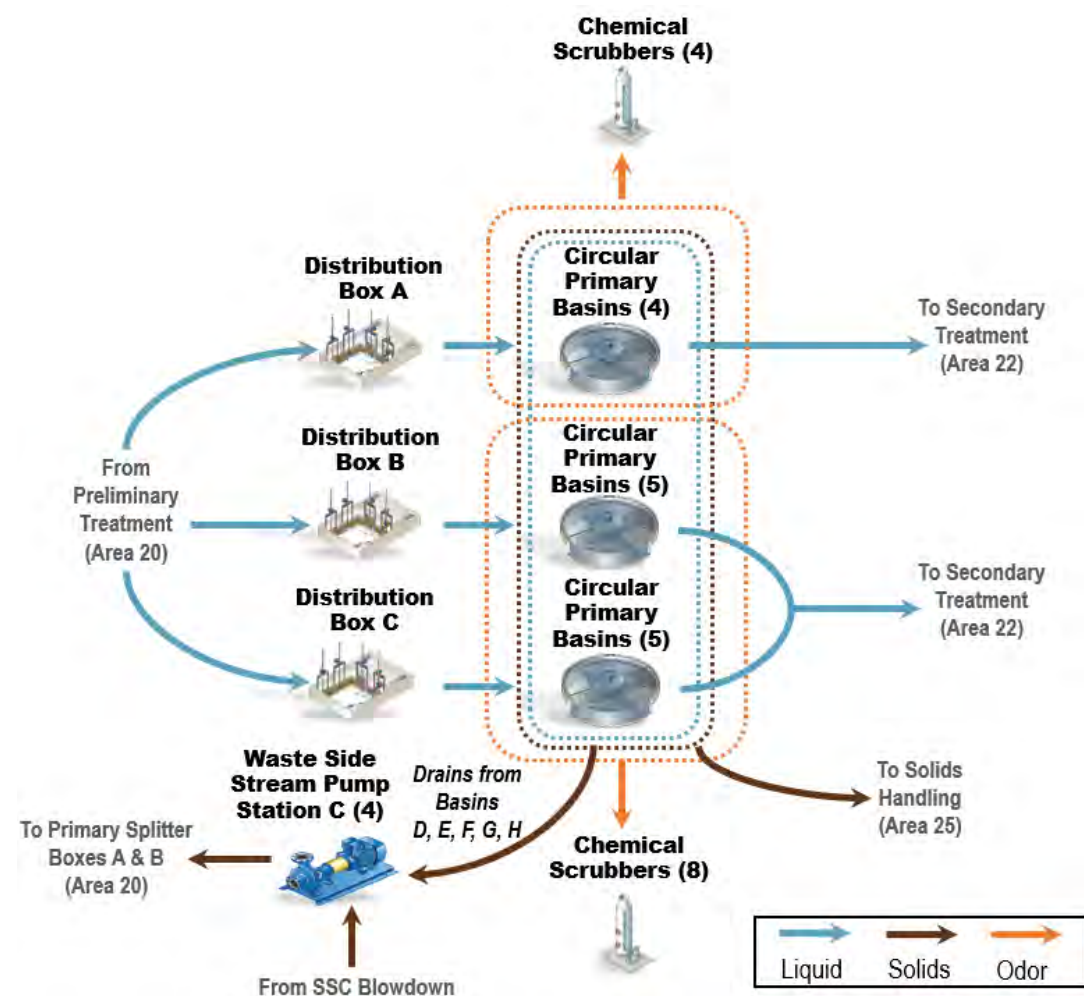
Process Schematic

AREA 21 ASSET MANAGEMENT SUMMARY – PLANT NO. 2 PRIMARY TREATMENT

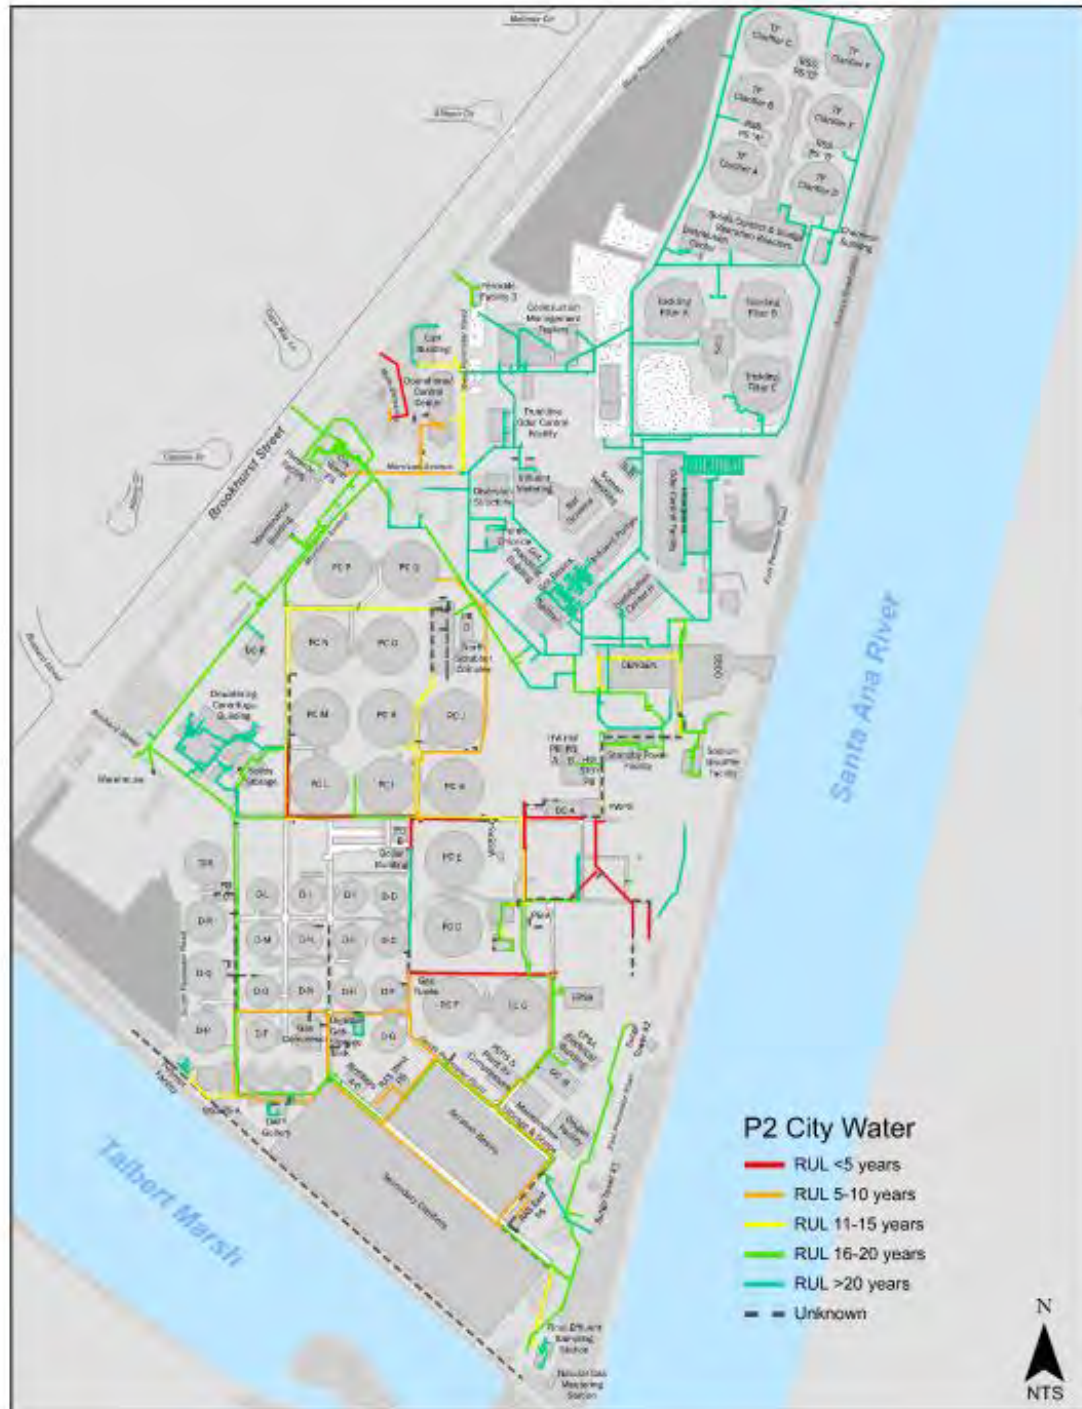
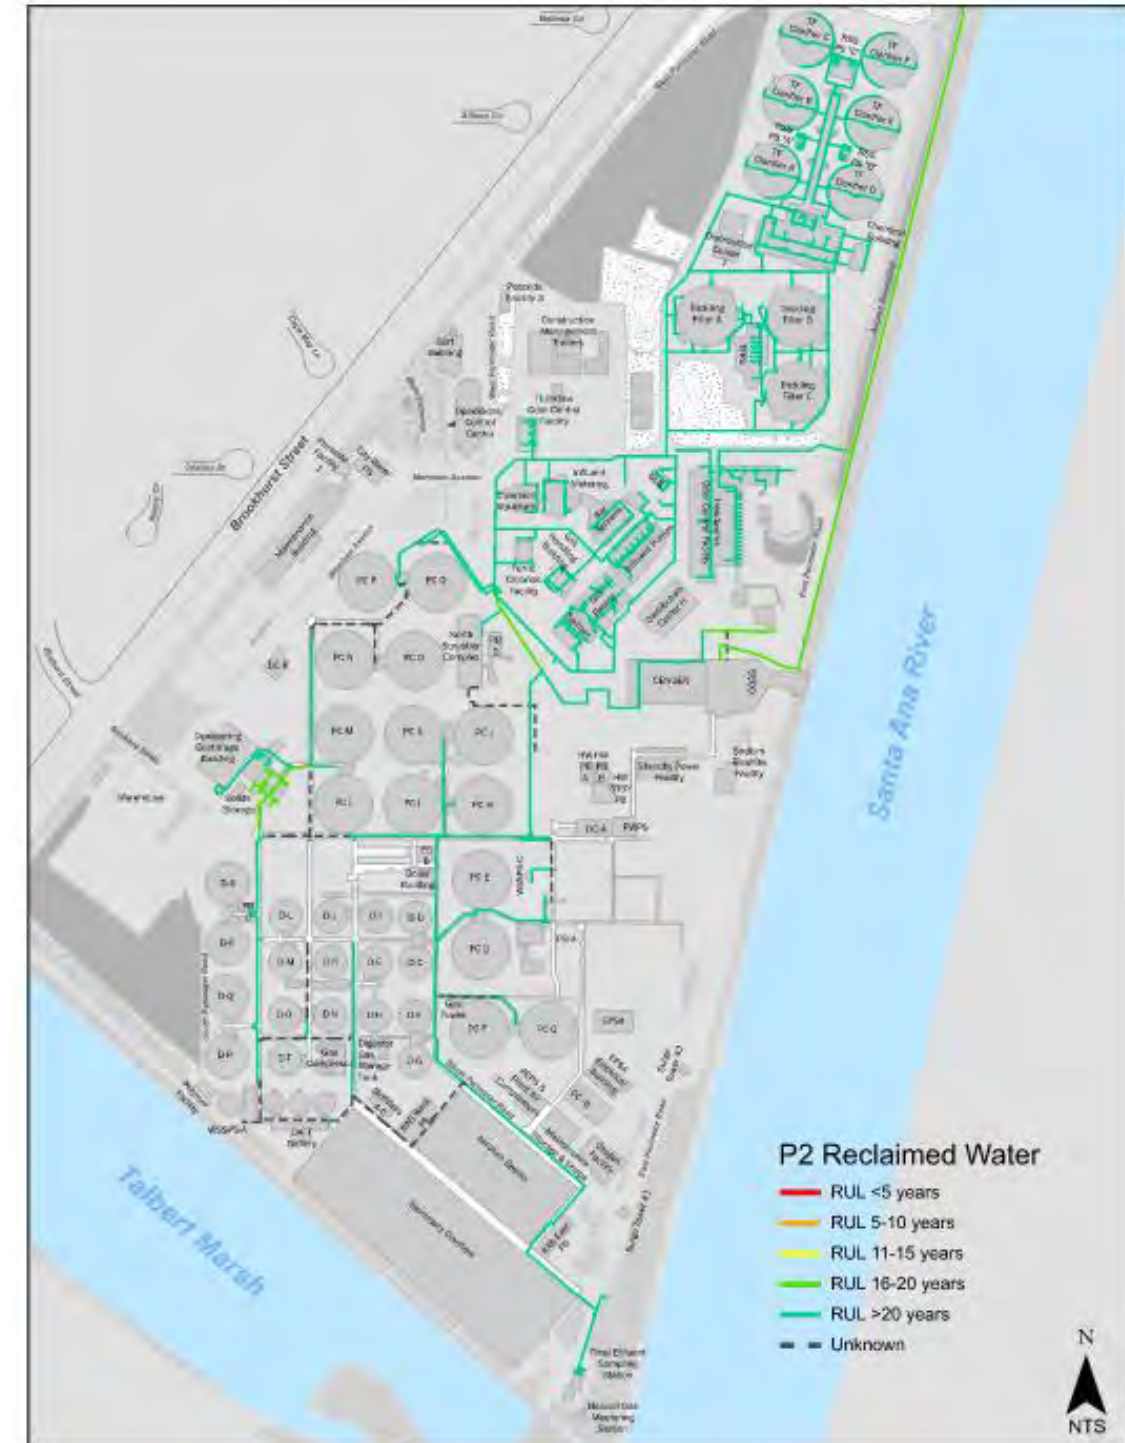
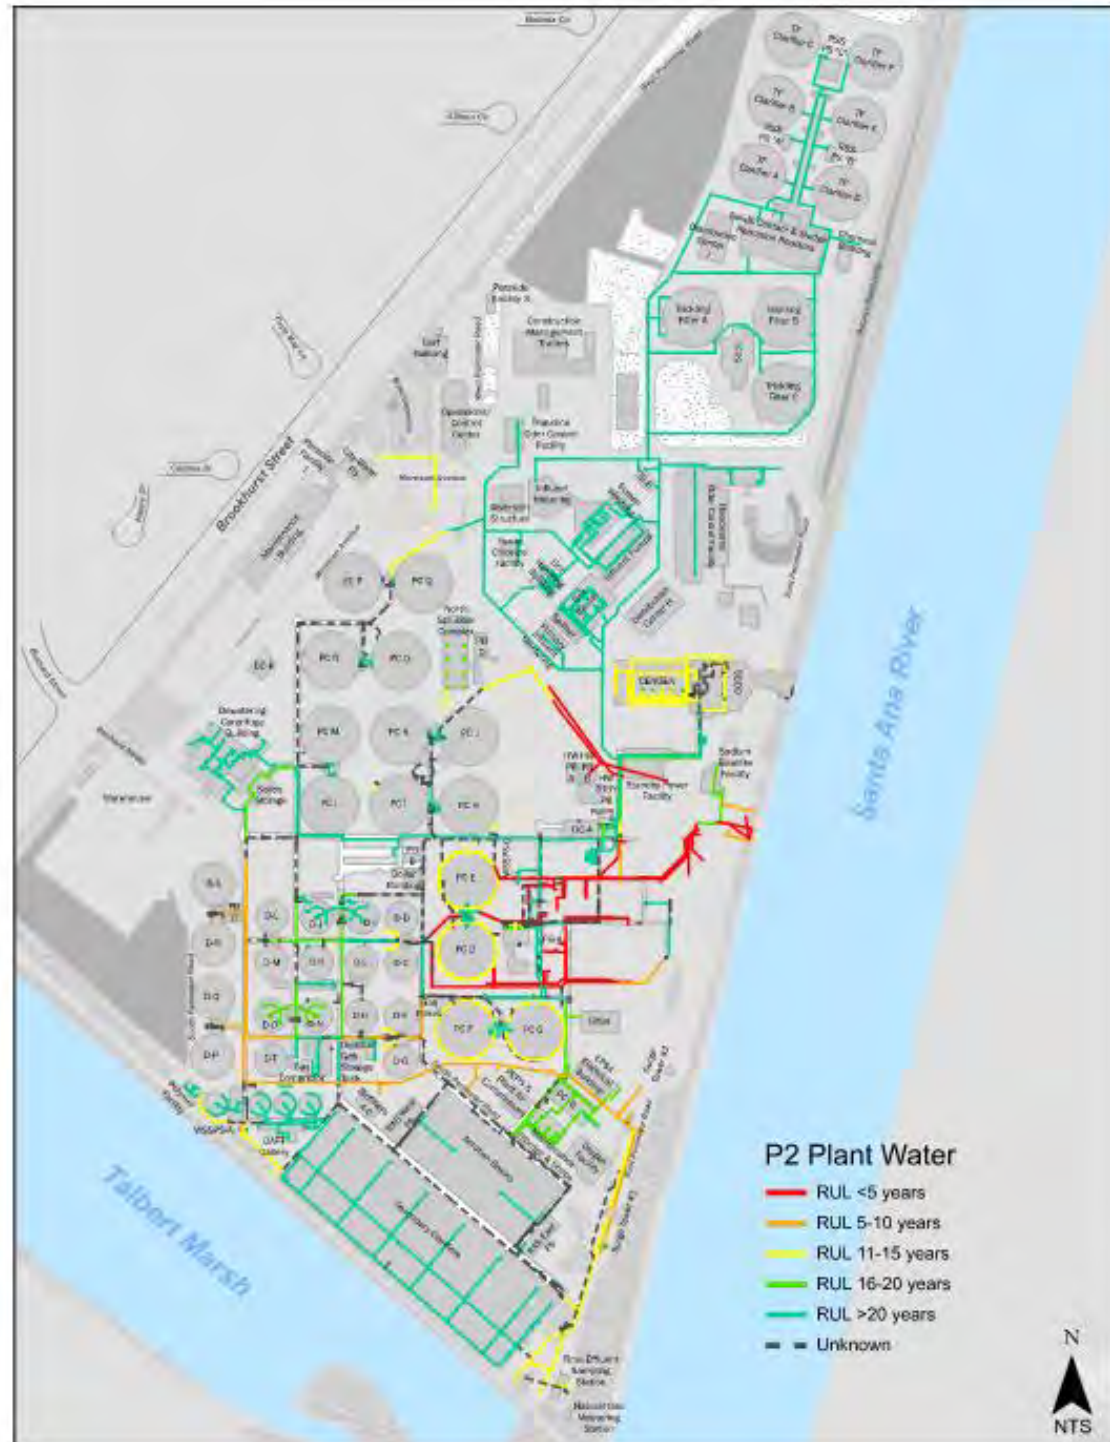
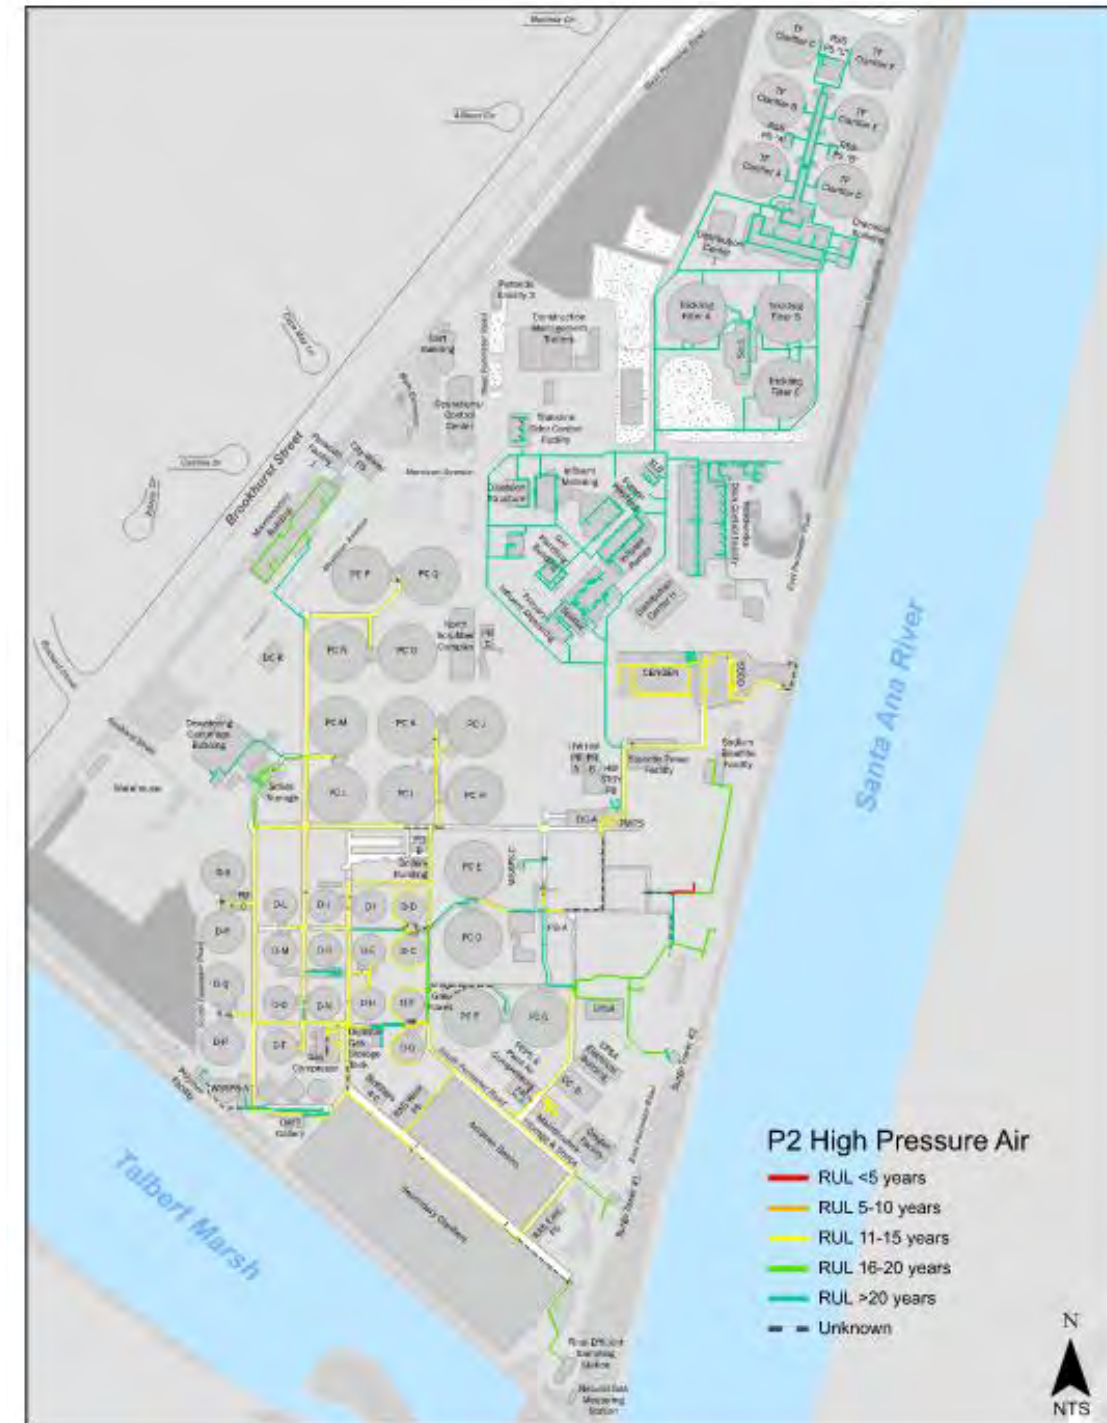
Remaining Useful Life of Utility Infrastructure

AREA 27 ASSET MANAGEMENT SUMMARY – PLANT NO. 2 UTILITIES
