Asset Management Plan 2024

OC San will know the condition of assets we own and will have a plan to operate and maintain these assets to deliver the required level of service, at the lowest life cycle cost, with an acceptable level of risk.

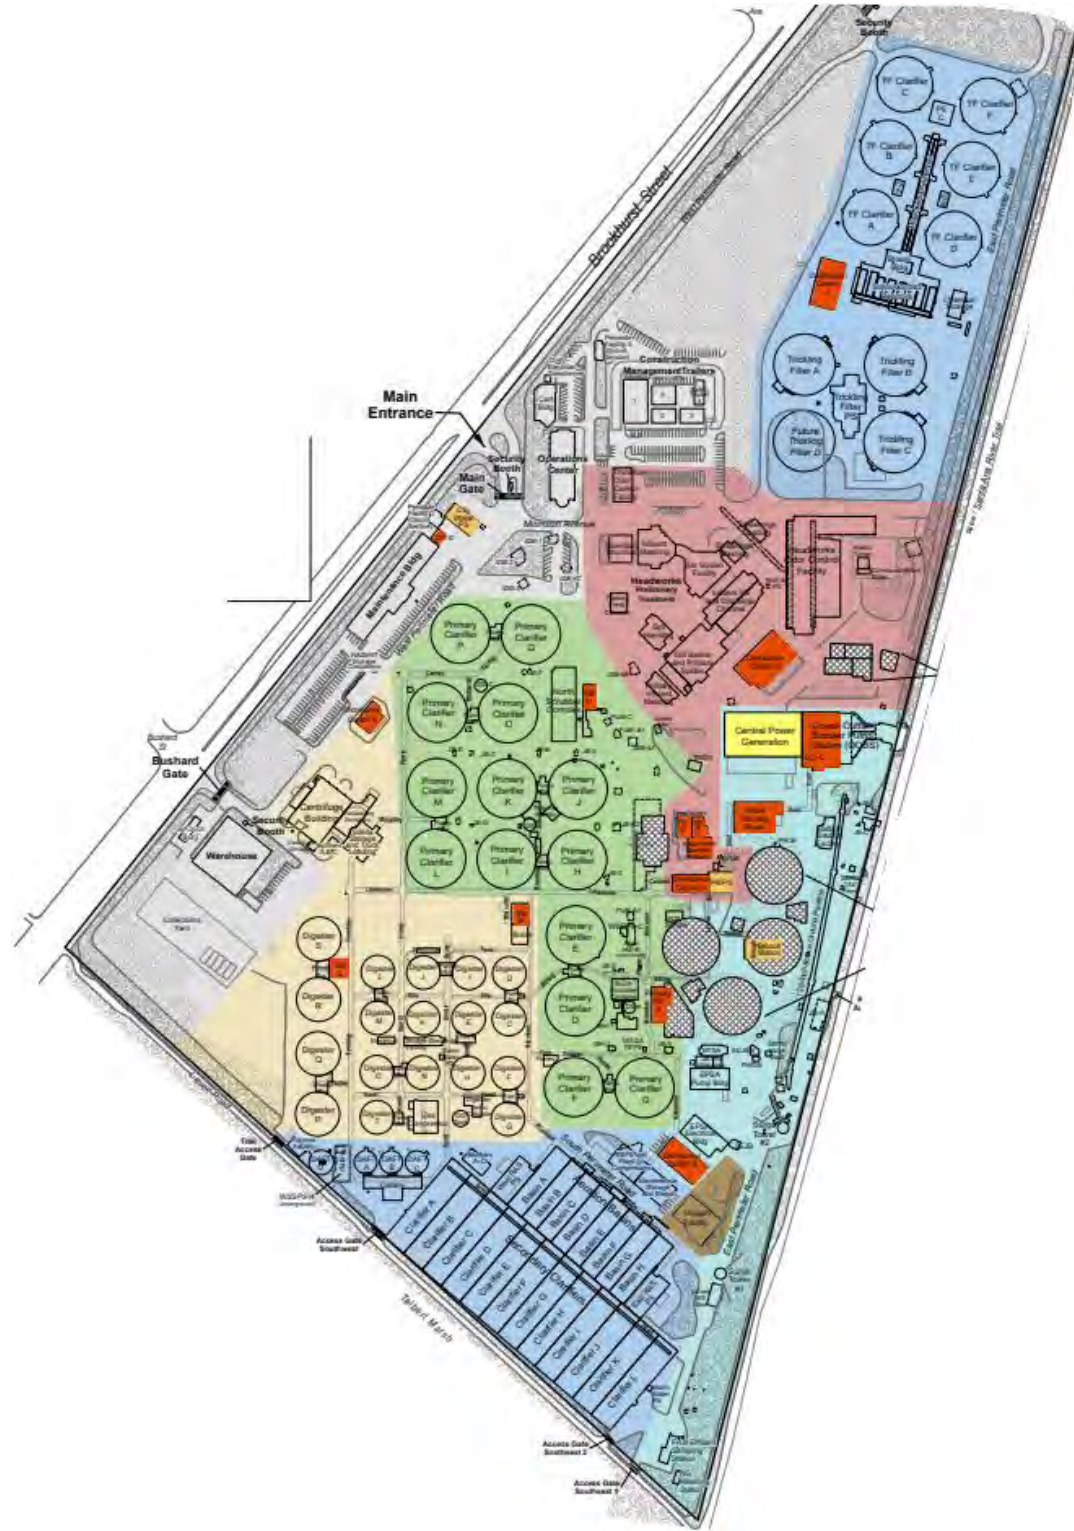
Occupied and Power Building Site Plan at Plant No. 2

AREA 29 ASSET MANAGEMENT SUMMARY – PLANT NO. 2 OCCUPIED & POWER BUILDINGS
