Asset Management Plan

2023

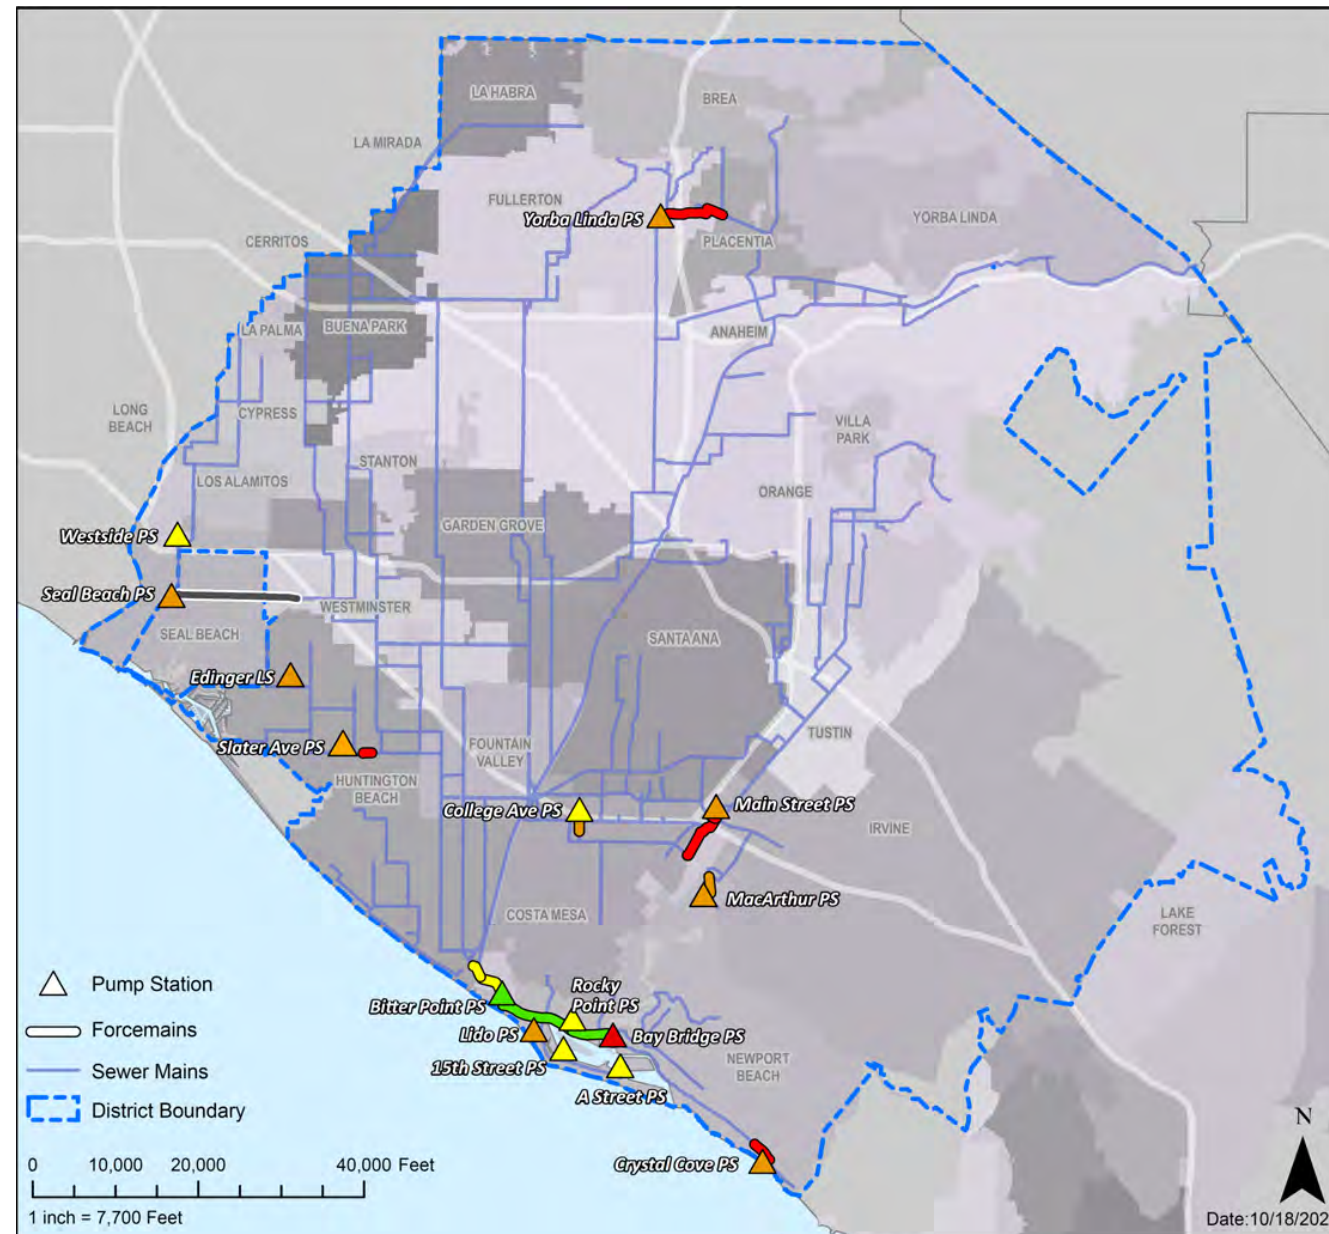
Figure ES-1-5. Collection System Pump Station – Remaining Useful Life Score Map

Note: Not all pump station force mains are shown on this map. Only longer force mains are shown. Scores for force mains come from actual force main scores in Chapter 2.

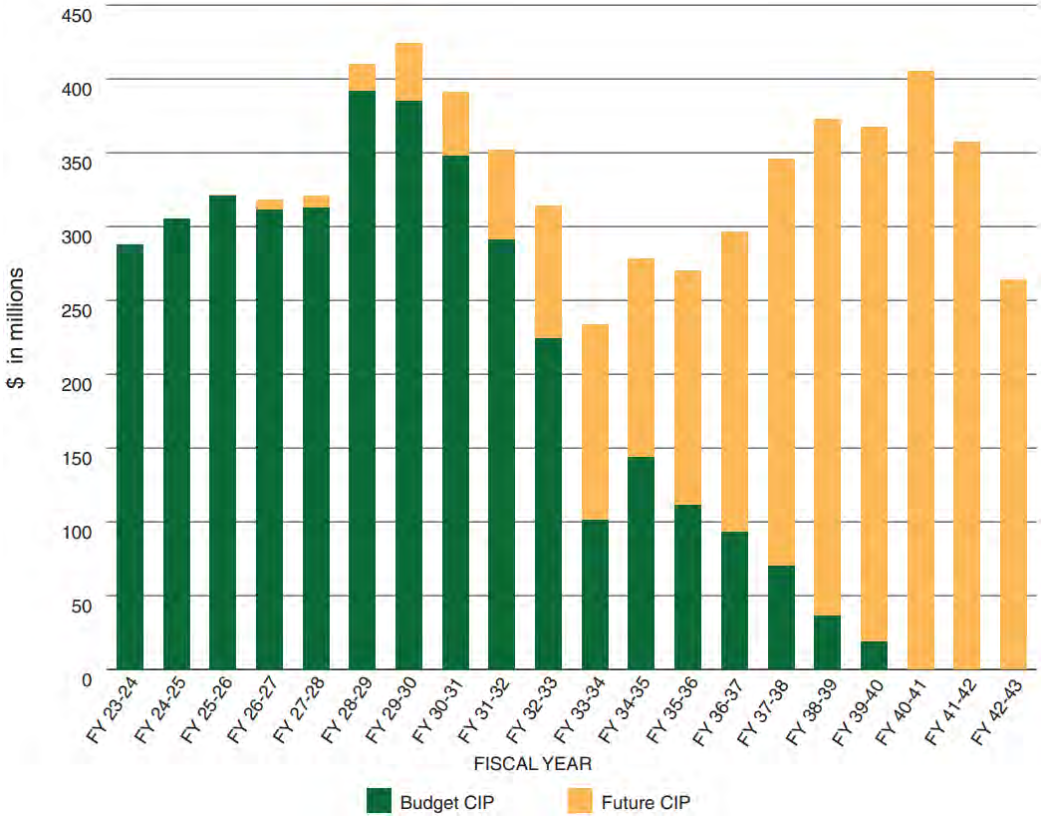
Figure ES-1-7. 20-Year CIP Outlay

The FY 2023–2024 Budget Update, the second year of the 2-year budget adopted in June 2022, includes updates to the 20-year Capital Improvement Program (CIP) outlay. Figure ES-1-7 includes current and projected CIP projects.

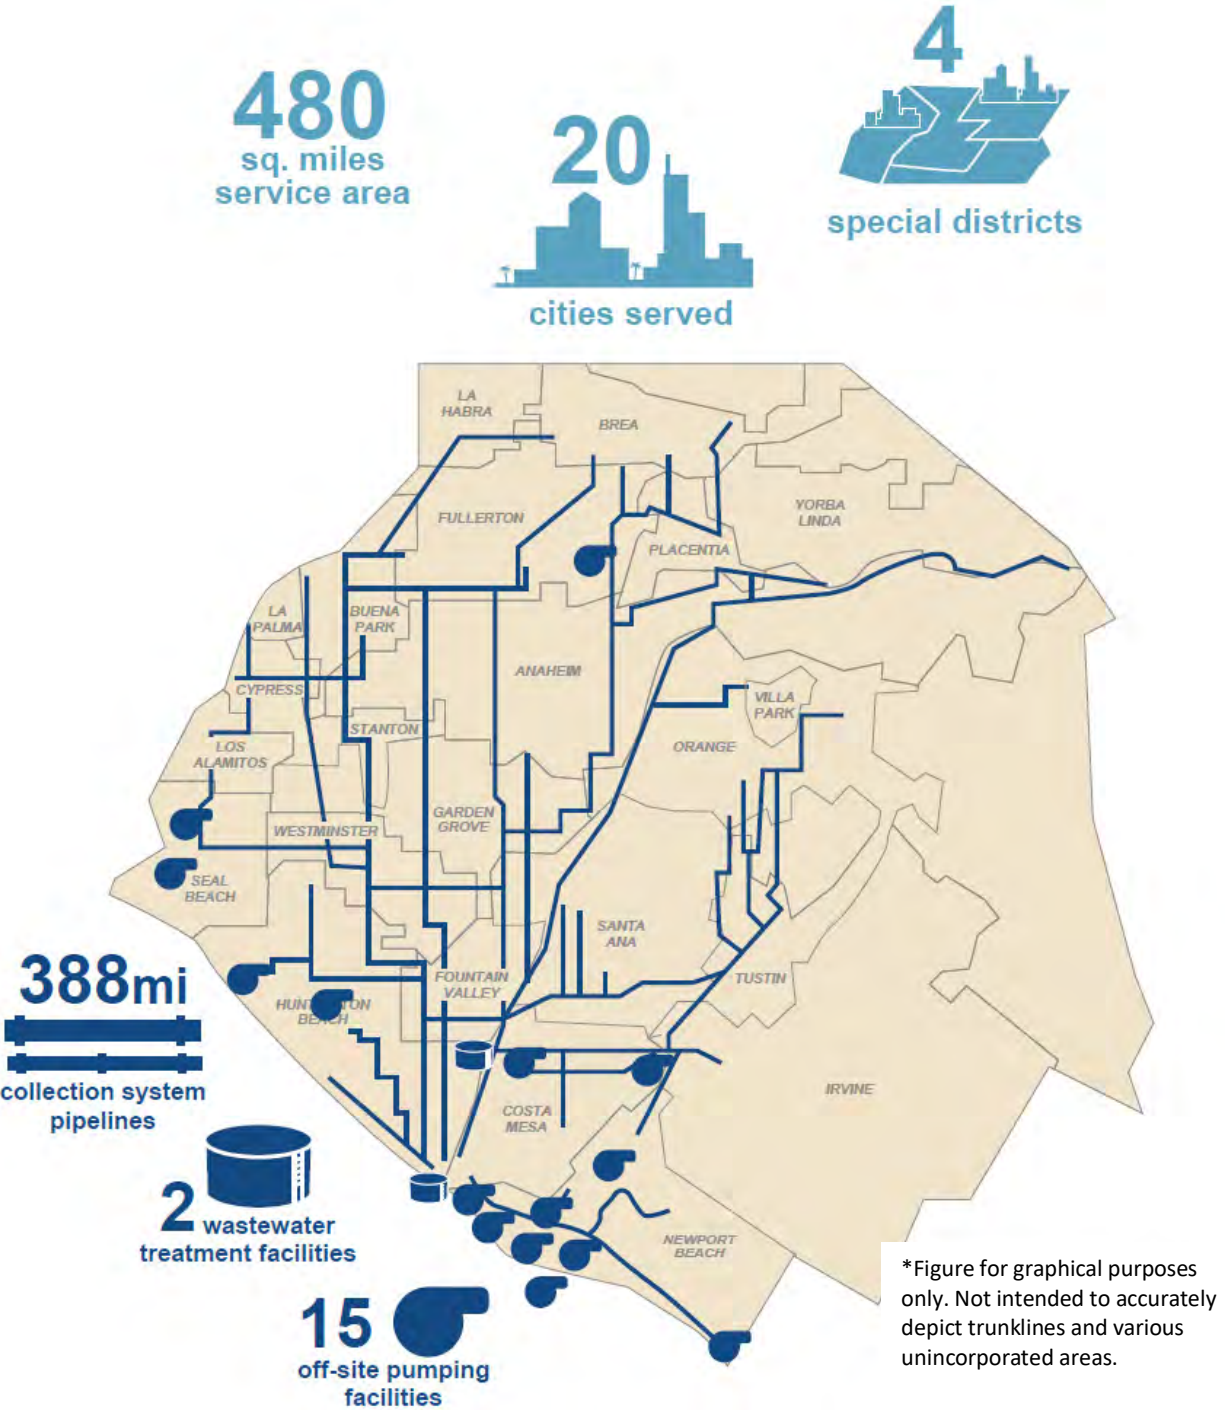
Figure 1-1. OC San's Service Area

In addition to our plant facilities, OC San owns and operates wastewater collection system infrastructure. Our collection system infrastructure includes 388 miles of regional trunk sewer pipelines and 15 pump stations throughout OC San's service area (Figure 1-1). Wastewater is conveyed via the collection system to Reclamation Plant Number (No.) 1 in Fountain Valley, and Treatment Plant No. 2 in Huntington Beach, where resource recovery and wastewater treatment take place.

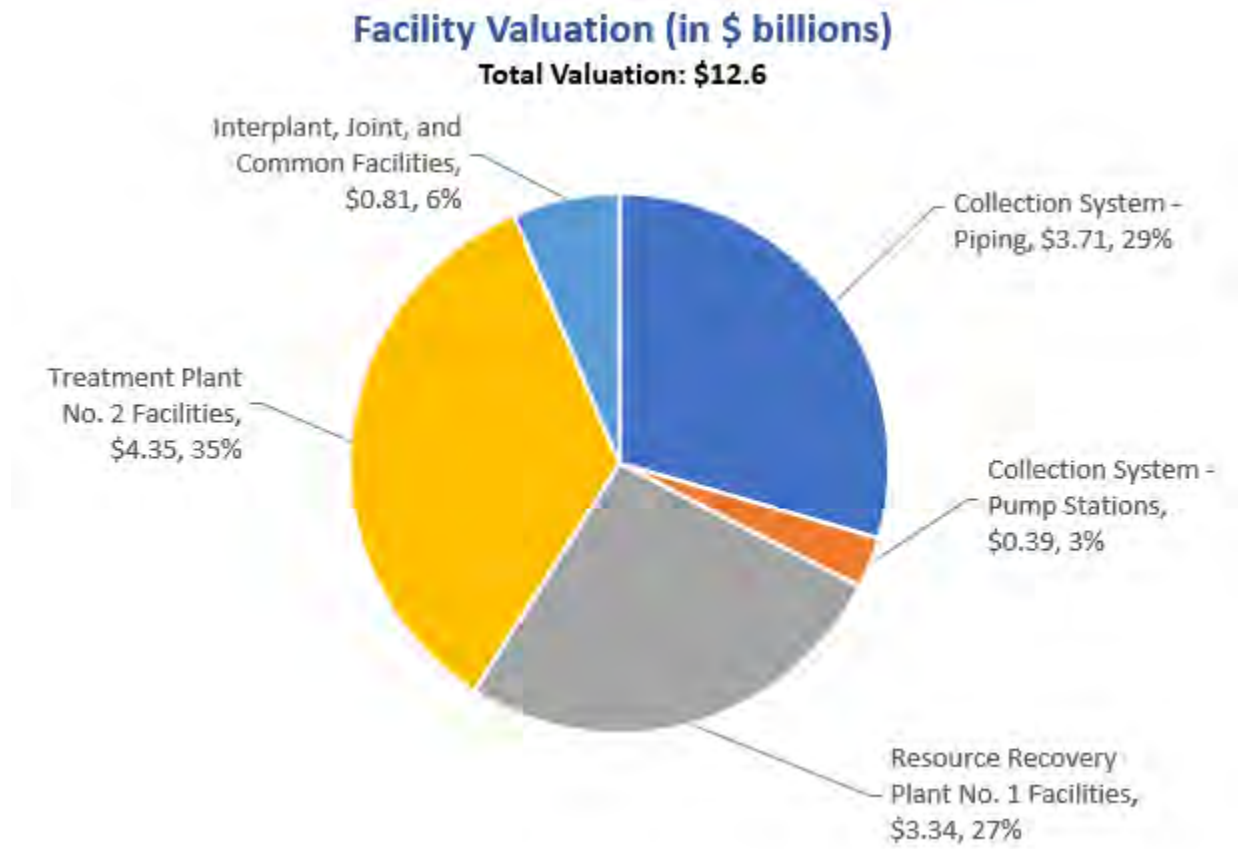
Figure 1-2. Facility Valuation by Area

Figure 1-2 shows the valuation information, presented in five general subprocess areas:

- Collections Systems Piping
- Collection Systems Pump Stations
- Reclamation Plant No. 1 Facilities
- Treatment Plant No. 2 Facilities
- Interplant, Joint, and Common Facilities

As part of the 2017 Facilities Master Plan, OC San commissioned an engineering study to determine the 2017 valuation of all OC San capital facilities, including Plant No. 1, Plant No. 2, interplant and joint treatment facilities, and the collection system (including sewer pipelines and pump stations). The estimated replacement value in Fiscal Year (FY) 2023–2024 is \$12.6 billion

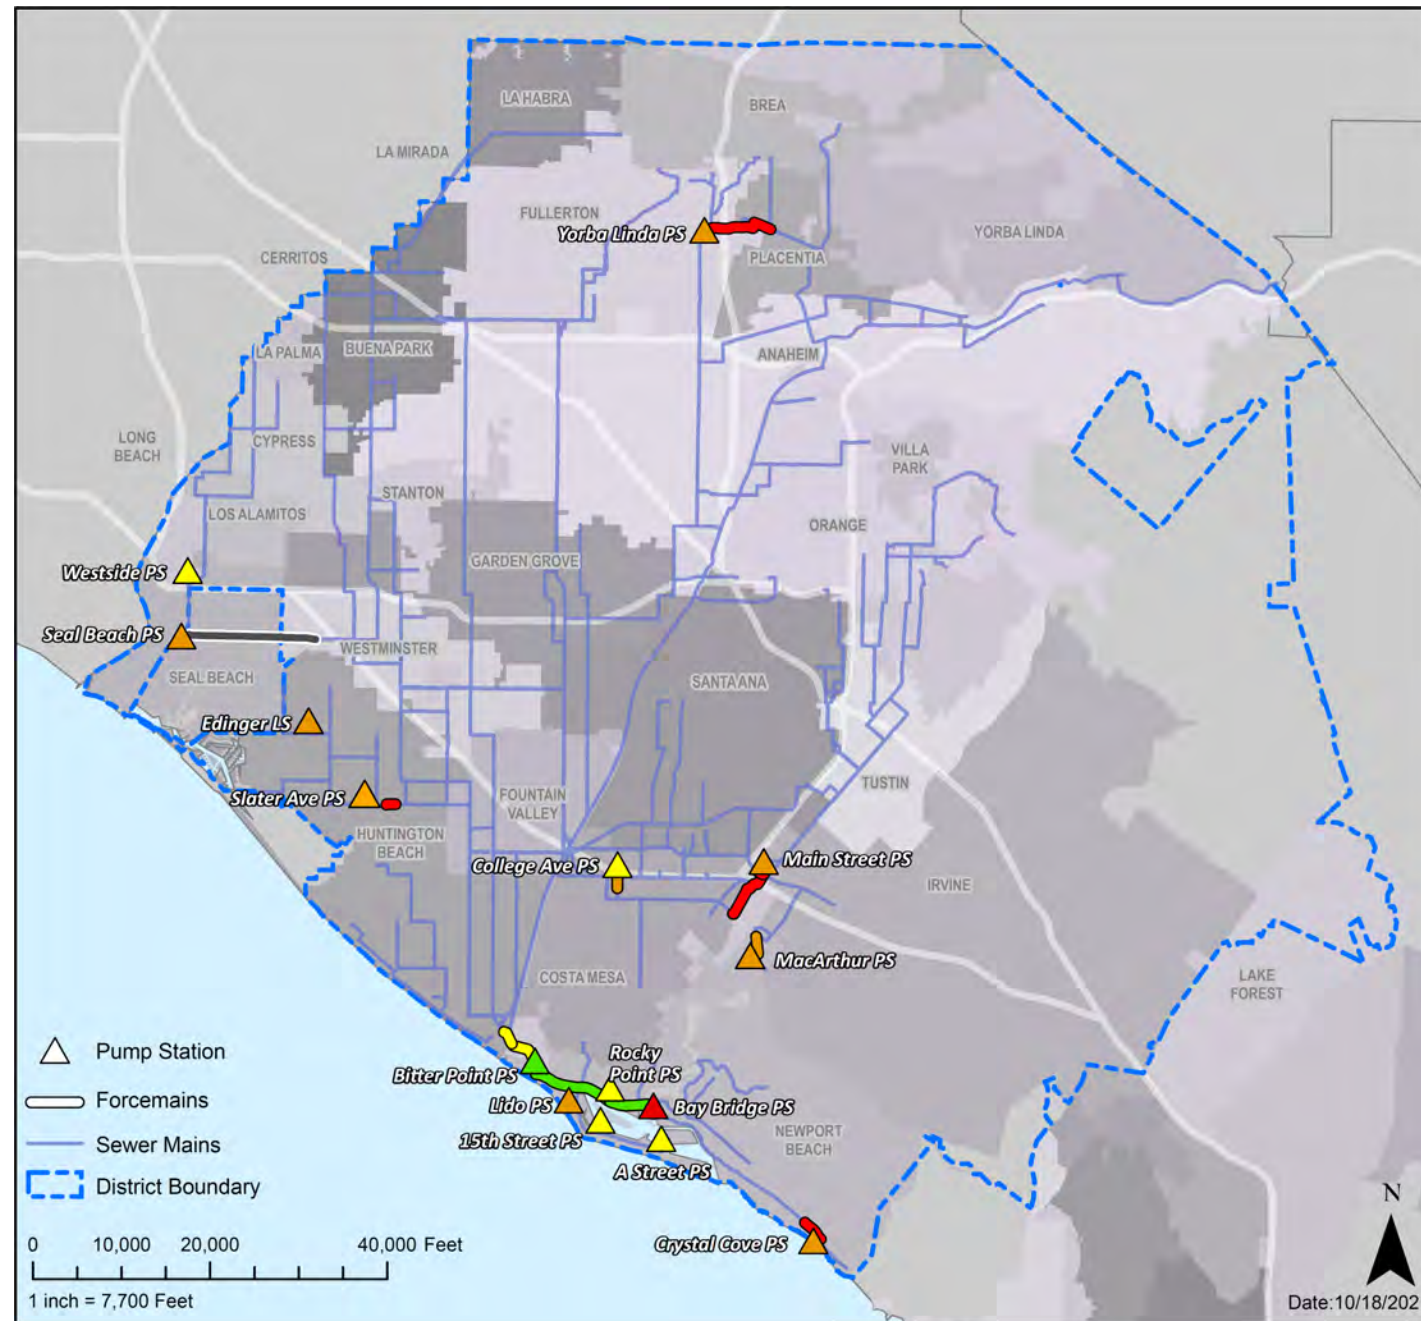
Figure 2-3. Collection System Pump Station – Remaining Useful Life Score Map

Note: Not all pump station force mains are shown on this map. Only longer force mains are shown.

The system-level summaries include an area map (Figures 2-1 through 2-4) showing the general layout of the process areas or collection system, and a table (Tables 2-1 through 2-4) with the following fields:

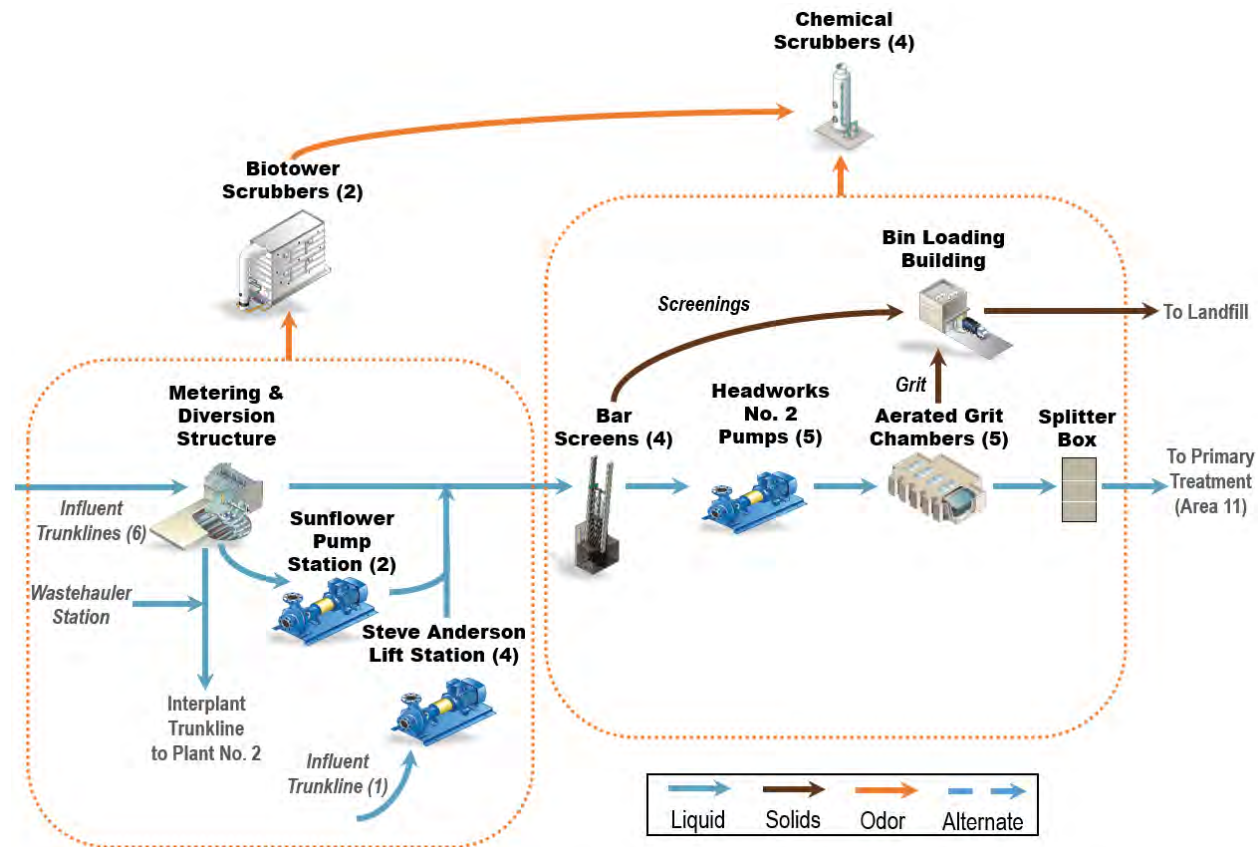
Process Schematic

ASSET MANAGEMENT SYSTEM SUMMARY – AREA 10 – PLANT NO. 1 PRELIMINARY TREATMENT

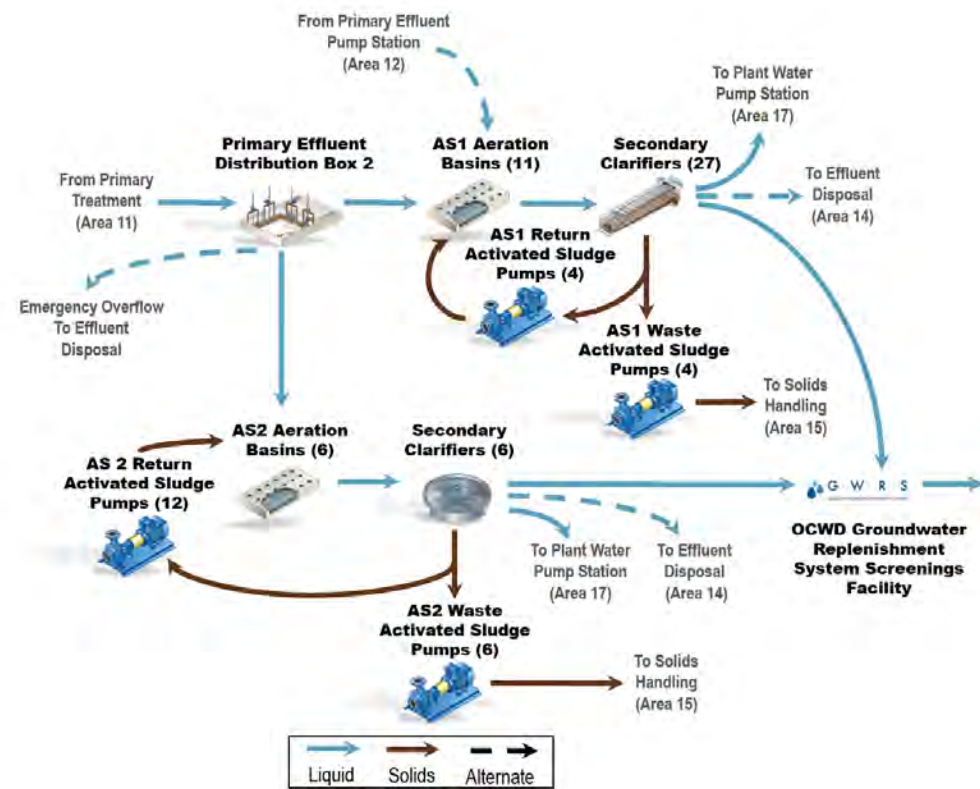
Process Schematic

ASSET MANAGEMENT SYSTEM SUMMARY – AREA 12 – PLANT NO. 1 SECONDARY TREATMENT – ACTIVATED SLUDGE

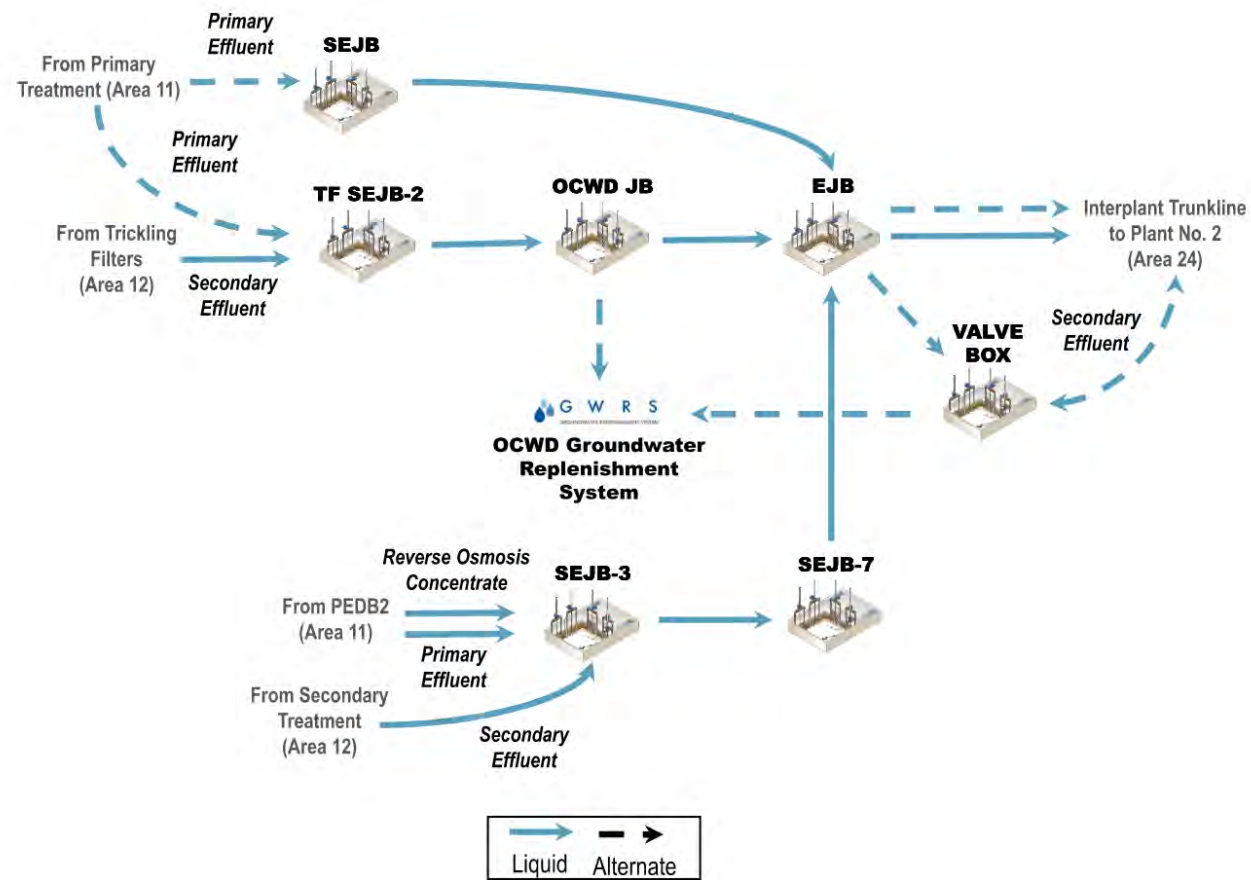
Process Schematic

ASSET MANAGEMENT SYSTEM SUMMARY – AREA 14 – PLANT NO. 1 INTERPLANT

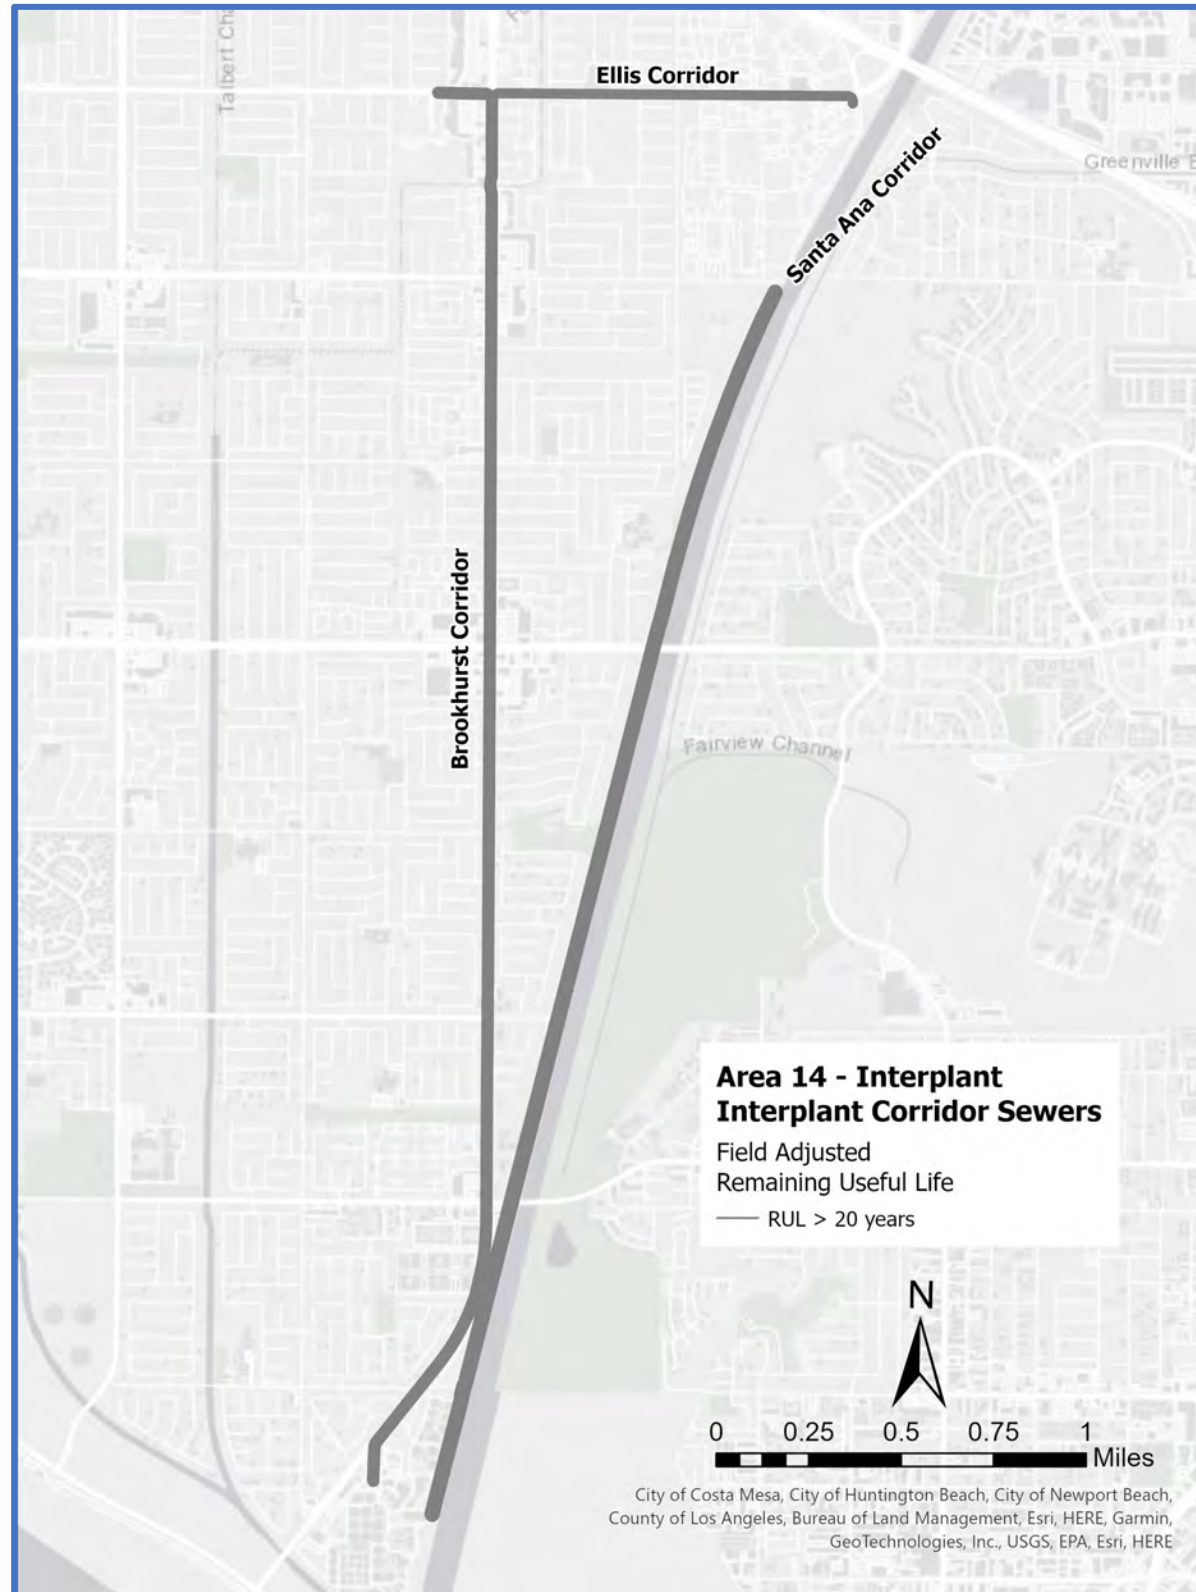
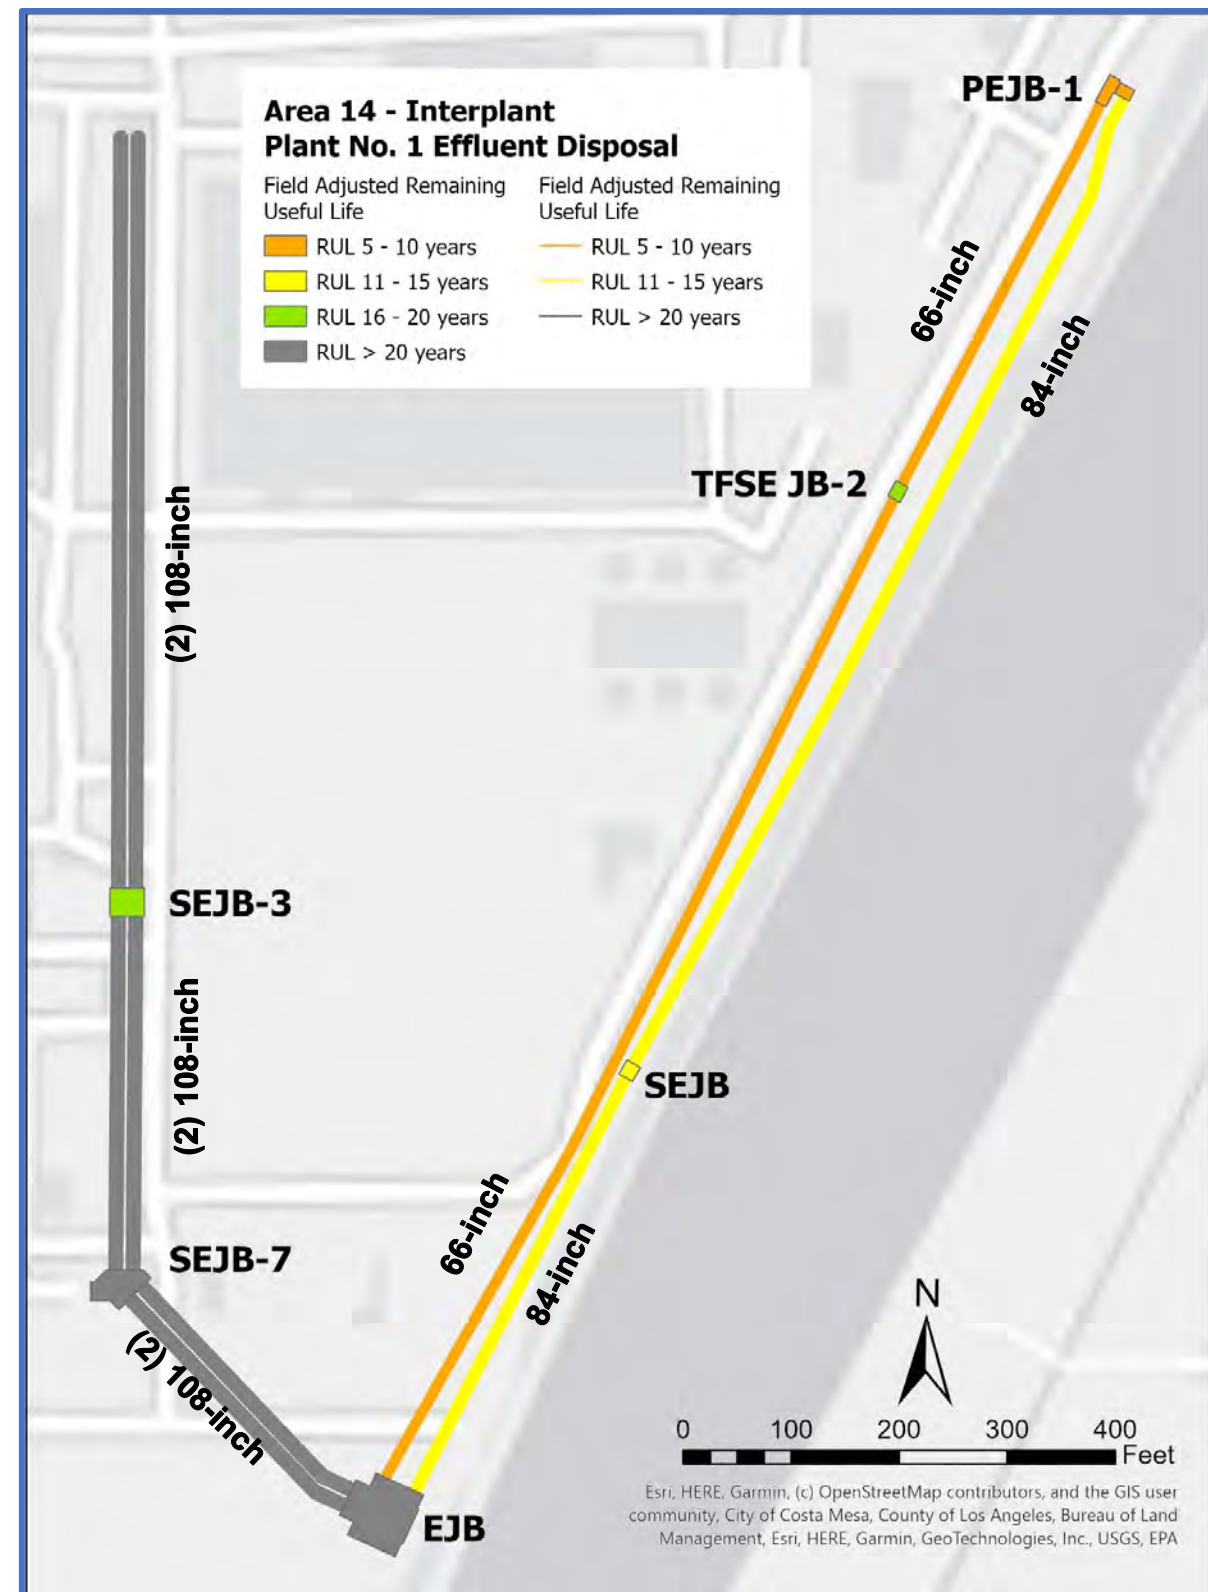
Remaining Useful Life Maps

ASSET MANAGEMENT SYSTEM SUMMARY – AREA 14 – PLANT NO. 1 INTERPLANT

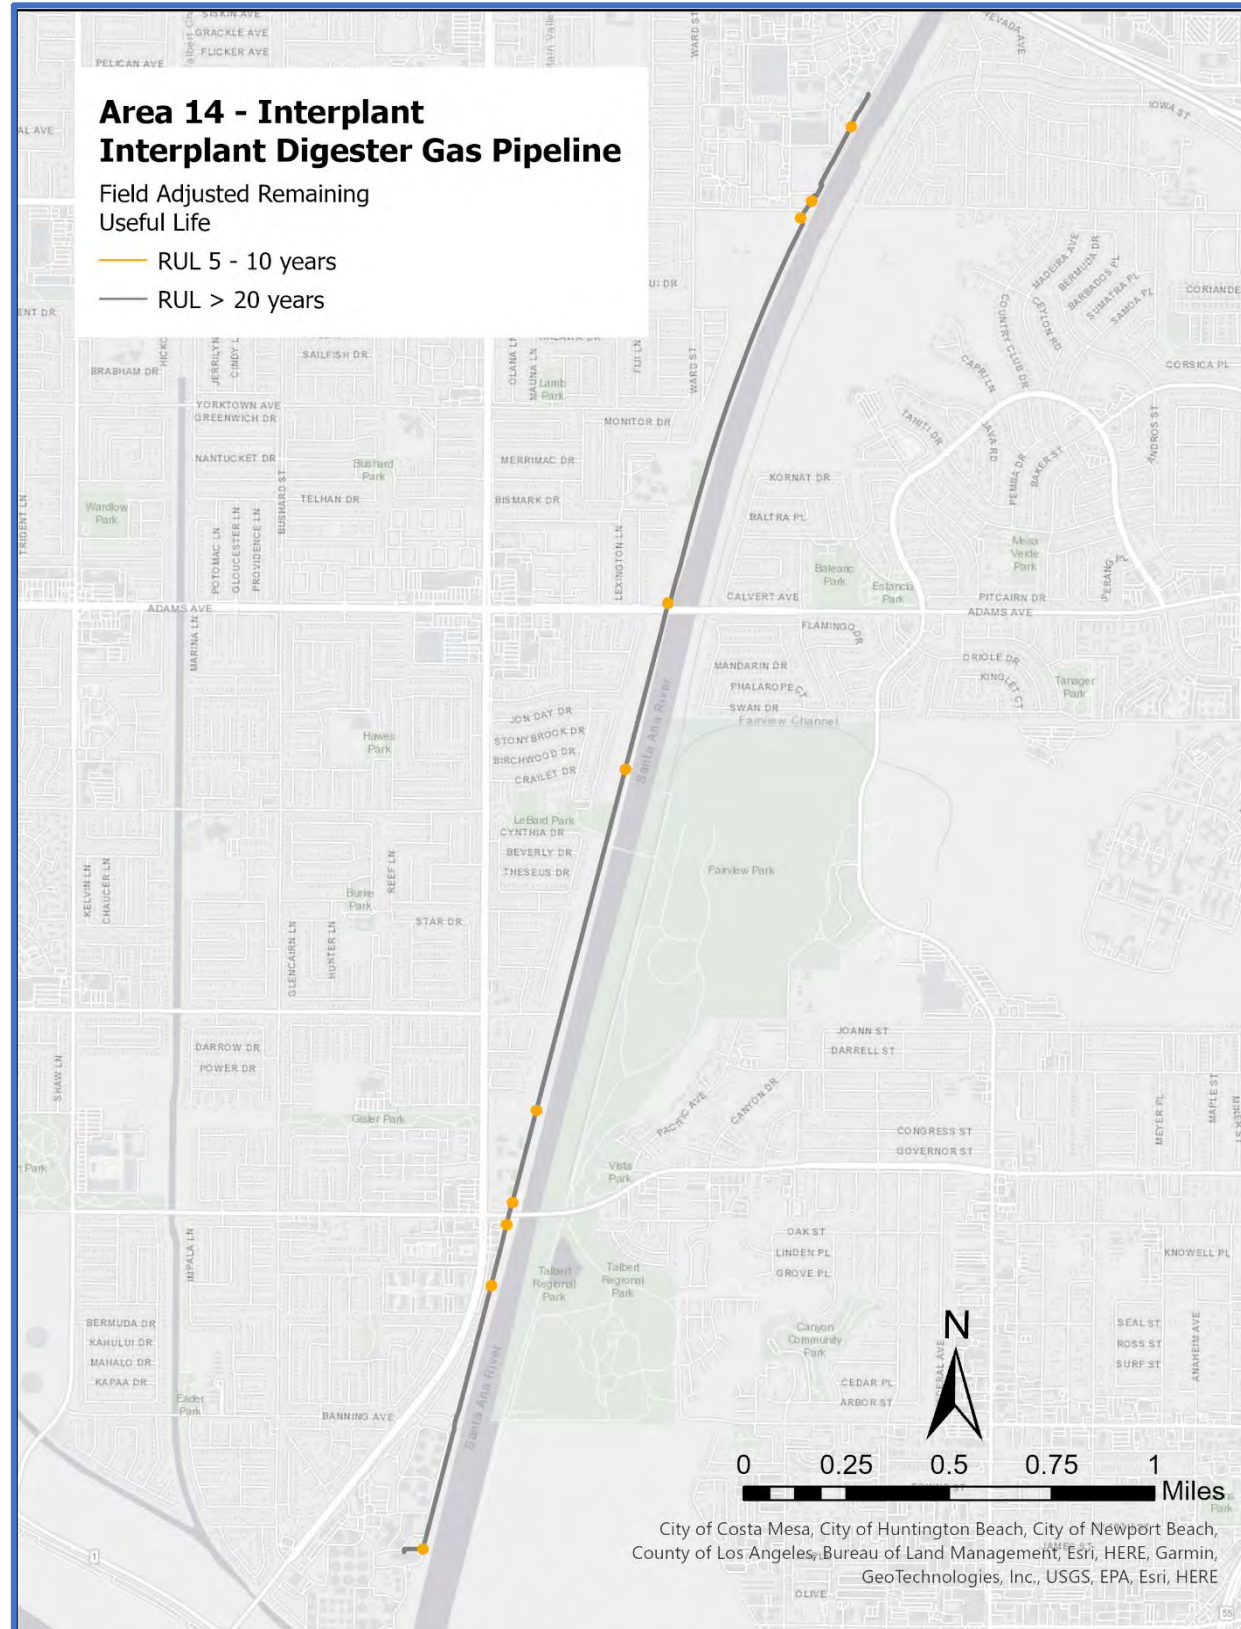
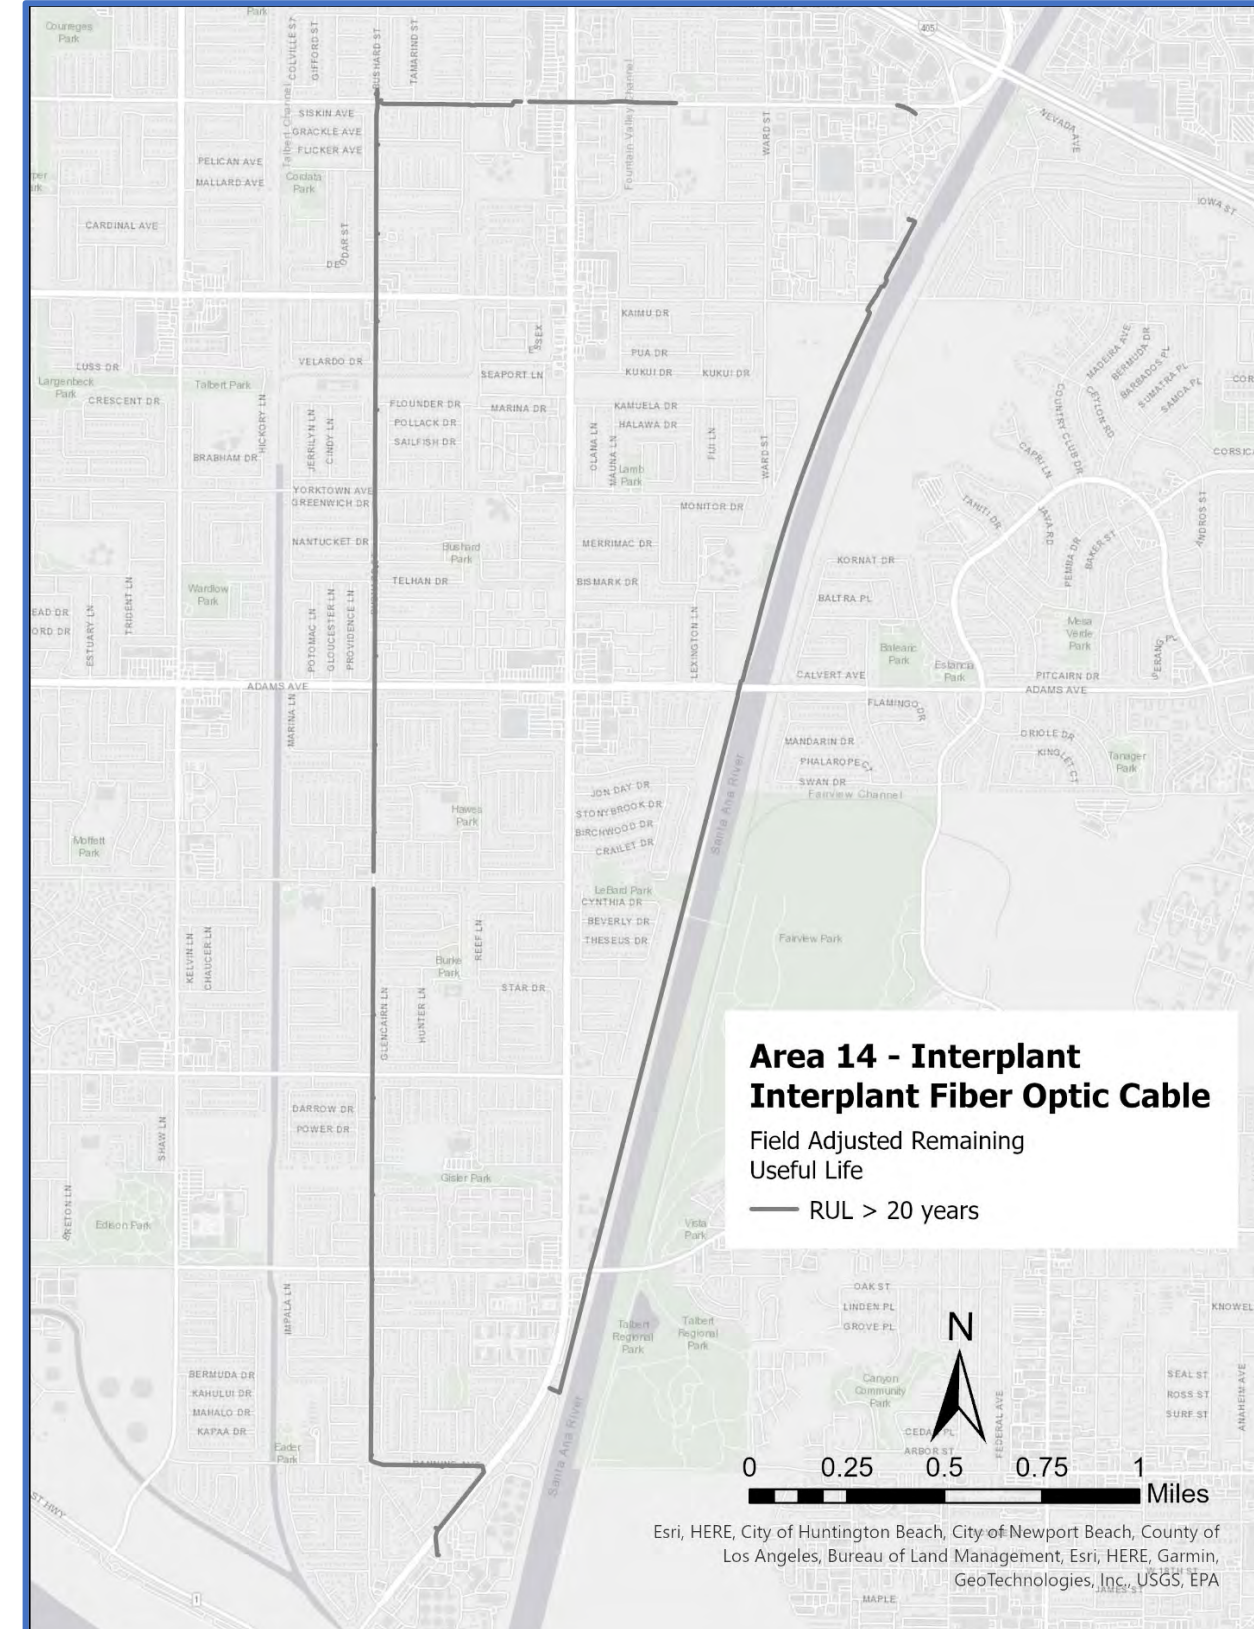
Remaining Useful Life Maps

ASSET MANAGEMENT SYSTEM SUMMARY – AREA 14 – PLANT NO. 1 INTERPLANT

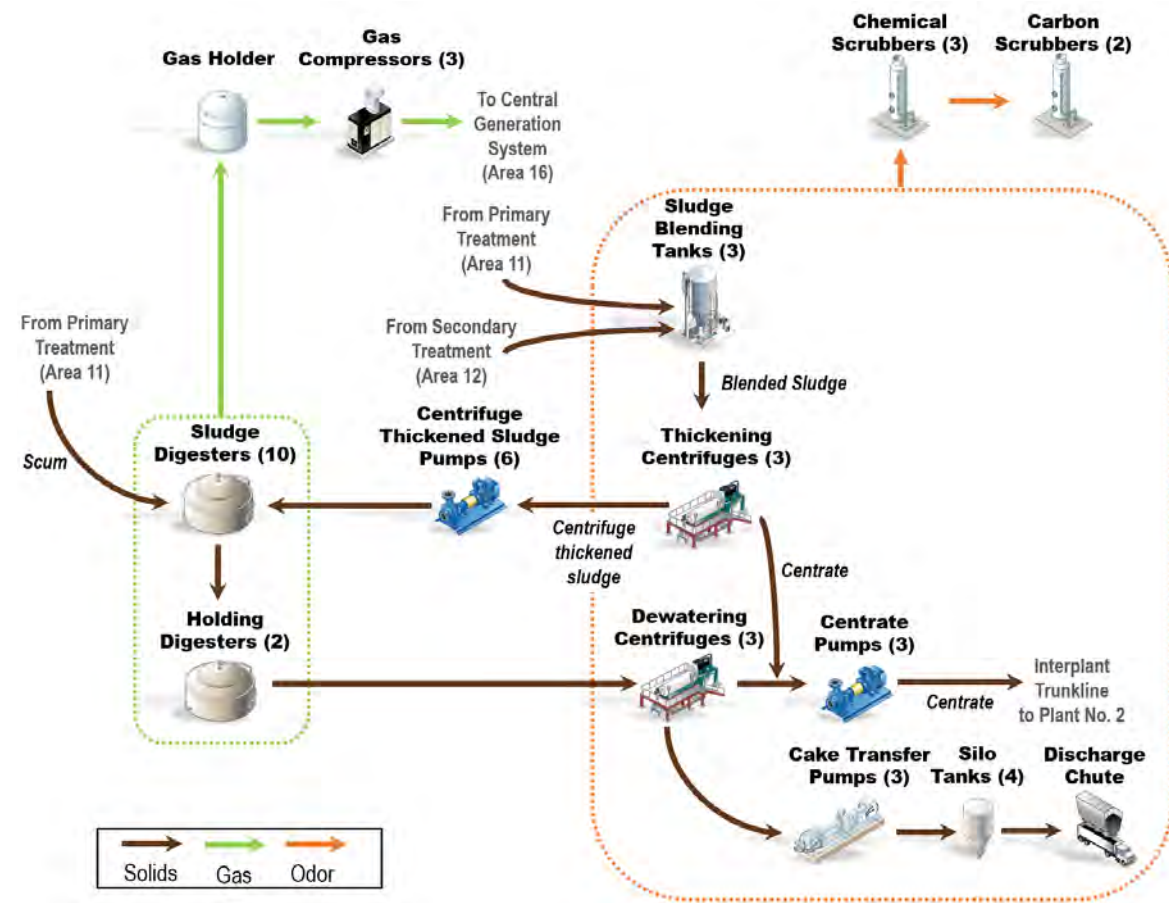
Process Schematic

ASSET MANAGEMENT SYSTEM SUMMARY – AREA 15 – PLANT NO. 1 SOLIDS HANDLING – DIGESTERS

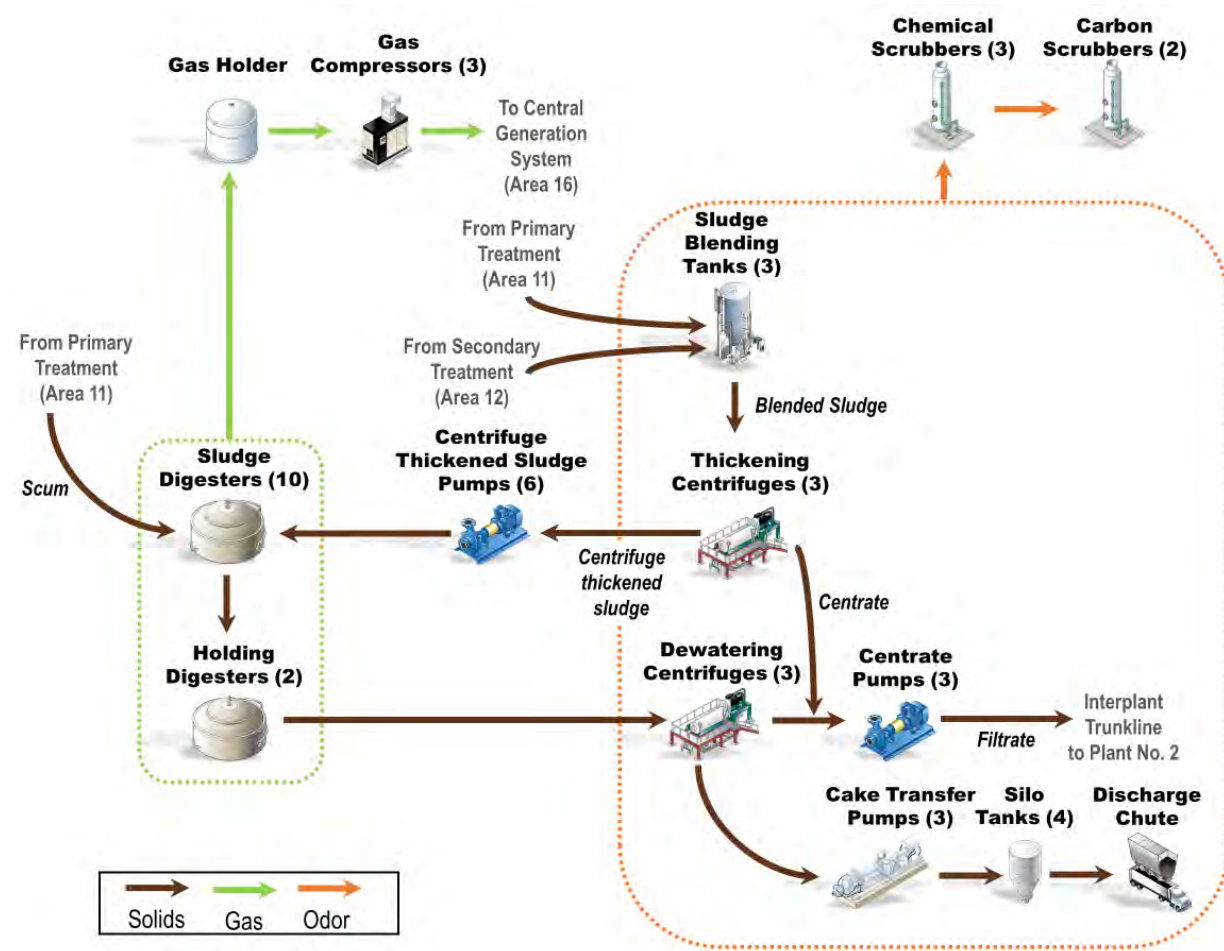
Process Schematic

ASSET MANAGEMENT SYSTEM SUMMARY – AREA 15 – PLANT NO. 1 SOLIDS HANDLING – FACILITIES

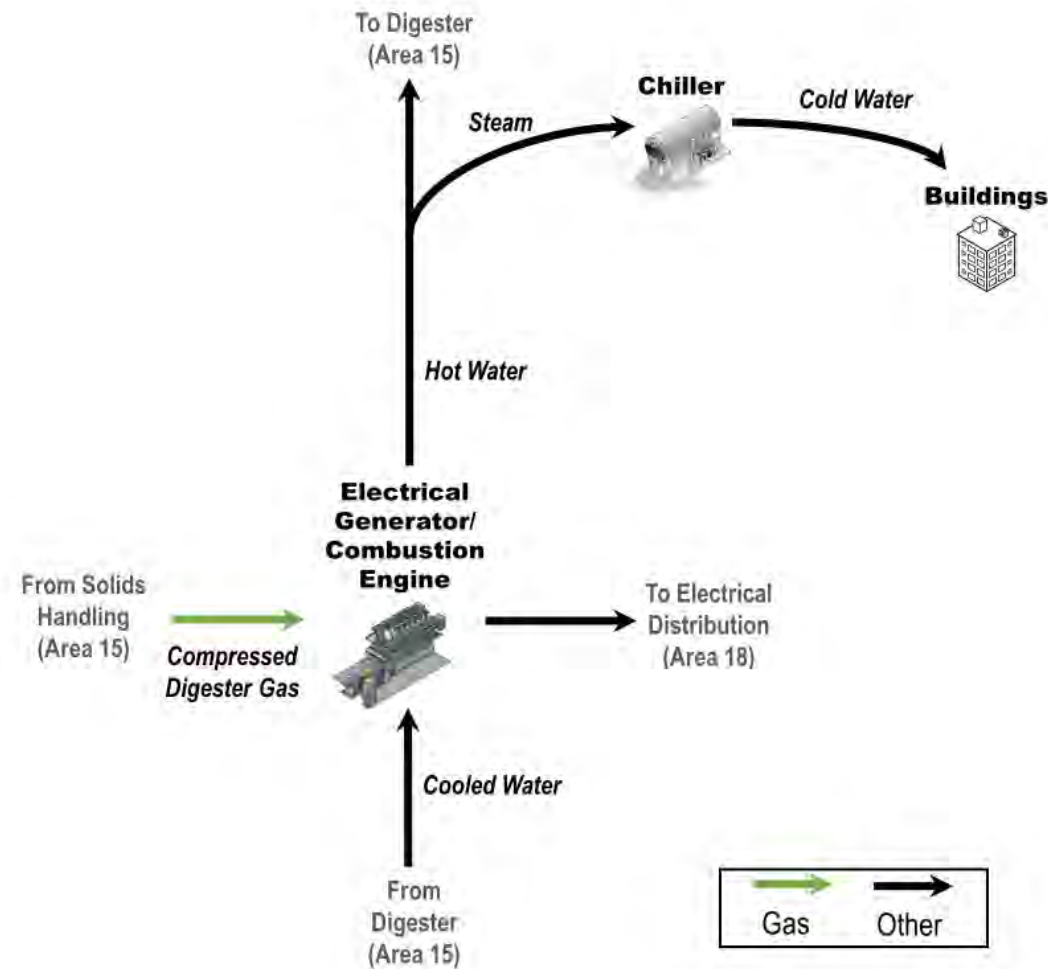
Process Schematic

ASSET MANAGEMENT SYSTEM SUMMARY – AREA 16 – PLANT NO. 1 CENTRAL GENERATION

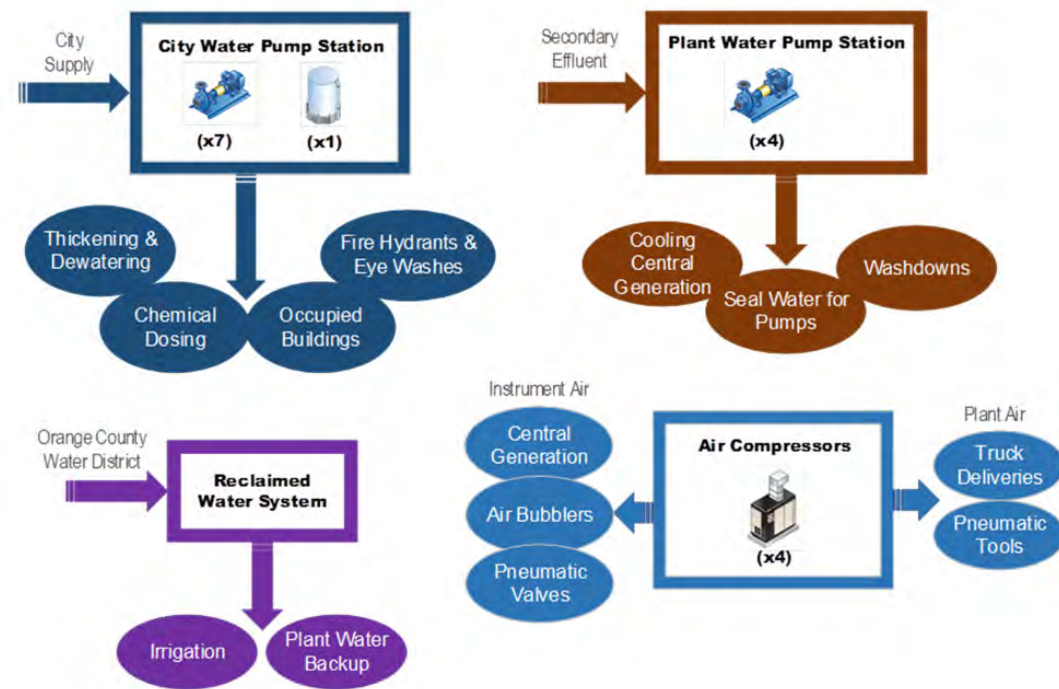
Process Schematic

ASSET MANAGEMENT SYSTEM SUMMARY – AREA 17 – PLANT NO. 1 UTILITIES
