Asset Management Plan

2023

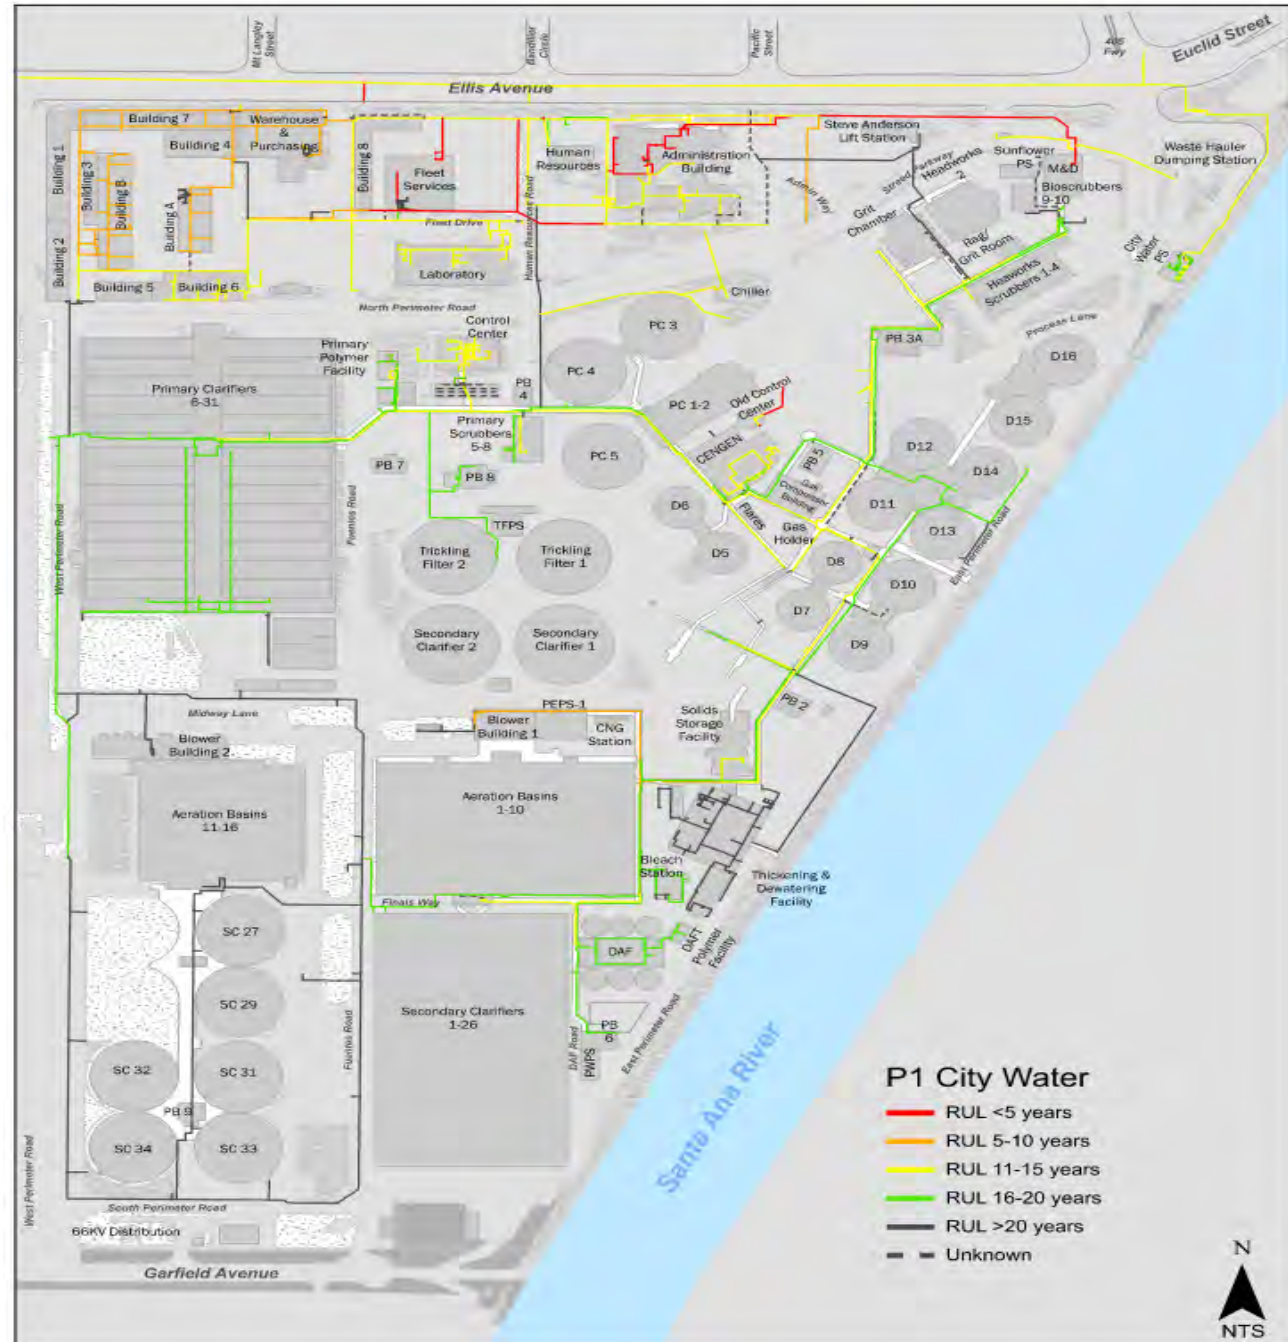
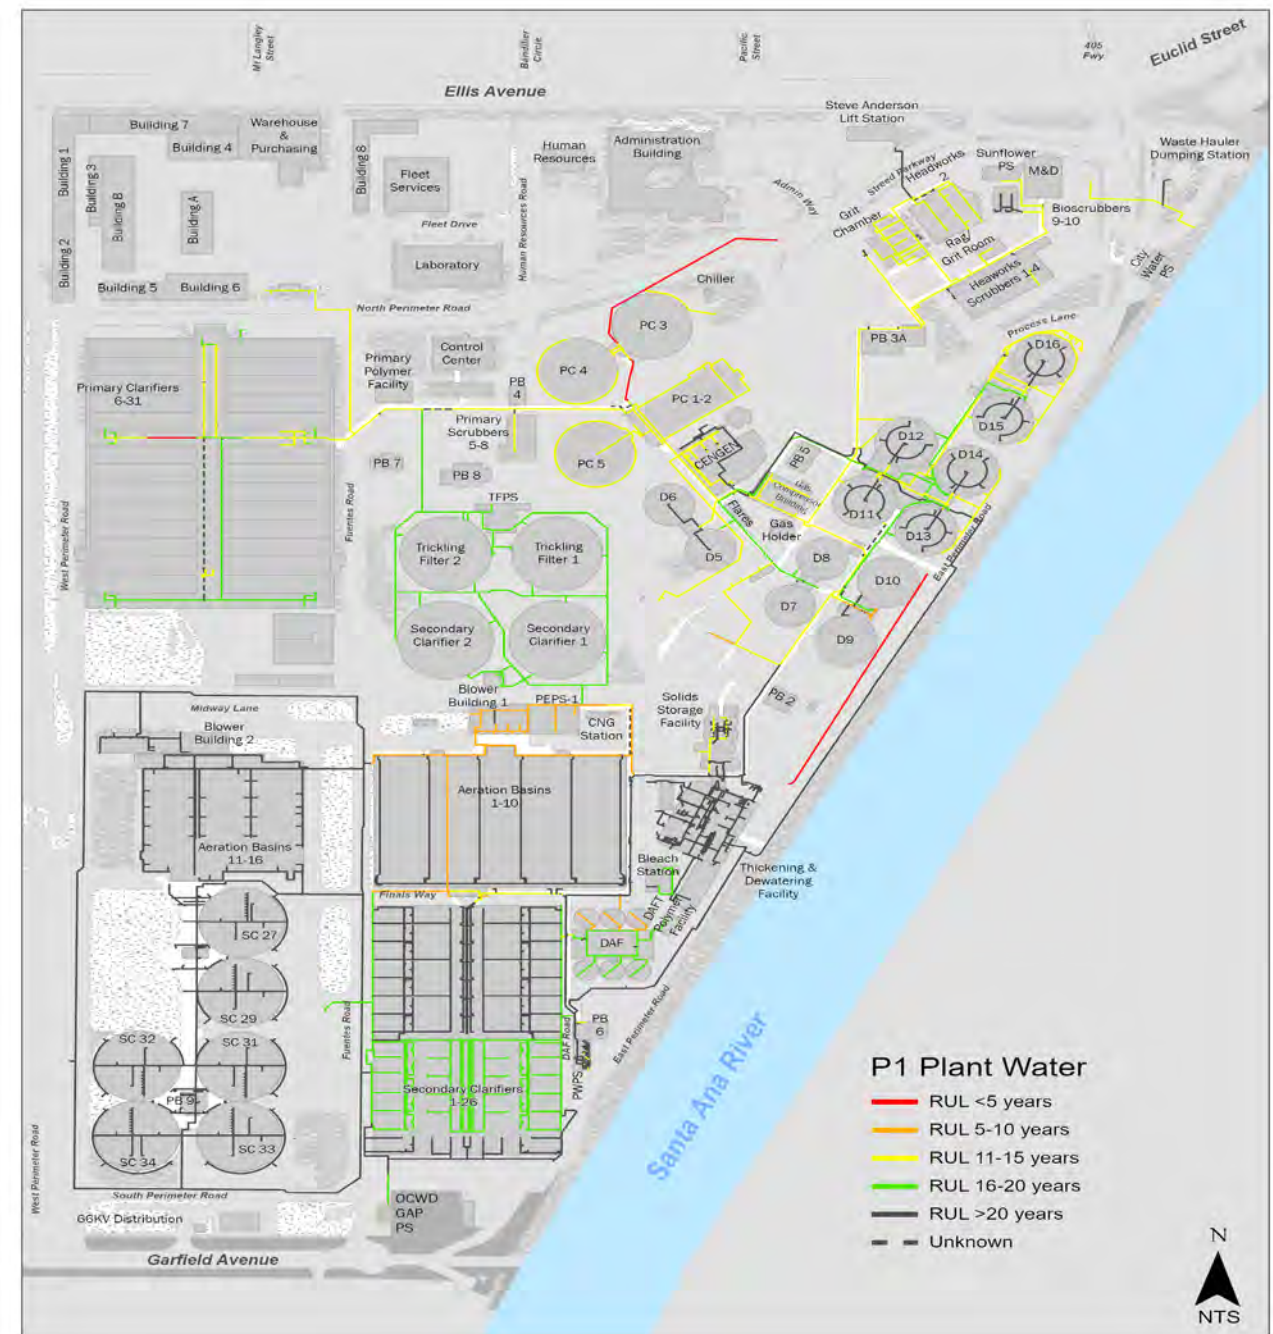
Remaining Useful Life of Utility Infrastructure

ASSET MANAGEMENT SYSTEM SUMMARY – AREA 17 – PLANT NO. 1 UTILITIES

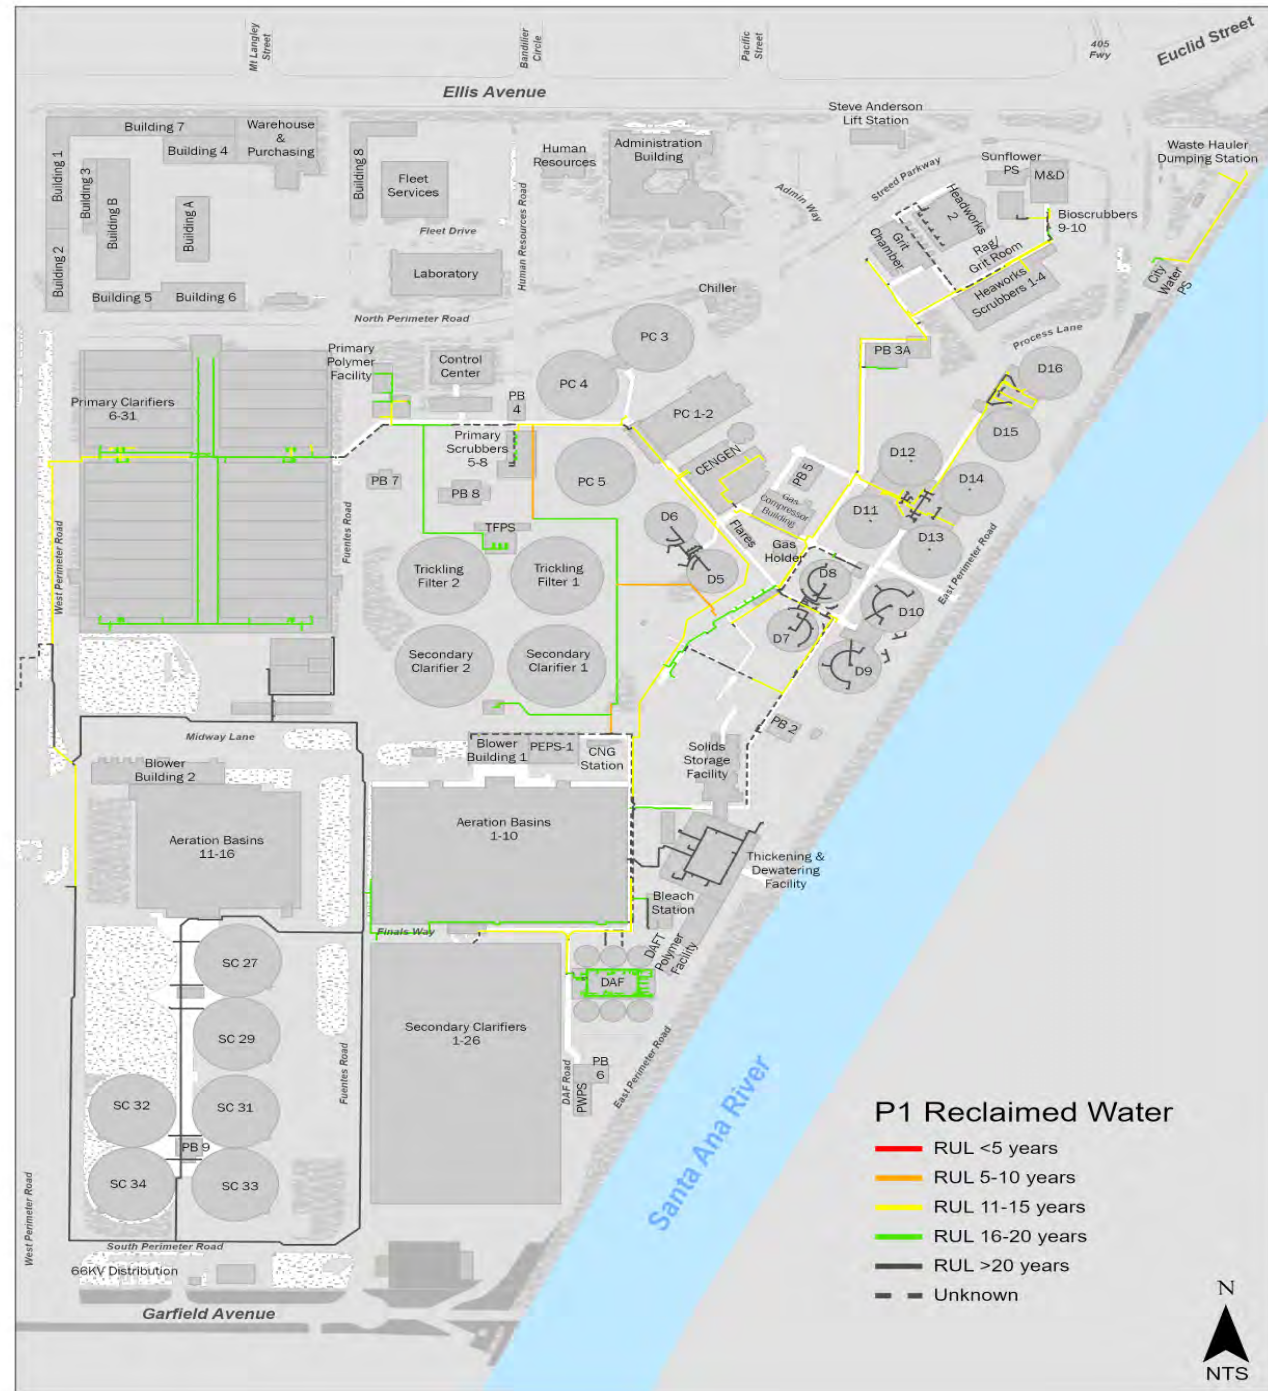
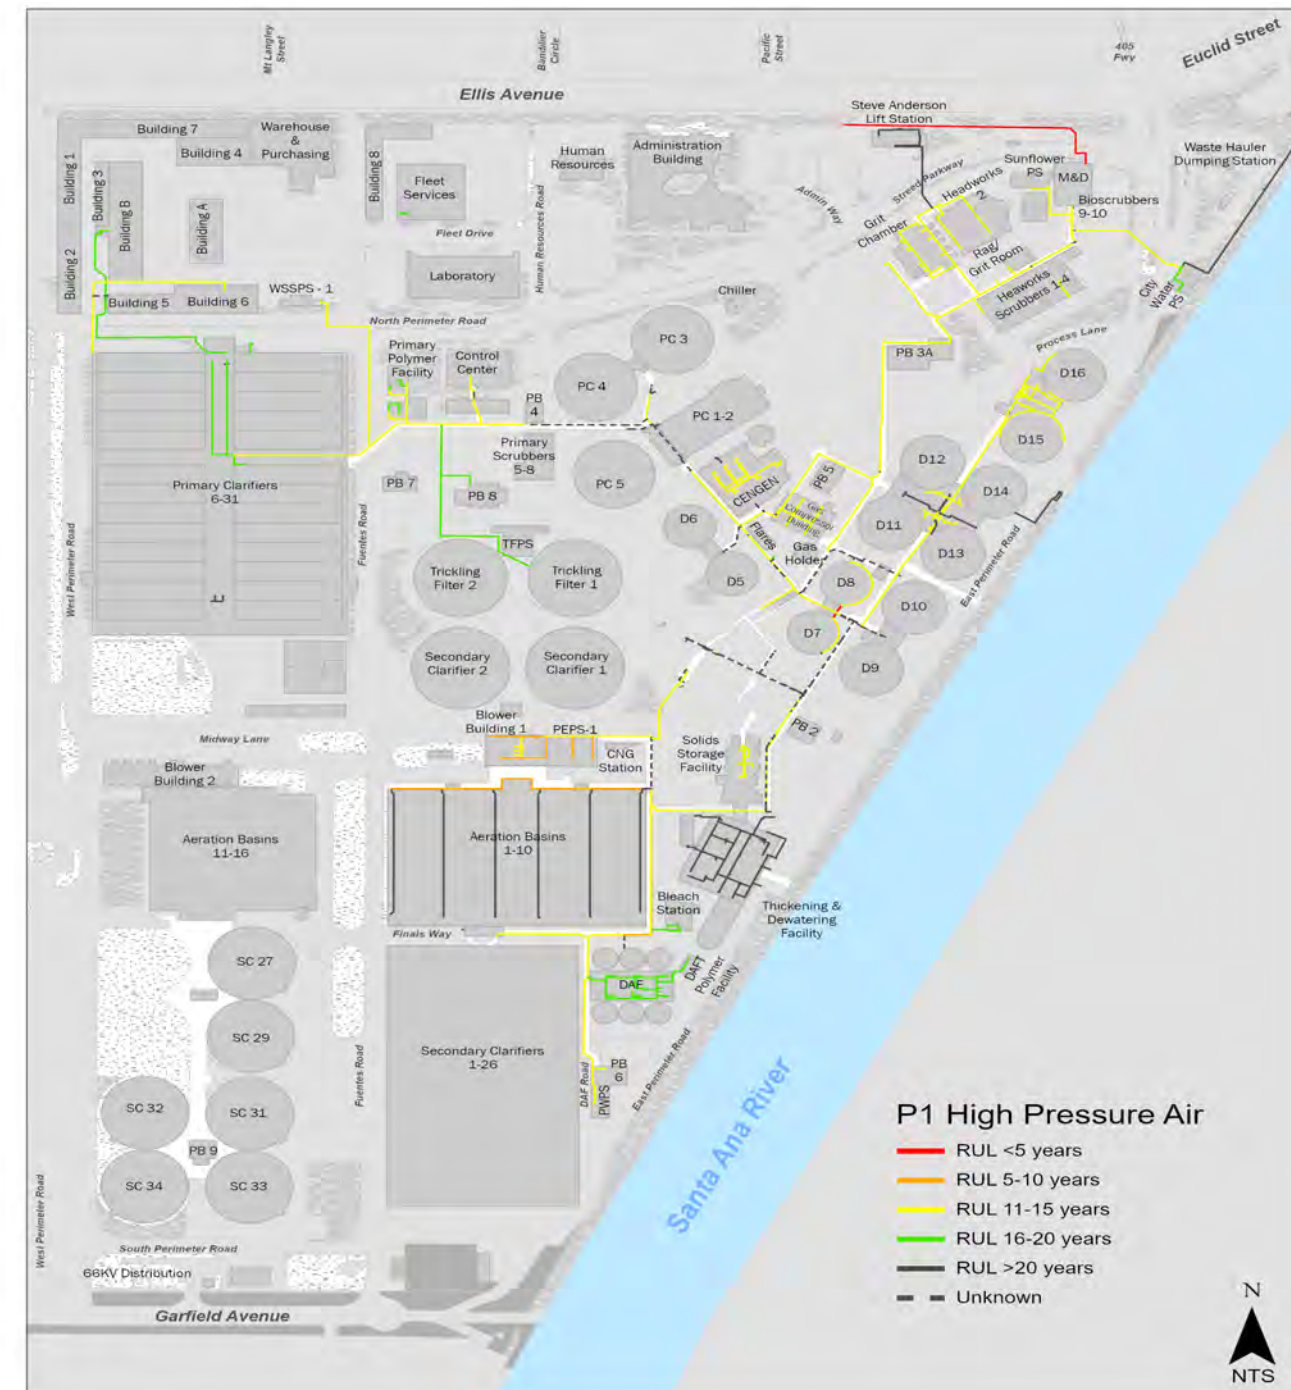
Remaining Useful Life of Utility Infrastructure

ASSET MANAGEMENT SYSTEM SUMMARY – AREA 17 – PLANT NO. 1 UTILITIES

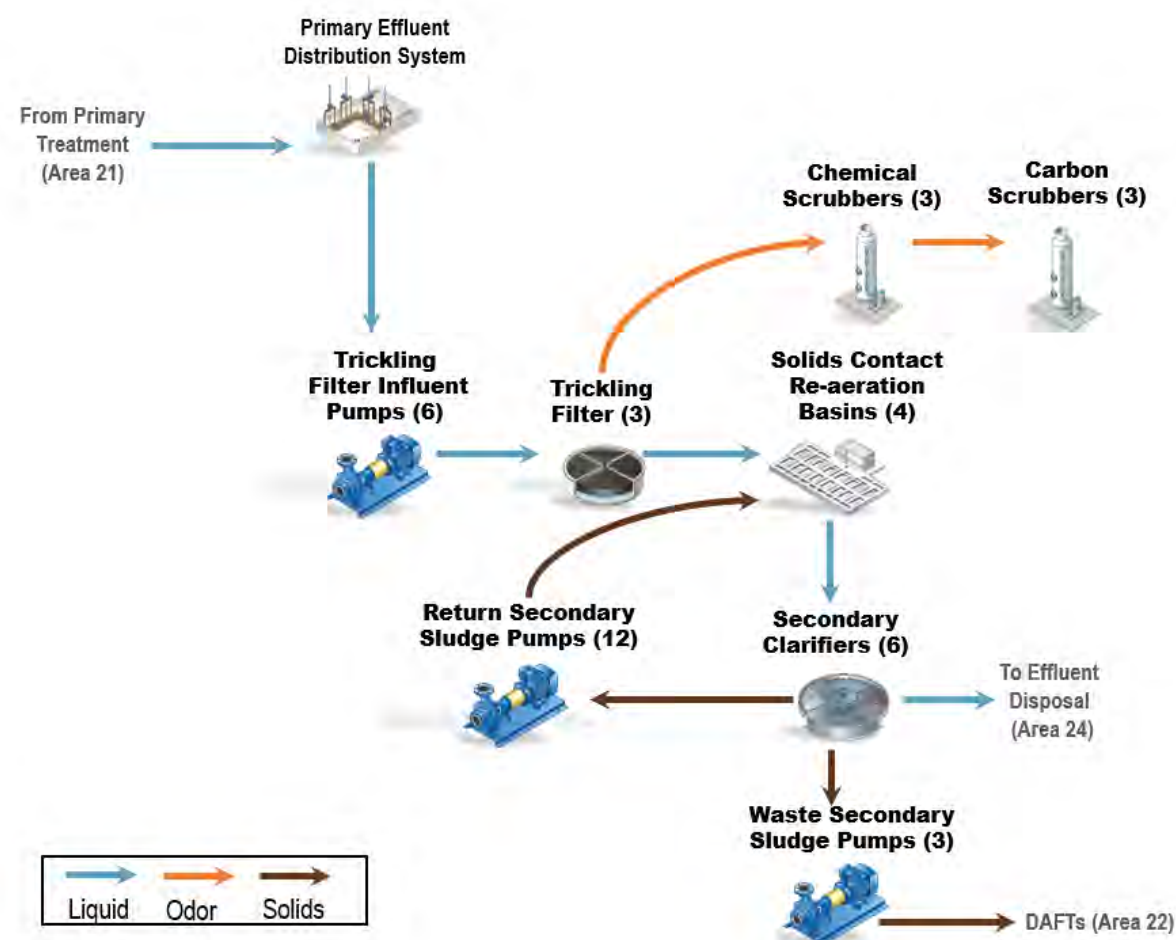
Process Schematic

ASSET MANAGEMENT SYSTEM SUMMARY – AREA 22 – PLANT NO. 2 SECONDARY TREATMENT – TRICKLING FILTERS AND SOLIDS CONTACT

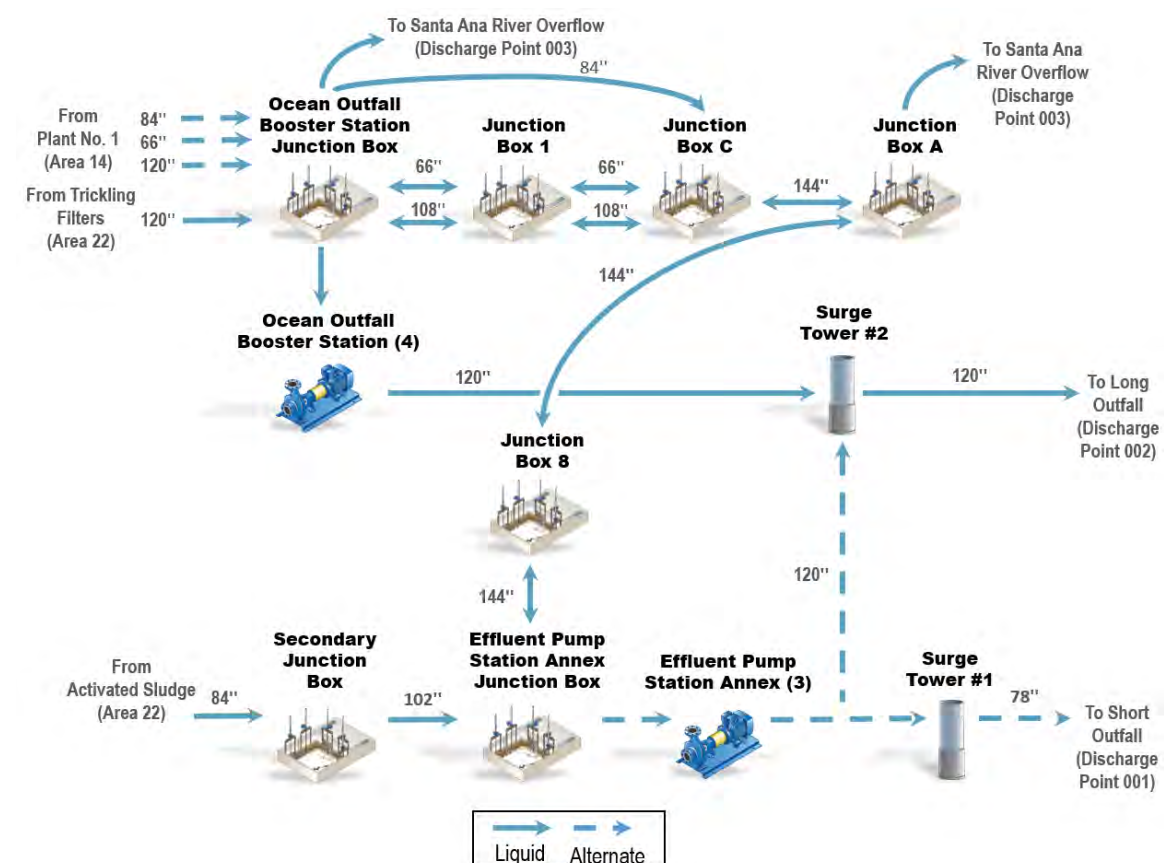
ASSET MANAGEMENT SYSTEM SUMMARY – AREA 24 – PLANT NO. 2 EFFLUENT DISPOSAL

Note: Process Schematic is general in nature. A detailed process diagram is provided in Appendix D.

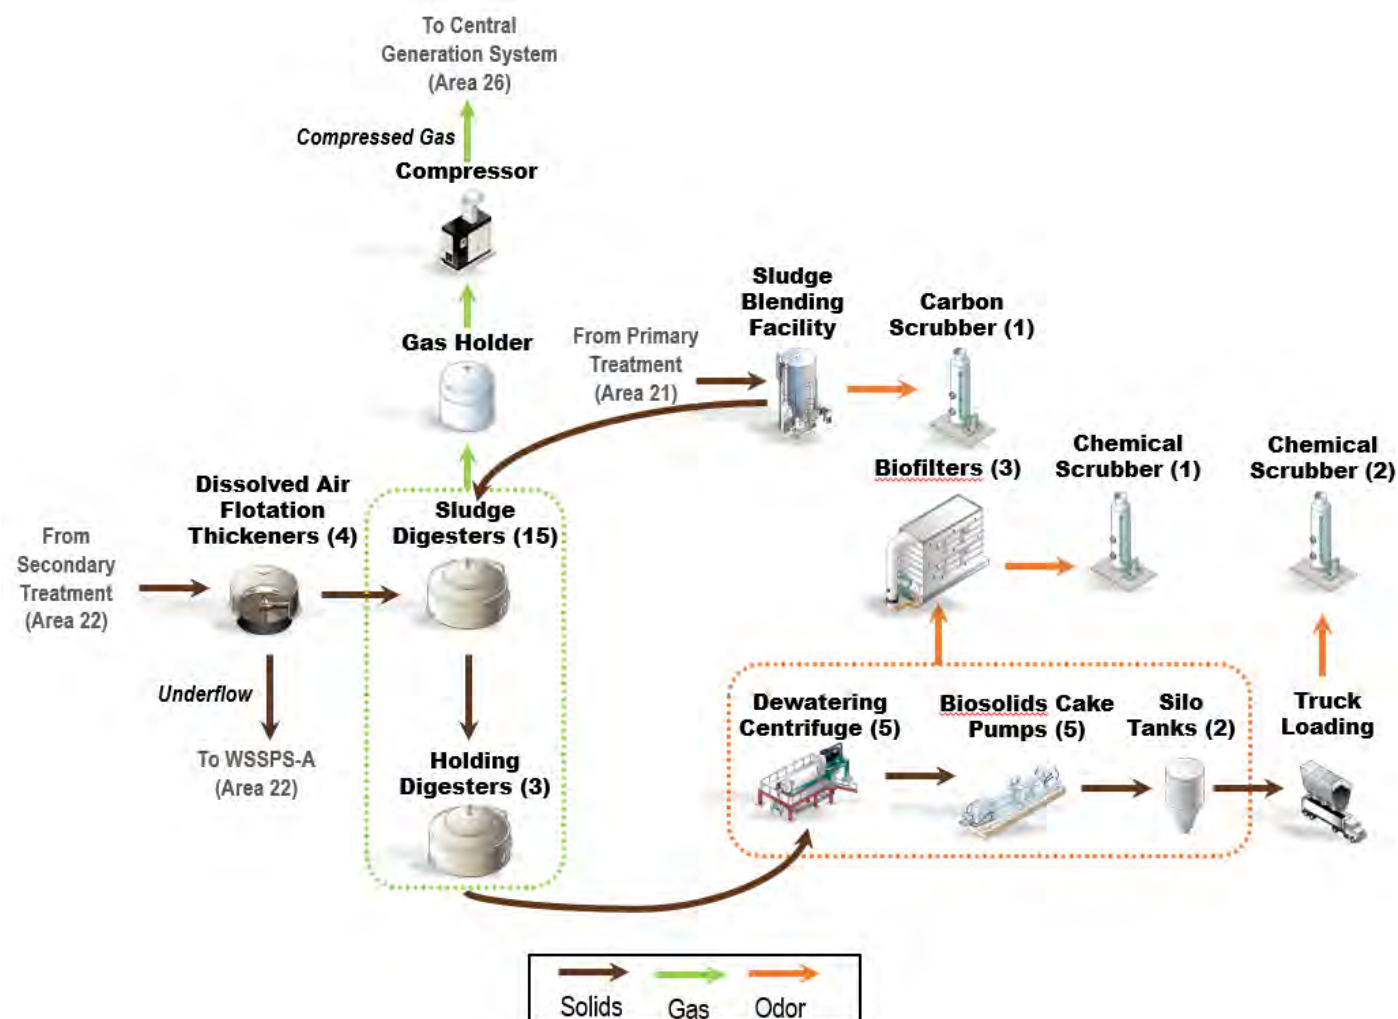
Process Schematic

ASSET MANAGEMENT SYSTEM SUMMARY – AREA 25 – PLANT NO. 2 SOLIDS HANDLING – DIGESTERS

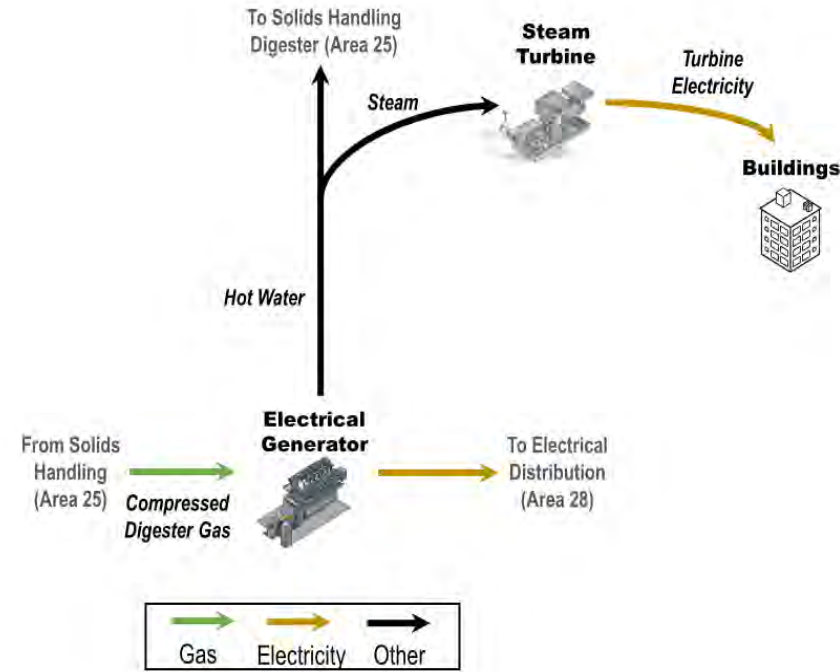
Process Schematic

ASSET MANAGEMENT SYSTEM SUMMARY – AREA 26 – PLANT NO. 2 CENTRAL GENERATION

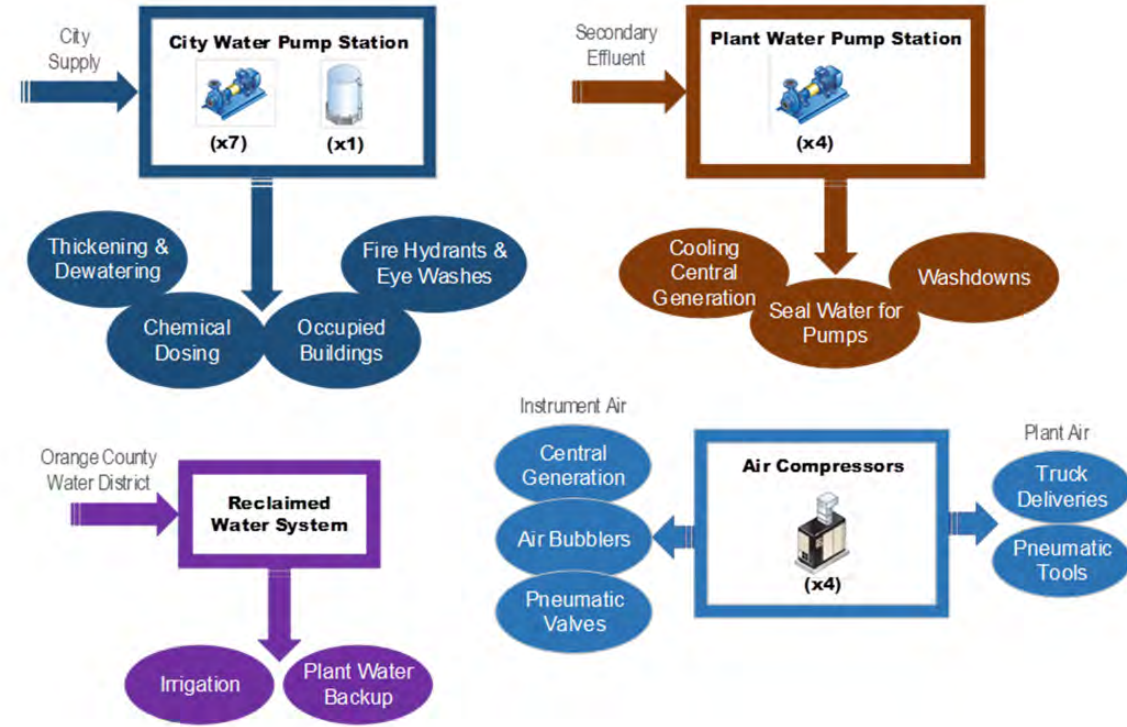
Process Schematic

ASSET MANAGEMENT SYSTEM SUMMARY – AREA 27 – PLANT NO. 2 UTILITIES

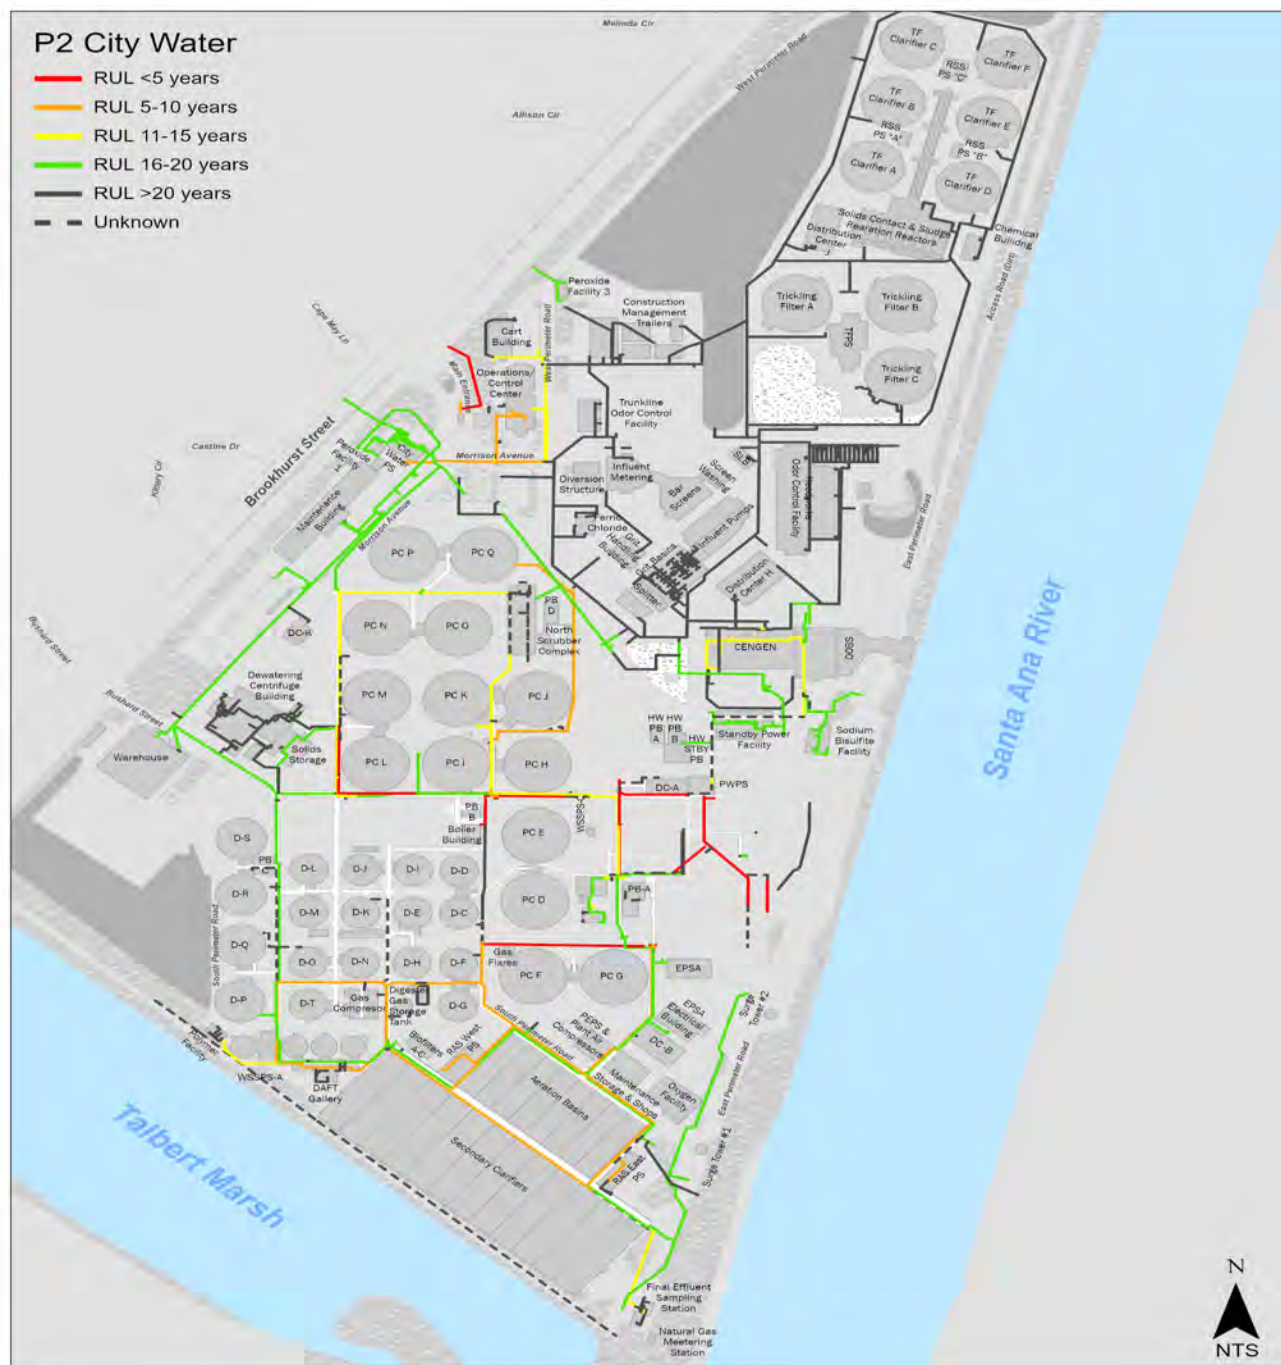
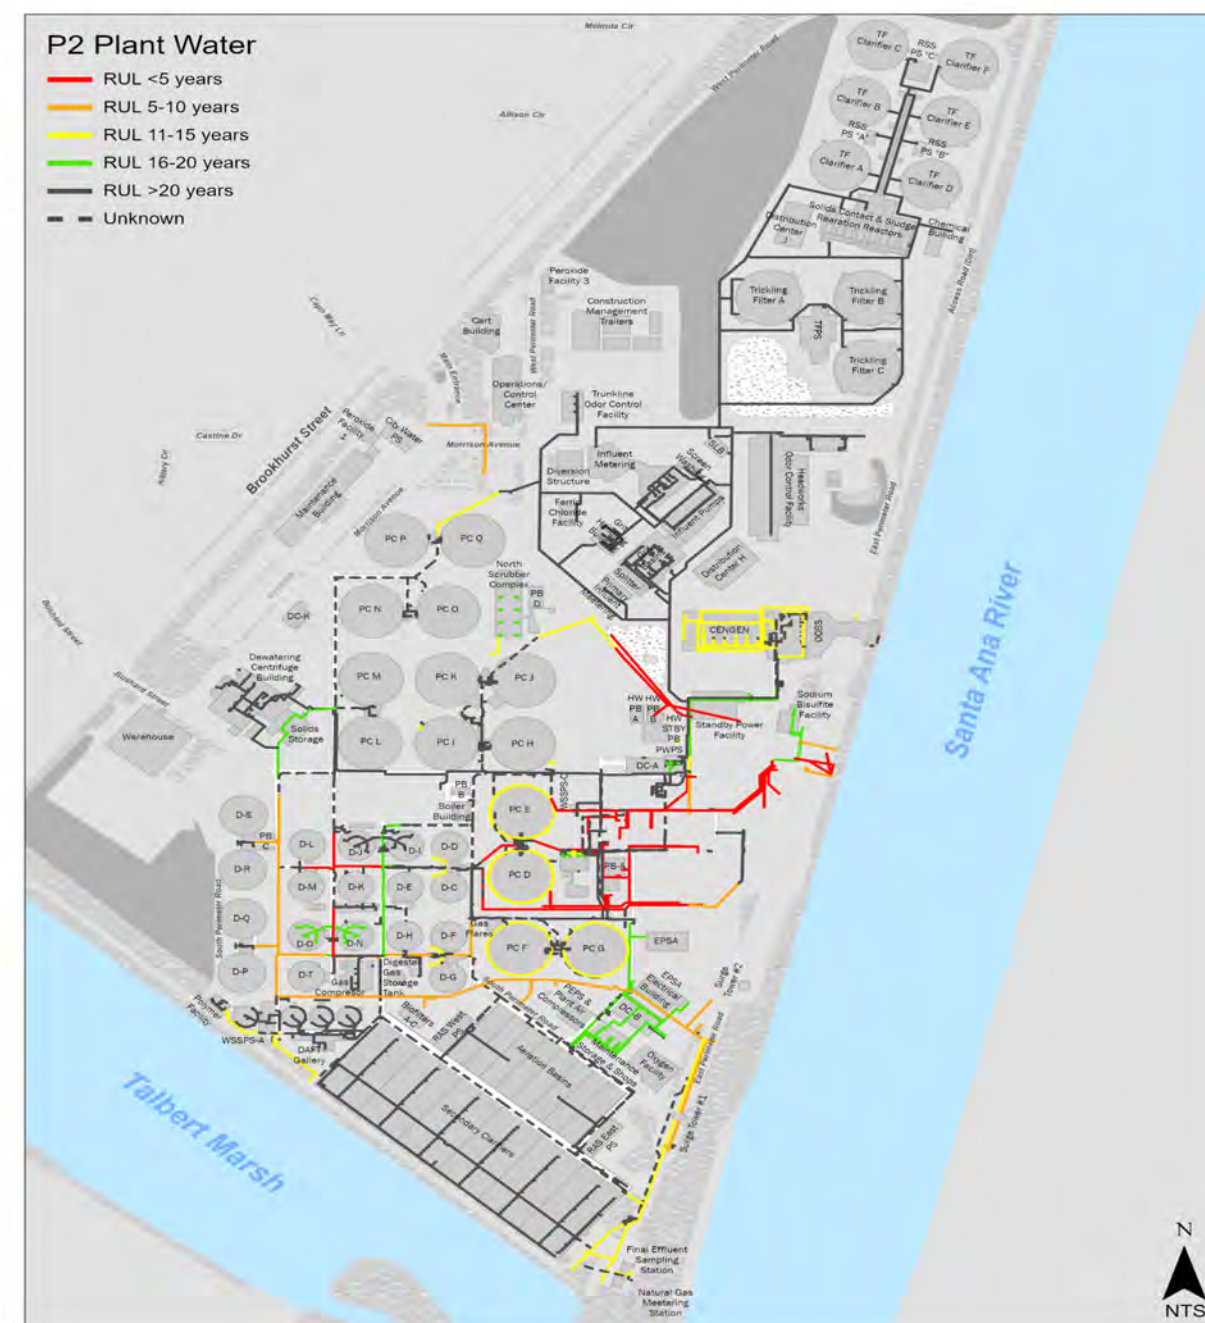
Remaining Useful Life of Utility Infrastructure

ASSET MANAGEMENT SYSTEM SUMMARY – AREA 27 – PLANT NO. 2 UTILITIES

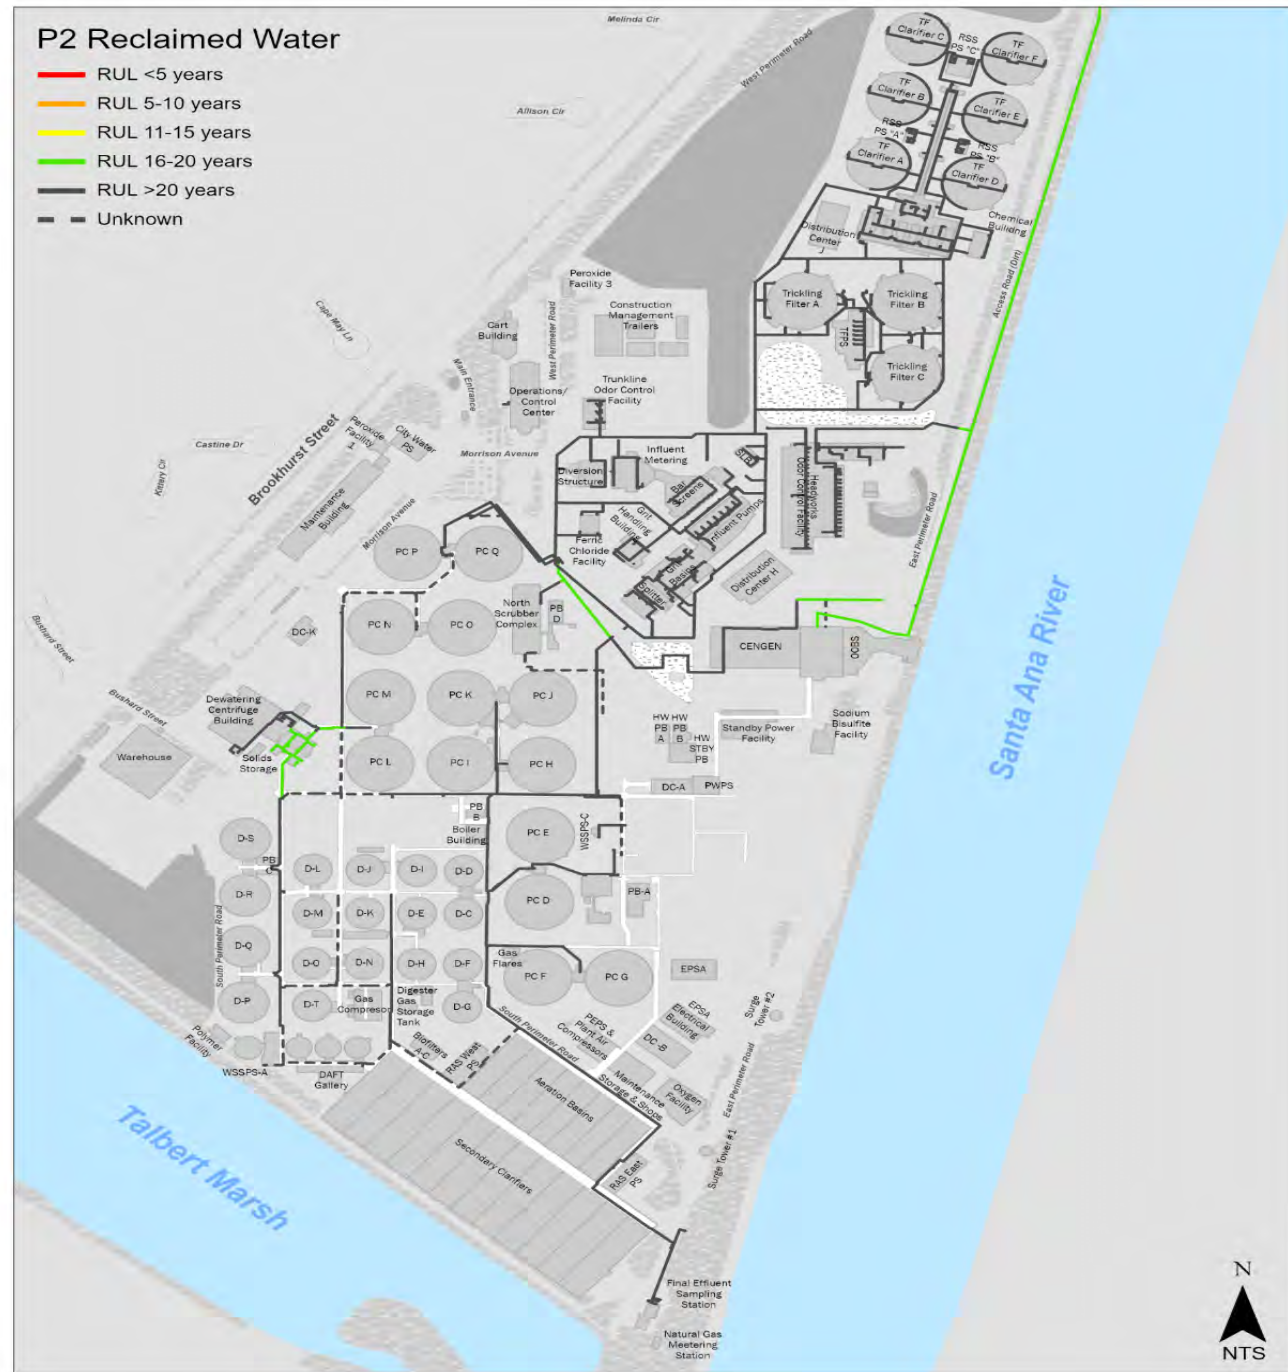
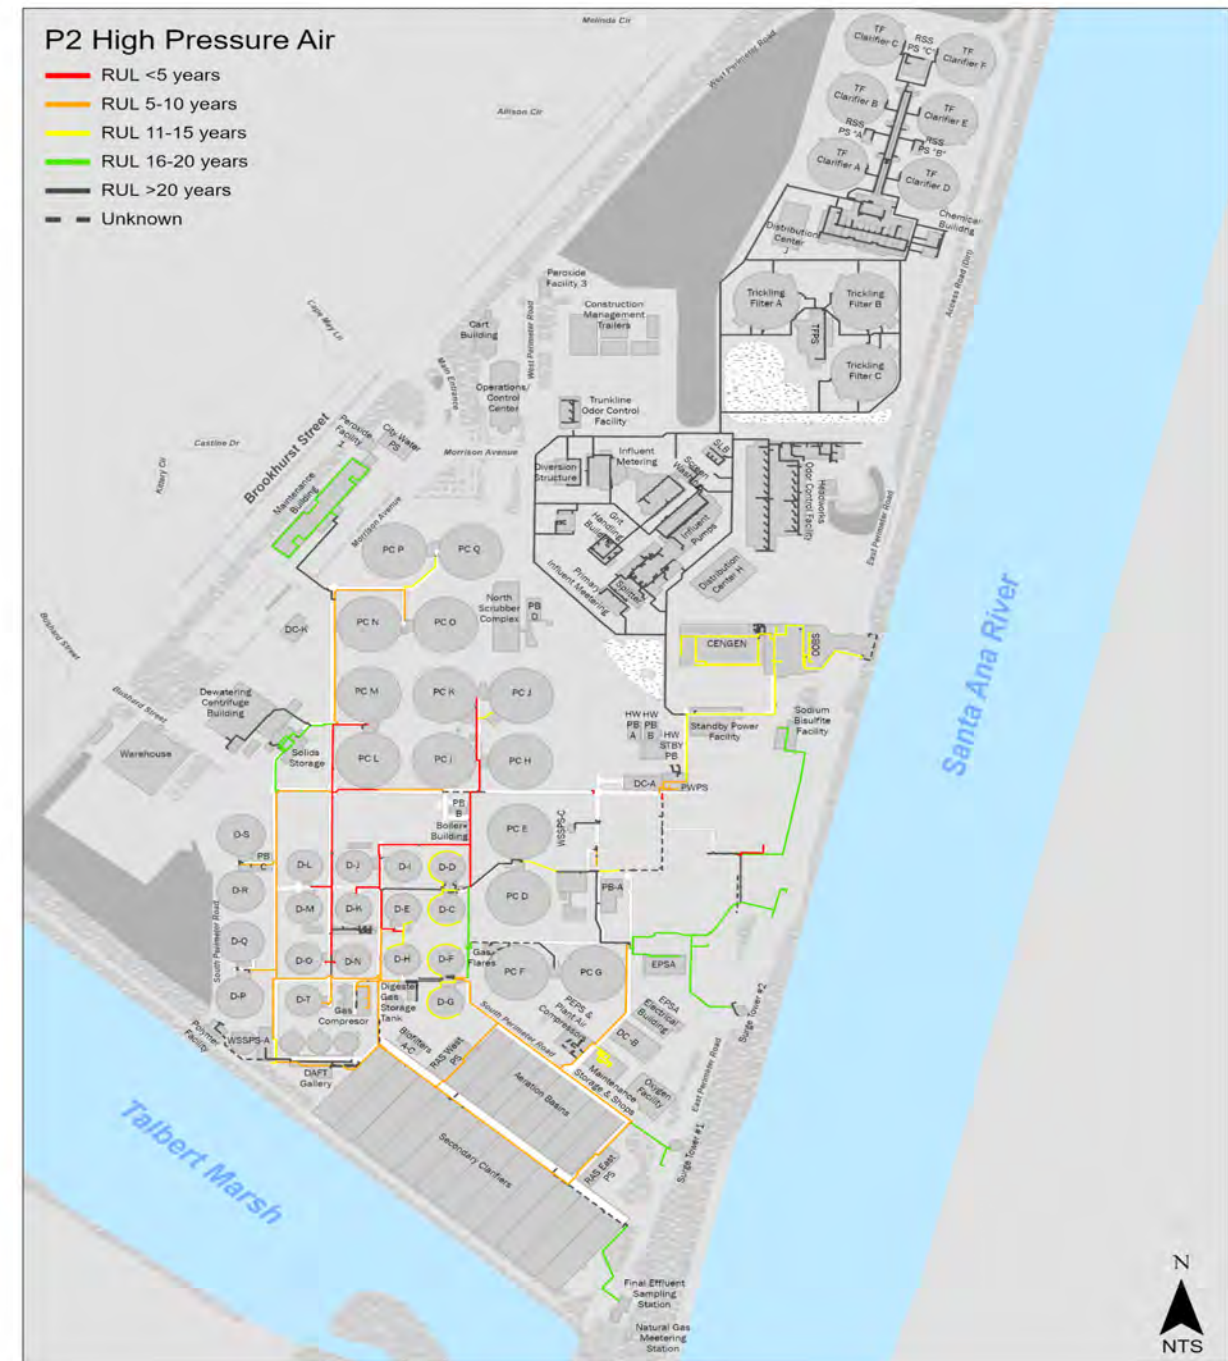
Remaining Useful Life of Utility Infrastructure

ASSET MANAGEMENT SYSTEM SUMMARY – AREA 27 – PLANT NO. 2 UTILITIES

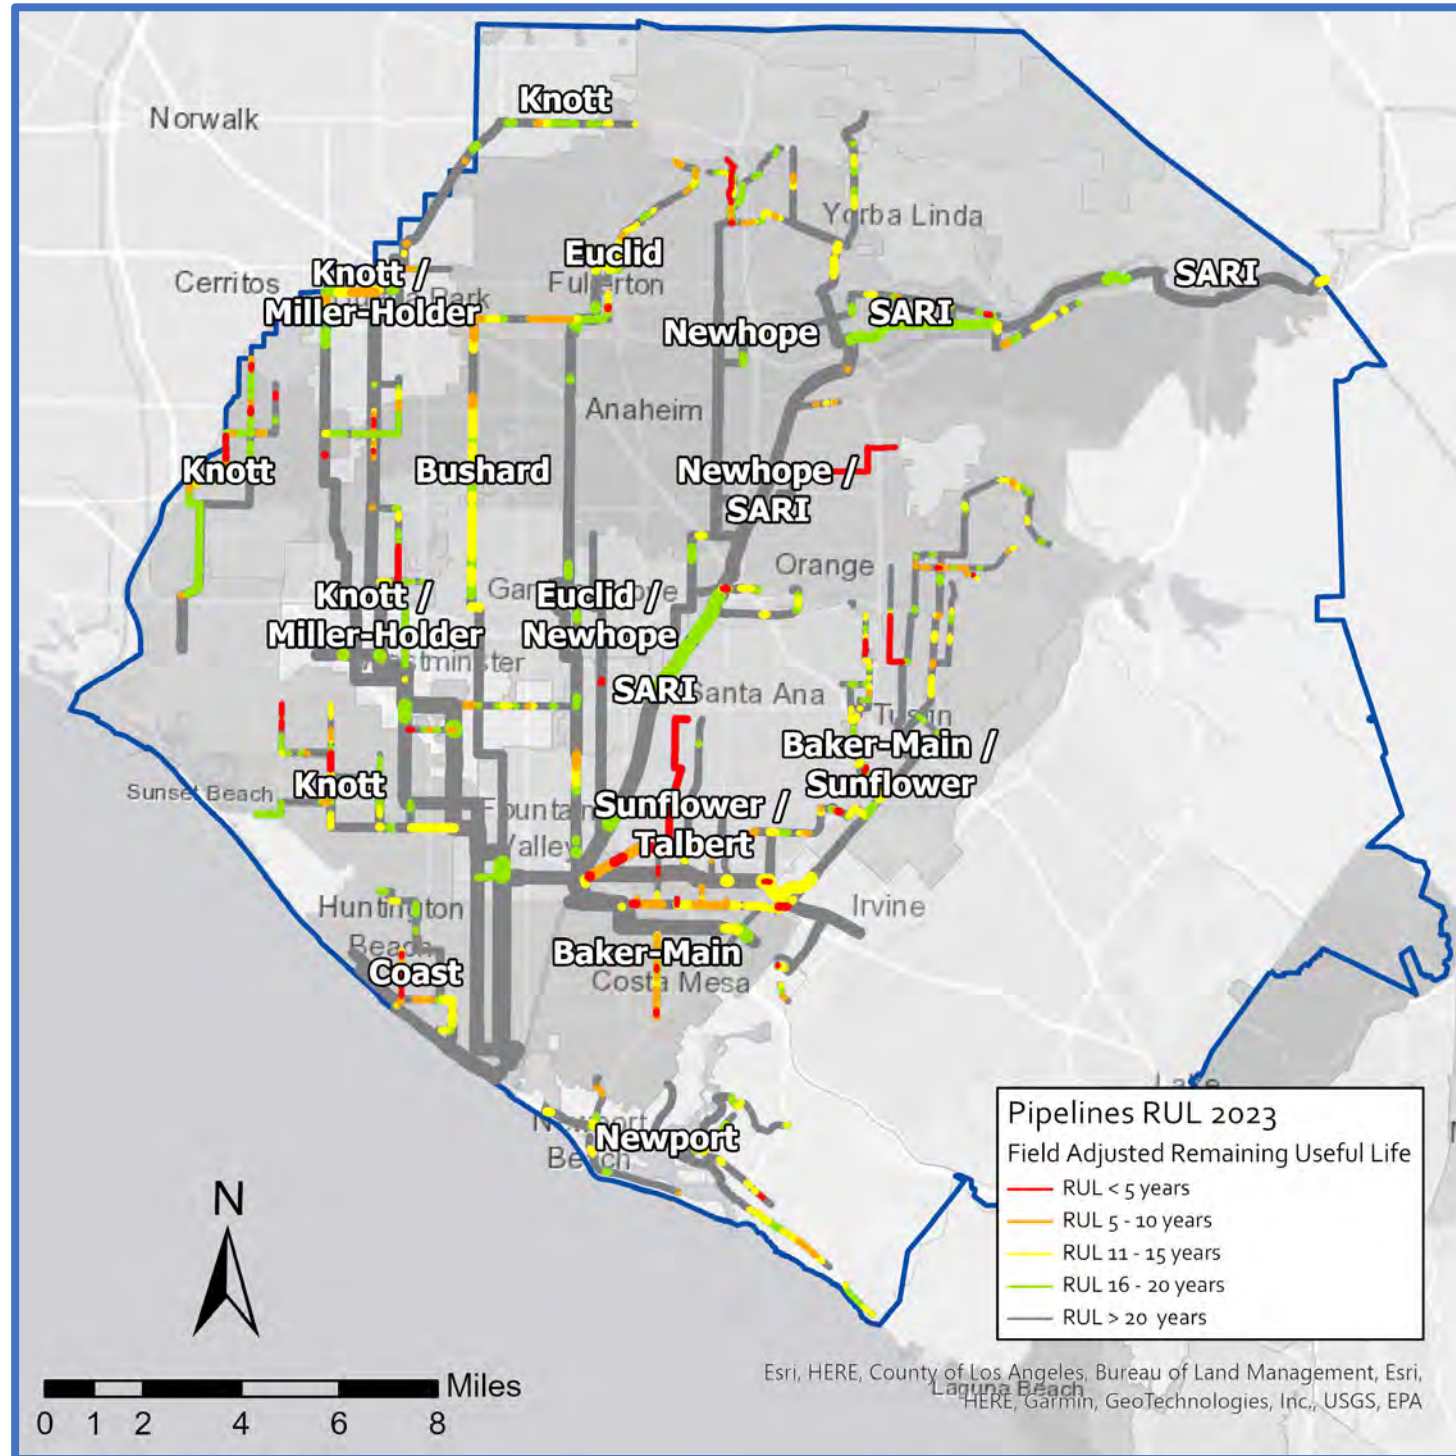
System Overview - Pipelines

ASSET MANAGEMENT SYSTEM SUMMARY – COLLECTION SYSTEM – ALL TRUNKS
