Asset Management Plan

2023

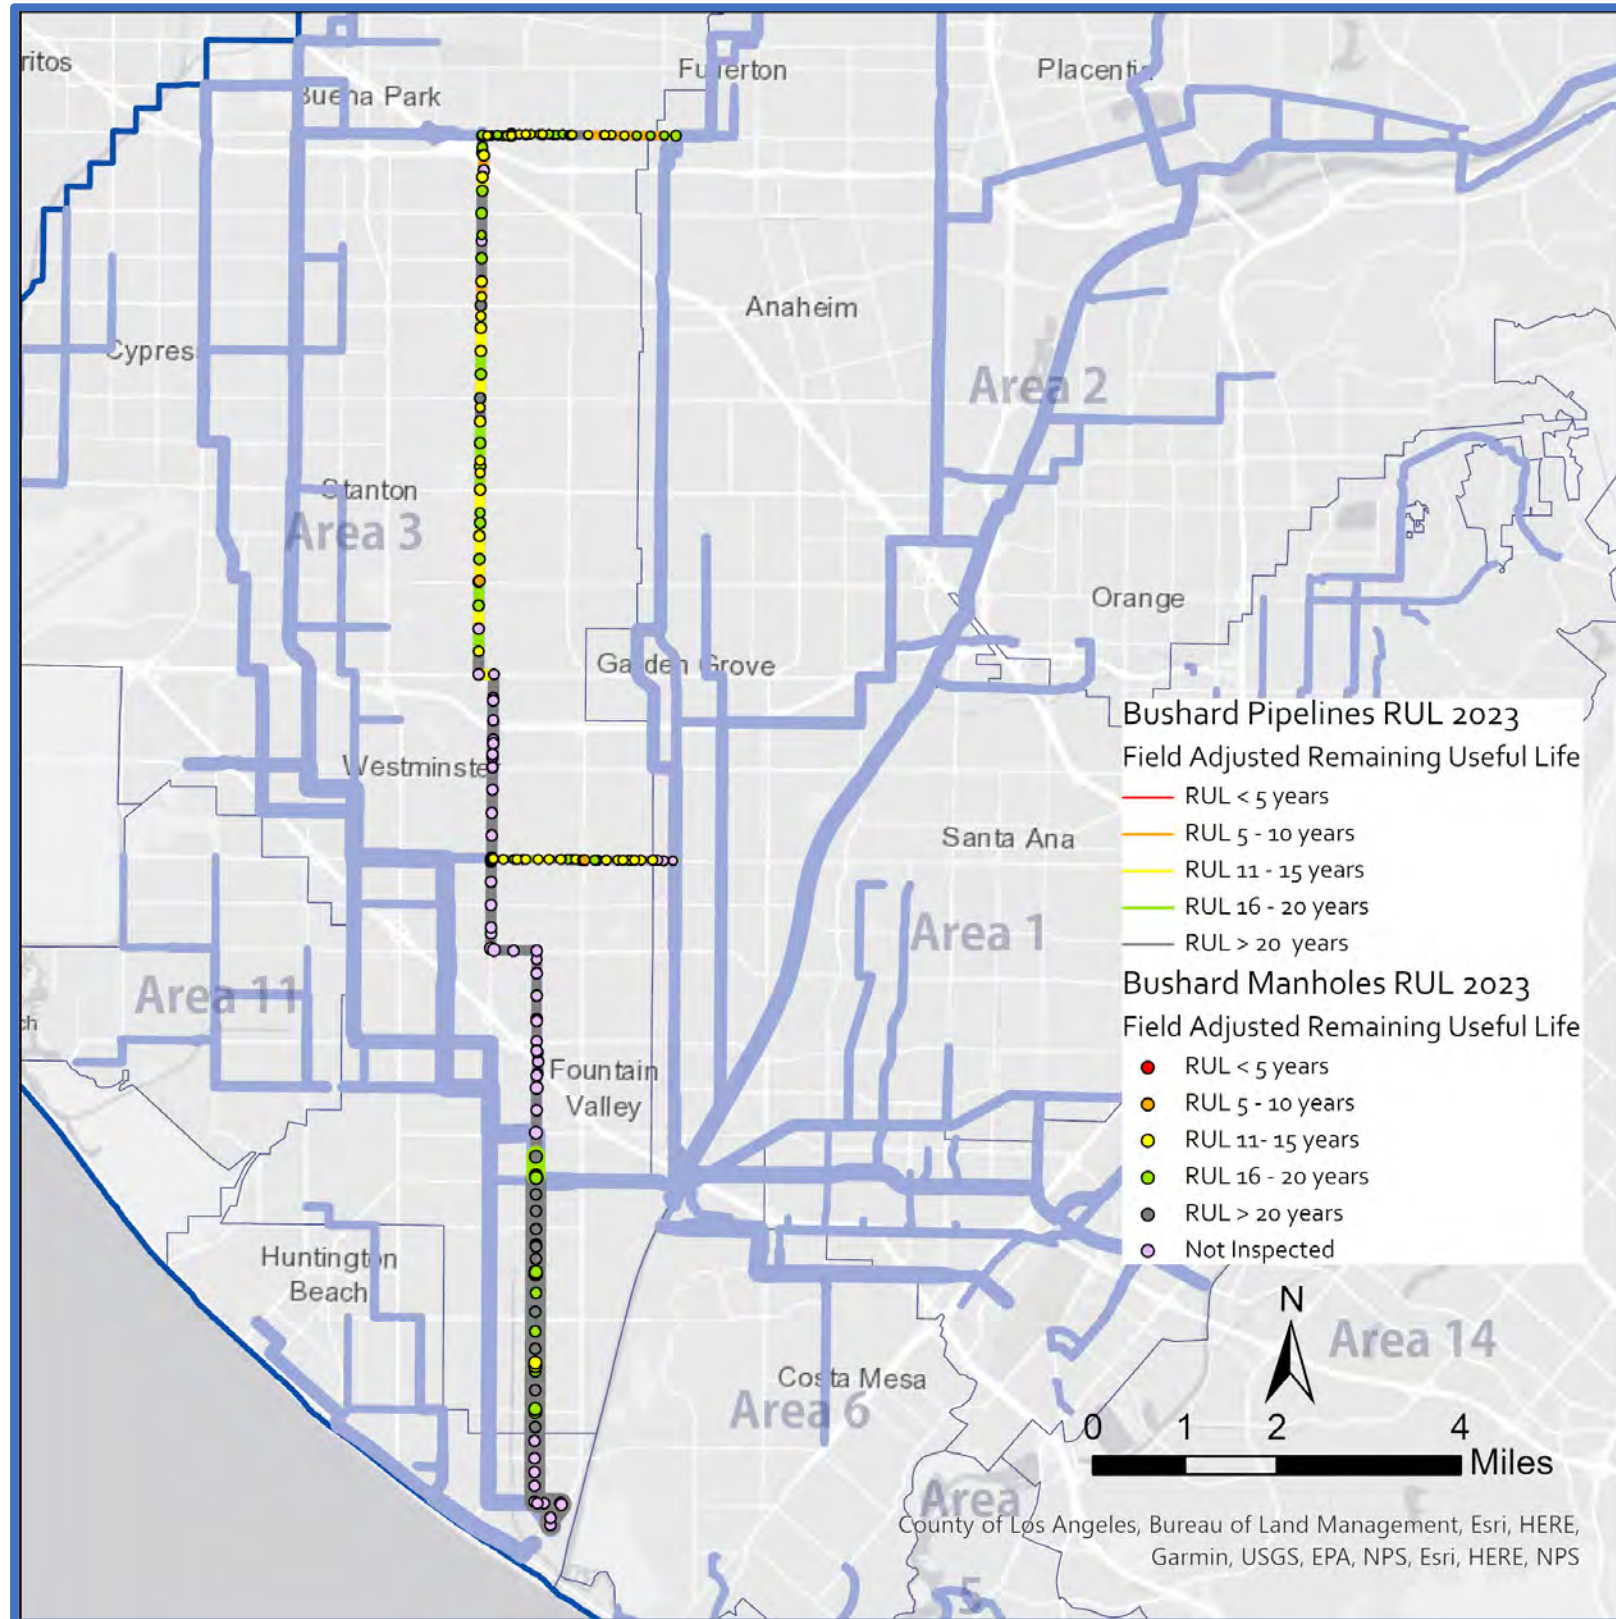
System Overview - Manholes

Asset Type	No. of Manholes	Average Age (years)	No. of Manholes with RUL Score of 5	No. of Manholes with RUL Score of 4
Concrete				
≤ 48" Ø	35	64	-	-
60"–72" Ø	52	39	-	2
> 72" Ø	115	38	-	1

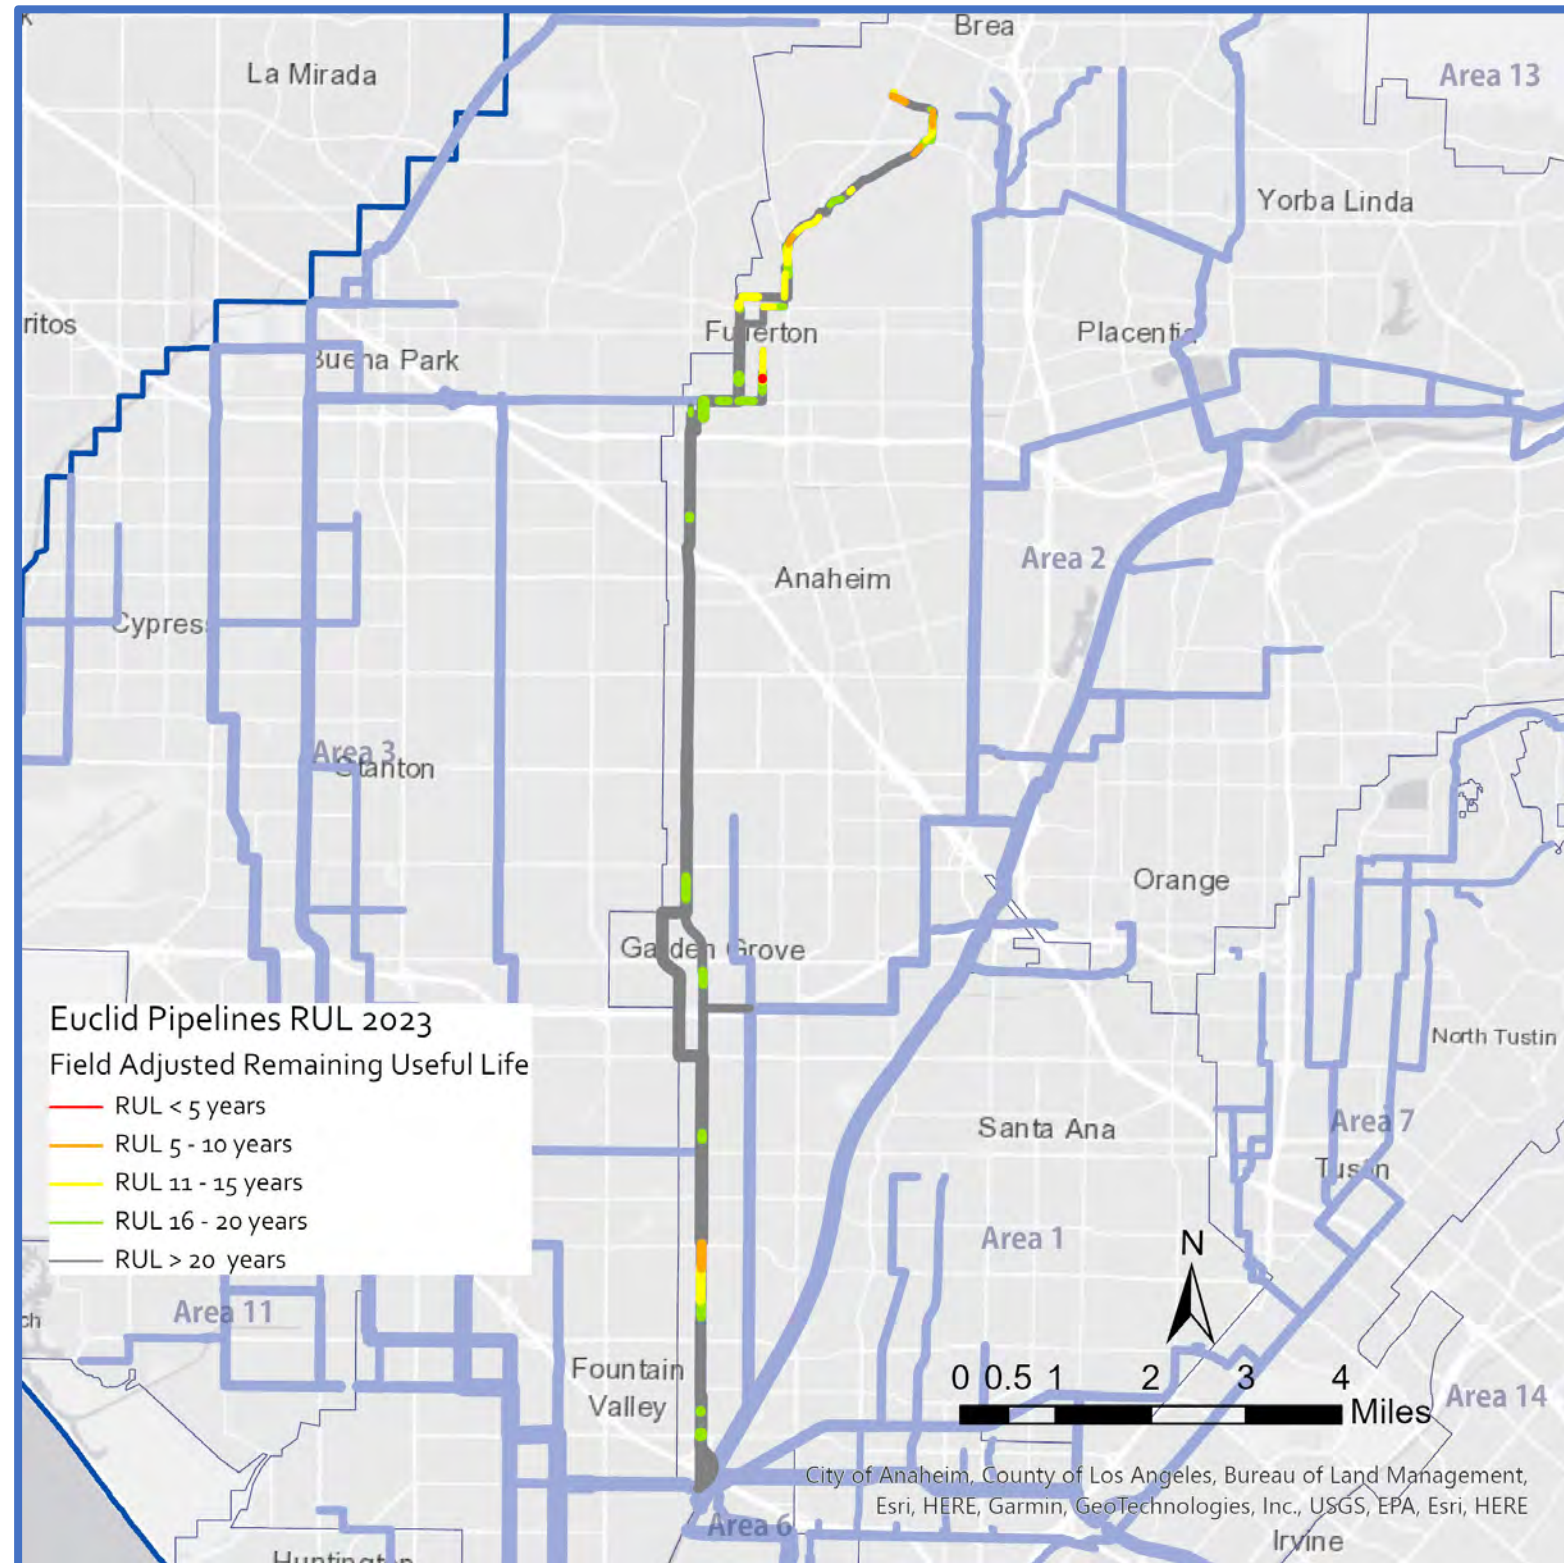
System Overview - Pipelines

Asset Type	Total Length (miles)	No. of Pipes	Average Age (years)	No. of Pipes with RUL Score of 5	No. of Pipes with RUL Score of 4
Vitrified Clay					
≤ 18" Ø	4.4	79	60	-	4
21"-27" Ø	3.9	52	40	-	1
≥ 30" Ø	12.1	151	51	1	1
Reinforced Concrete					
≤ 42" Ø	2.4	15	51	-	-
45"-60" Ø	11.6	131	34	-	-
Polyvinyl Chloride					
10"-30" Ø	0.1	12	18	-	-
Steel					
10" Ø	0.01	3	14	-	-
High-Density Polyethylene					
26" Ø	0.05	1	14	-	-

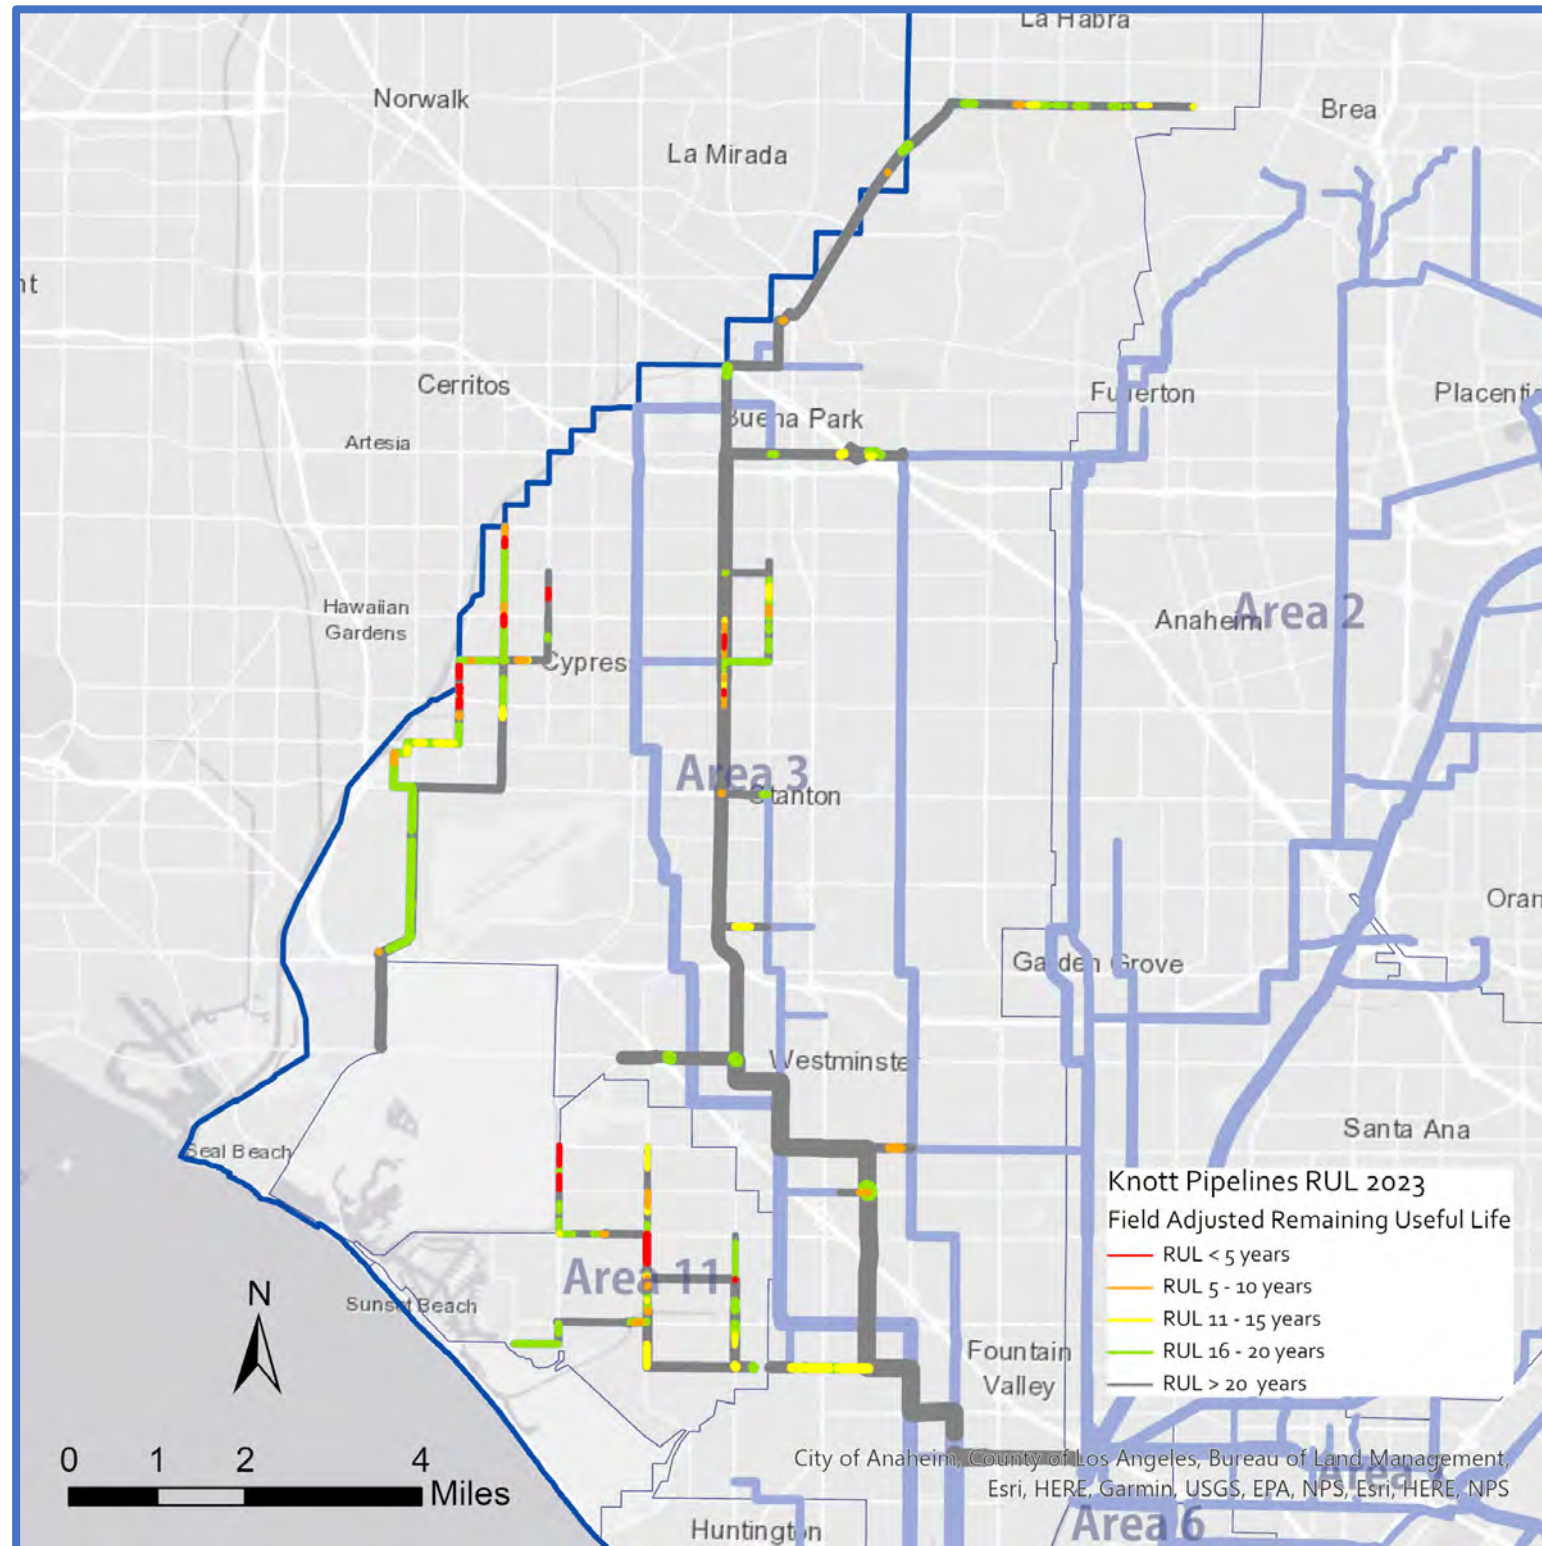
System Overview - Pipelines

Note: Map and data table include Interplant IPE pipelines and manholes.

Key Issues	Actions & Recommendations
<ul style="list-style-type: none"> Missing Air Jumpers – Four out of 17 inverted siphon/reduction locations in the Knott Trunk system do not have air jumpers. 	<ul style="list-style-type: none"> Project X-078 includes constructing a new air jumper at two locations. Two other locations do not require air jumpers due to lack of normal surcharge conditions at one location and an infeasible location at the end of a force main.
<ul style="list-style-type: none"> Pipeline Fracturing – CCTV identified several areas with significant fracturing of VCP pipelines. Most fractures are concentrated in northern Huntington Beach, Cypress, and with small-diameter sewers owned and operated by the City of Anaheim in the northern central area of the trunk. 	<ul style="list-style-type: none"> Projects 3-60, 3-64B and C, 11-35, X-061, X-078, X-085, and X-130 will address the majority of fractures by rehabilitating the pipelines. OC San staff will coordinate with the City of Anaheim pertaining to operation and maintenance of the local small-diameter sewers. Isolated defects elsewhere not included or near a CIP project and two pipelines that may not have fractures addressed in time by the X-061 project have been identified as high-priority point repairs. OC San staff are in the process of grouping point repairs together for 7-pack task orders.

<ul style="list-style-type: none"> Uninspected Gravity Pipelines – Three gravity sewers have never been inspected in the Knott and Ellis Avenue Trunk systems. There is no condition data for these reaches to determine field-adjusted RUL. 	<ul style="list-style-type: none"> There are no known access issues for the three uninspected gravity sewers. Inspections will be completed via future CCTV PM work orders or separate CCTV work orders.
<ul style="list-style-type: none"> Vault Vibration Issues – Three sewer vaults in Warner Avenue cause local vibration/resonance issues to nearby residences when cars pass over them. 	<ul style="list-style-type: none"> Project FRC-0010 will rehabilitate each of the Warner Avenue vaults to eliminate local vibration/resonance issues.

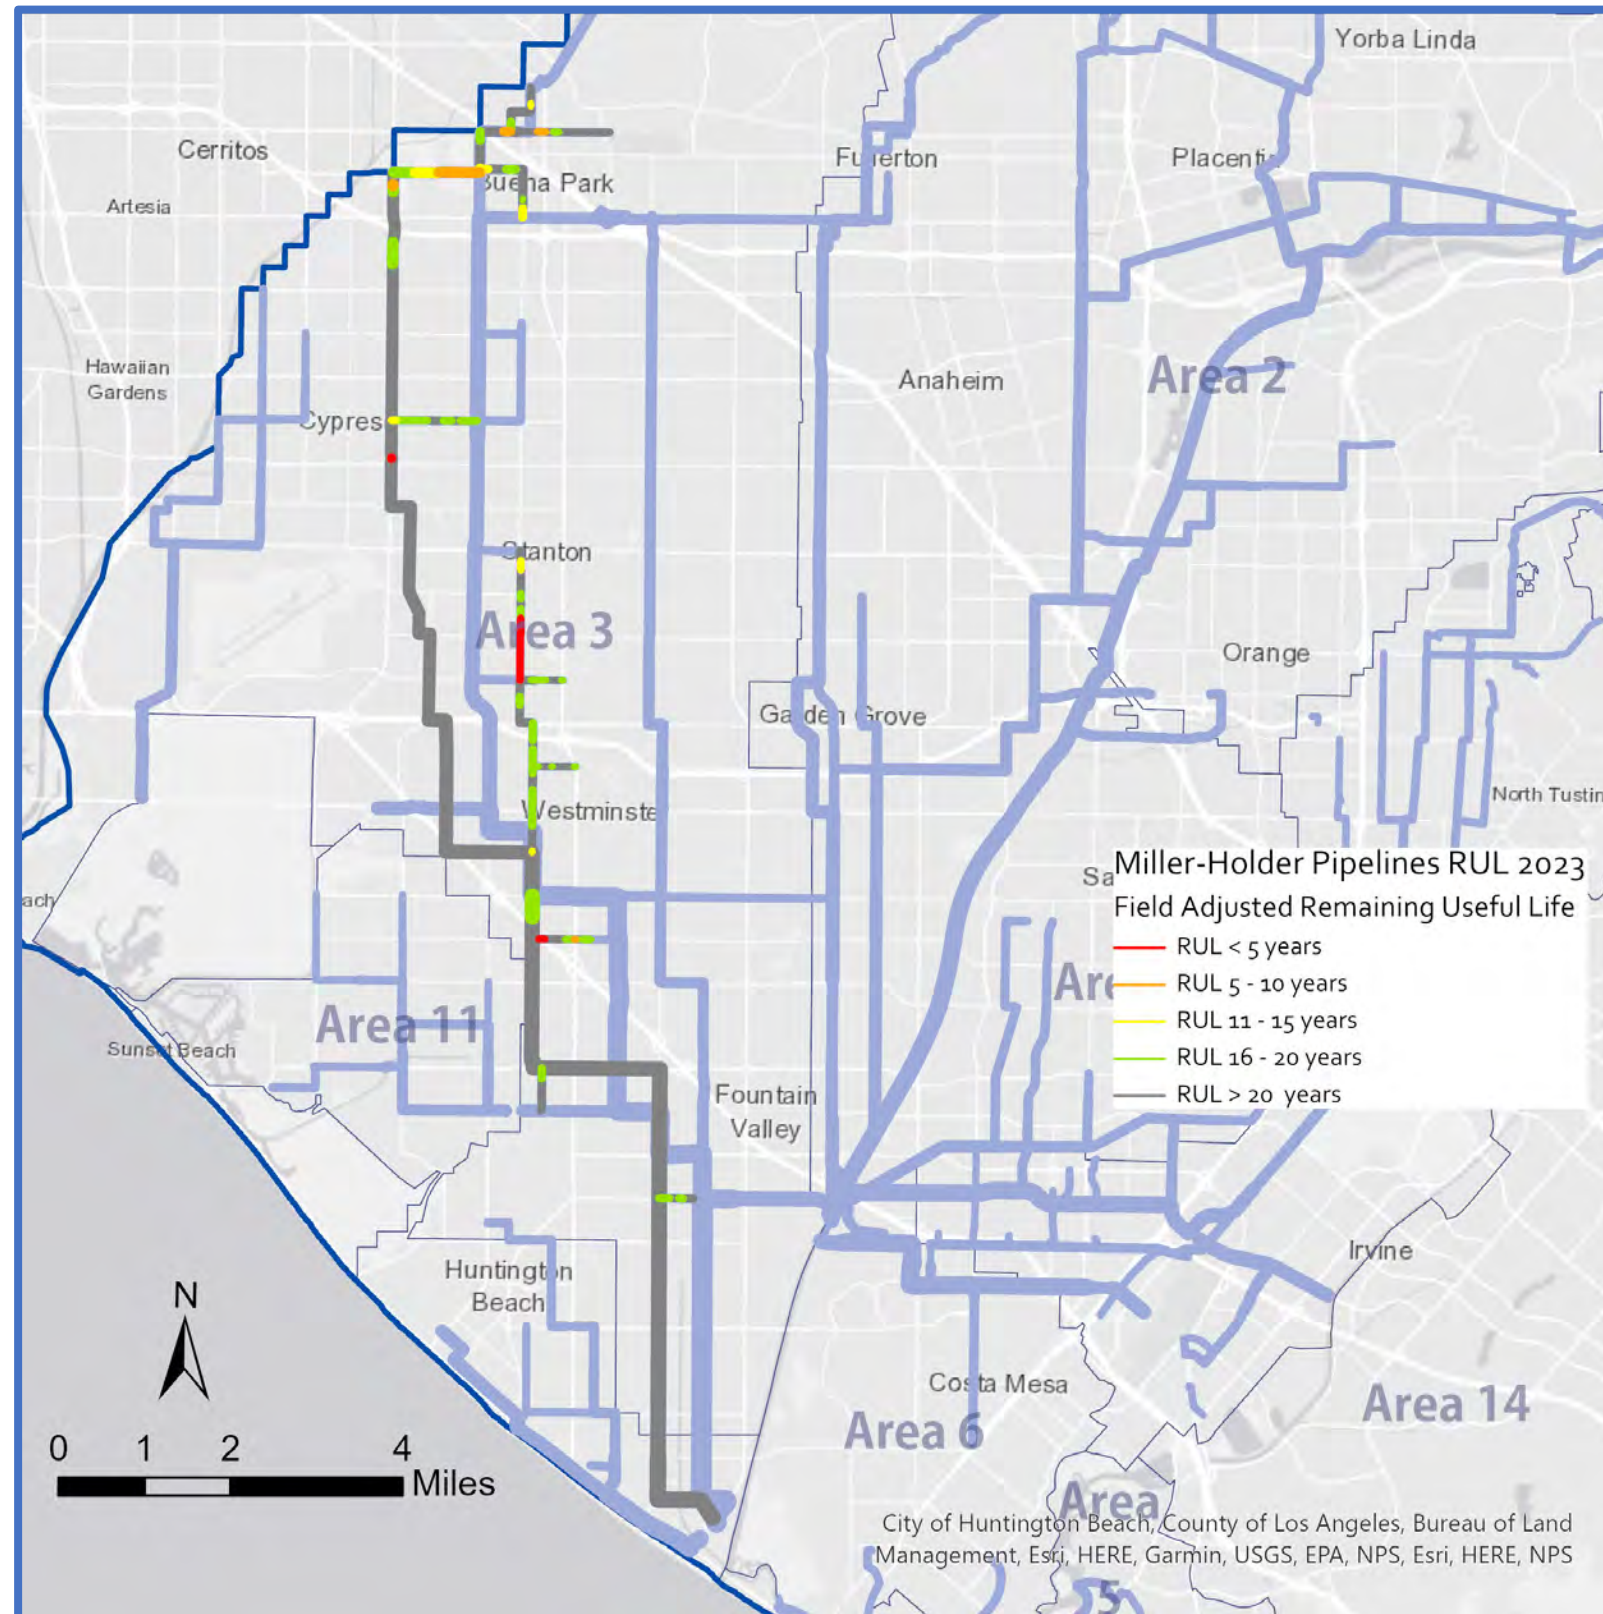
System Overview - Pipelines

Asset Type	Total Length (miles)	No. of Pipes	Average Age (years)	No. of Pipes with RUL Score of 5	No. of Pipes with RUL Score of 4
Vitrified Clay					
≤ 18" Ø	2.9	50	63	1	2
21"-27" Ø	6.9	87	62	10	-
≥ 30" Ø	2.5	27	61	1	3
Reinforced Concrete					
45"-69" Ø	13.4	76	64	-	1
≥ 72" Ø	5.8	25	73	-	-
Ductile Iron					
≤ 18" Ø	0.1	5	41	-	3
Polyvinyl Chloride					
24" Ø	0.02	1	21	-	-

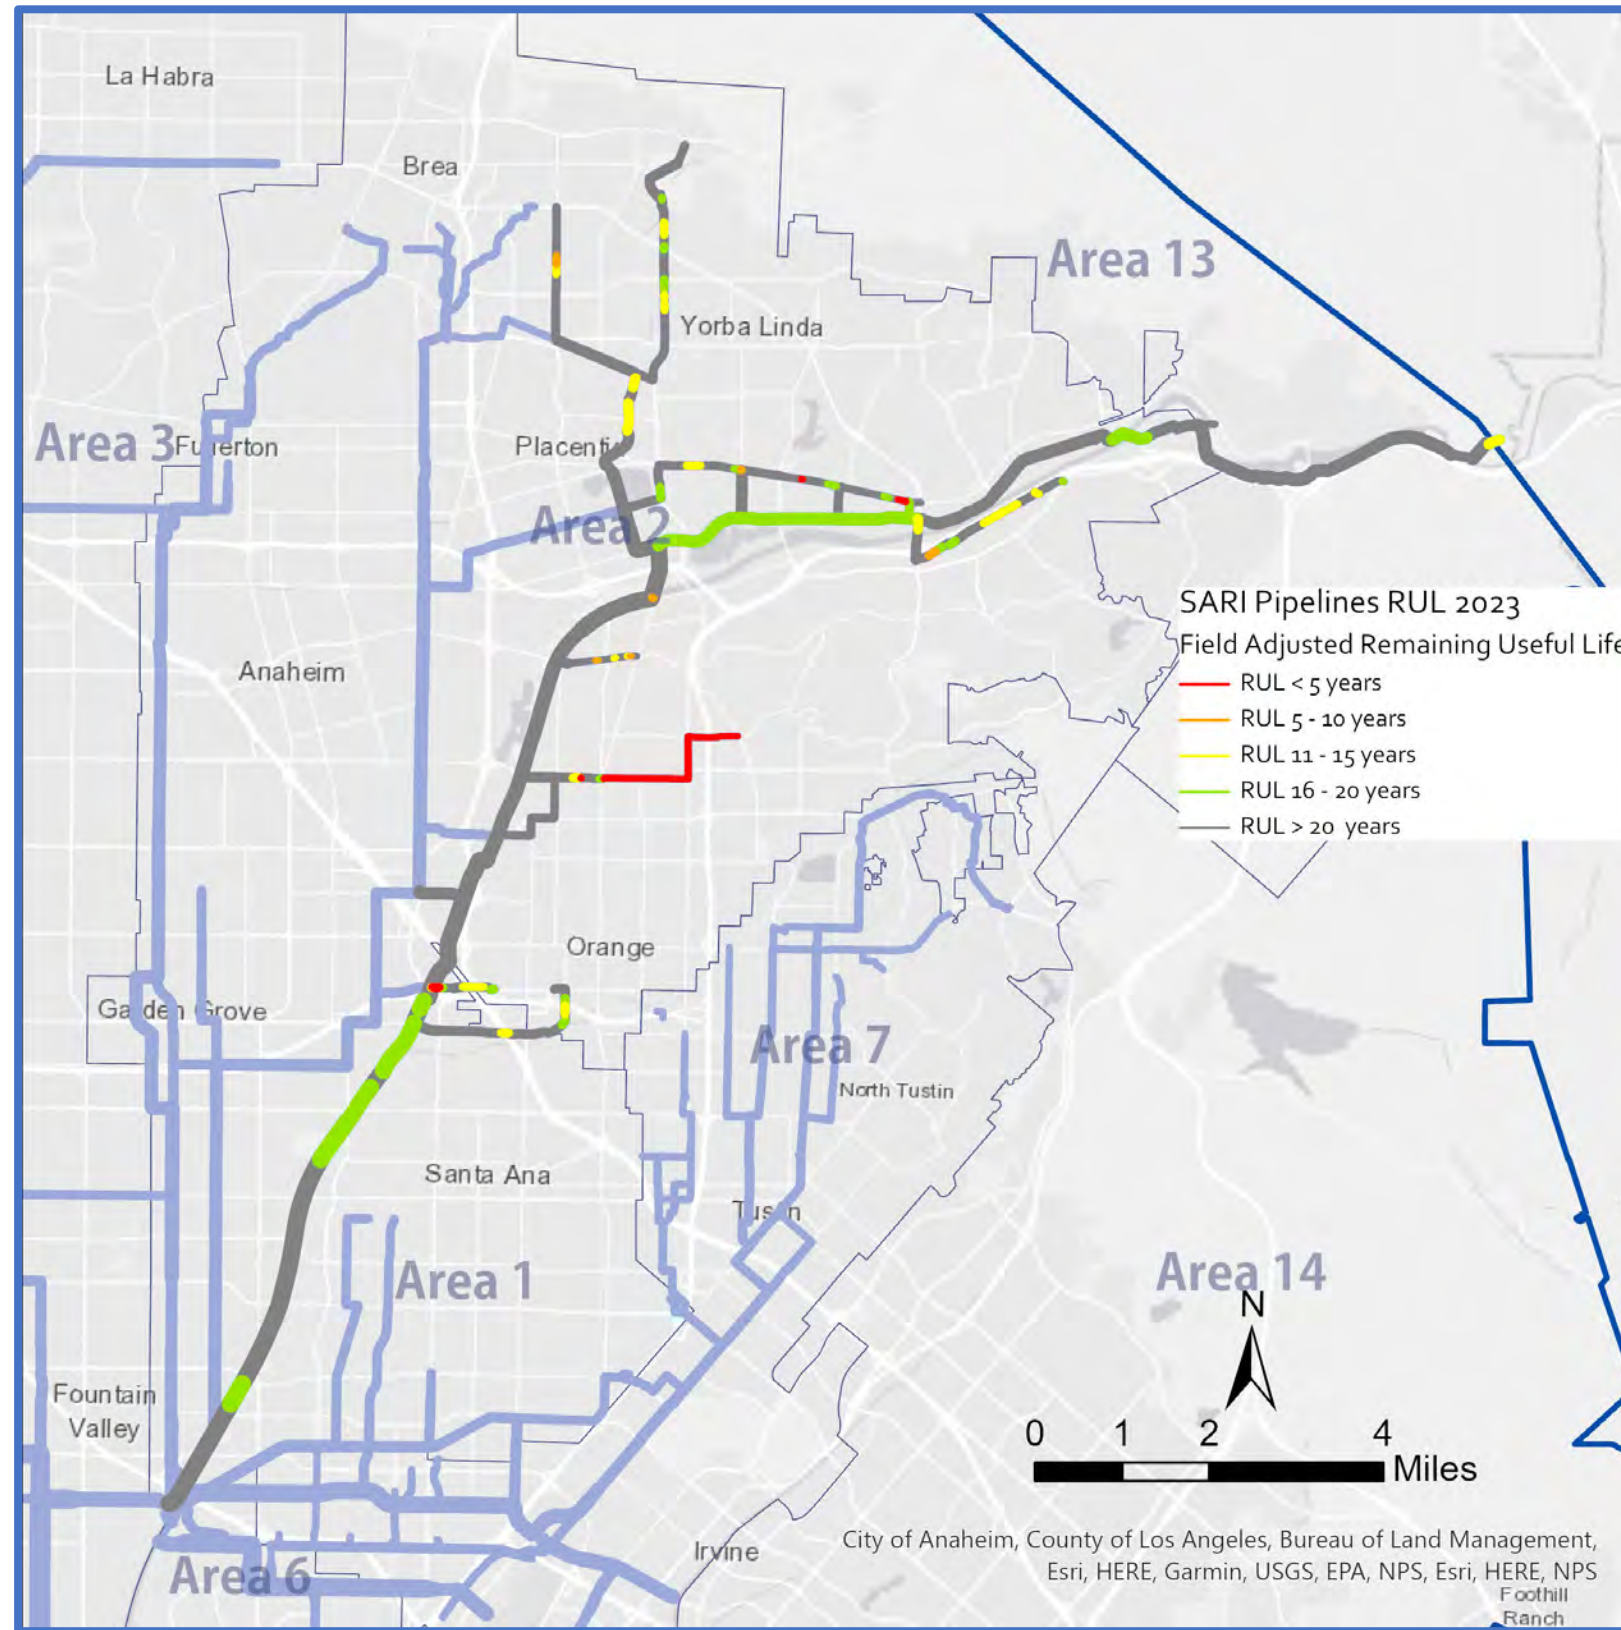
System Overview - Pipelines

Asset Type	Total Length (miles)	No. of Pipes	Average Age (years)	No. of Pipes with RUL Score of 5	No. of Pipes with RUL Score of 4
Vitrified Clay					
≤ 18" Ø	5.0	113	58	46	3
21"-27" Ø	11.4	184	47	-	3
≥ 30" Ø	5.7	79	38	-	-
Reinforced Concrete					
42"-66" Ø	12.0	88	44	-	-
≥ 72" Ø	10.0	50	48	-	-
Fiberglass Reinforced Plastic					
36"-54" Ø	3.9	41	12	-	-
High-Density Polyethylene					
≤ 18" Ø	0.5	4	9	-	-
30" Ø	0.7	3	12	-	-
Ductile Iron					
24"-30" Ø	0.8	10	37	2	-
Steel					
30" Ø	0.03	2	12	-	-
Cured-in-Place					
33" Ø	0.3	4	14	-	-
Polyvinyl Chloride					
12" Ø	0.01	1	7	-	-

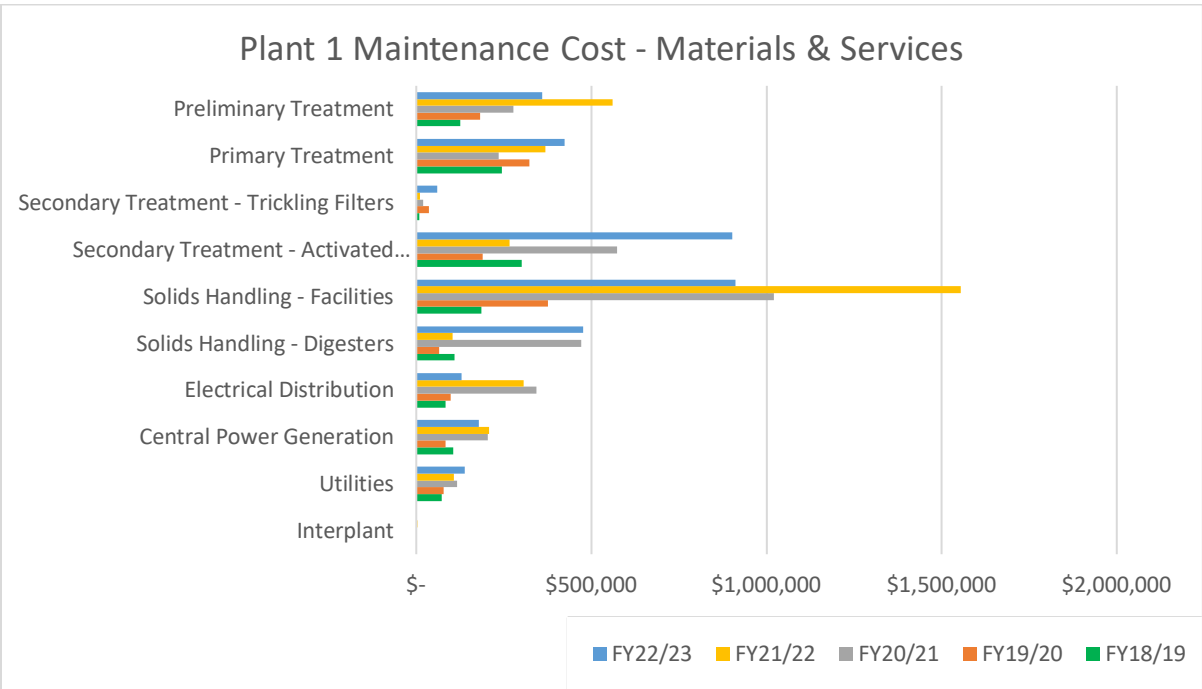
Figure 3-3. Graph of Maintenance Costs (Materials and Services) at Plant No. 1

OC San uses the maintenance costs and number of labor hours over time as trend indicators to indicate the amount of resources devoted to reliably maintaining the process areas. Figure 3-3 shows maintenance costs (materials and services) per FY broken down by process area at Plant No. 1. The data indicate that there has been a large increase in maintenance costs at the Plant No. 1 Activated Sludge facility due to several in-house maintenance activities for the aging assets such as the installation of a new WAS pump, and lighting improvement to replace old LED lights. Dewatering centrifuge overhaul is one of the most expensive maintenance activities at the T&D building that happened in both FY 2022–2023 and FY 2021–2022. Overall, the maintenance cost is expected to reduce at the T&D building with several in-house improvements in the past couple of years.

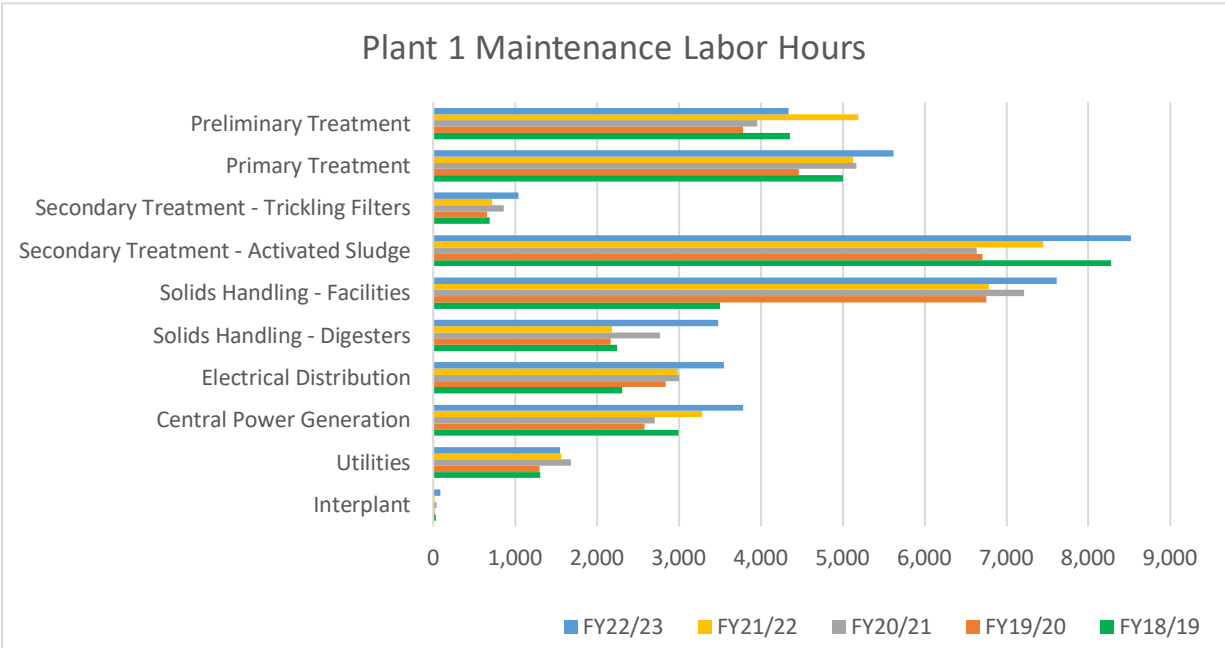
Figure 3-4. Graph of Maintenance Labor Hours at Plant No. 1

Figure 3-4 shows Maintenance labor hours per FY broken down by process area at Plant No. 1. The labor hours are high at the Plant No. 1 secondary facility because of the older equipment at activated sludge facility 1, which is scheduled for rehabilitation under Project P1-140. The labor hours are also high at the solids handling facility because the new thickening and dewatering process has more complex equipment that requires more staff to operate and maintain. In FY 2022–2023, the rebuild of two high-rate pumps and several mechanical seal replacements were among the most labor-intensive activities in the digester area.

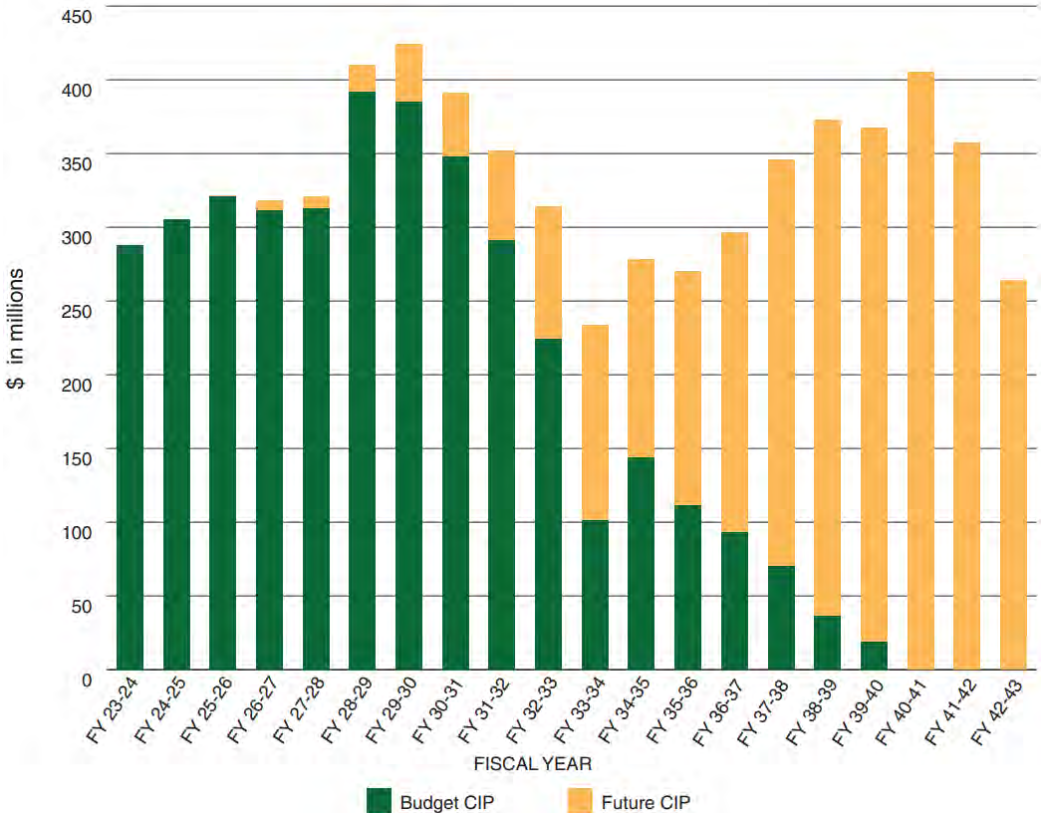
Figure 4-1. 20-Year CIP Outlay

The FY 2023–2024 Budget Update, the second year of the 2-year budget adopted in June 2022, includes updates to the 20-year CIP outlay. Figure 4-1 shows the 20-year CIP outlay, which includes current and projected future CIP projects. The FY 2023–2024 CIP Outlay is \$288.6 million and is further divided into process categories, as shown on Figure 4-2. From the chart, it is apparent that liquid treatment, support facilities, and collection facilities are primary areas where the FY 2023–2024 CIP Outlay will be spent.

For liquid treatment, Project No. P1-105, Headworks Rehabilitation at Plant No. 1, and Project No. P2-98A, A-Side Primary Clarifiers Replacement at Plant No. 2, are expected to be the largest expenditures of \$62.7 million and \$23.9 million, respectively, in FY 2023–2024. For support facilities, Project No. P1-128, Headquarters Complex, is the biggest driver with \$35.1 million in FY 2023–2024. Lastly, for collection facilities, Project No. 3-64, Rehab of Western Regional Sewers, and Project No. 7-68, MacArthur Force Main Improvements, comprise nearly one-third of Collections CIP spending at \$6.3 million and \$4.3 million, respectively.

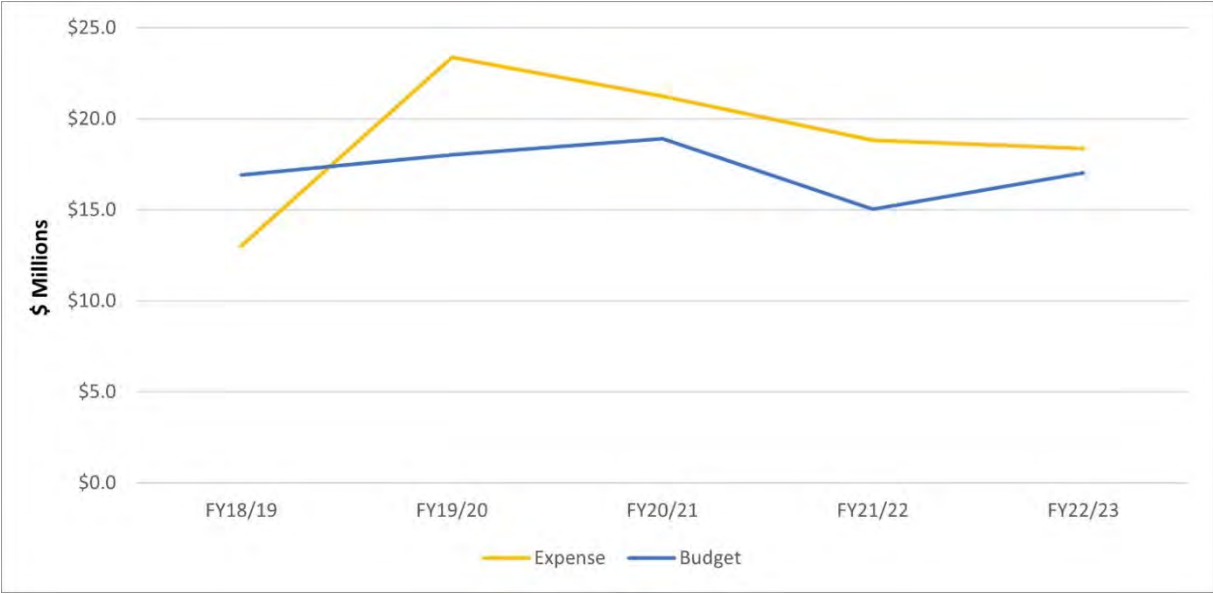
Figure 4-3. Five-Year Historical Maintenance Costs for Treatment Plants

- The treatment plant expenditures include maintenance services and materials (budget objects 54010 and 54020).
- The collection system expenditures include maintenance services and materials (budget objects 54010, 54020, and 53180).
- These costs represent the O&M costs of fixed assets, including operationally funded repair/replacement projects.

Figure 4-3 and Figure 4-4 show the historical actual spent versus budgeted operational and maintenance expenditures for the treatment plants and collection system, respectively.

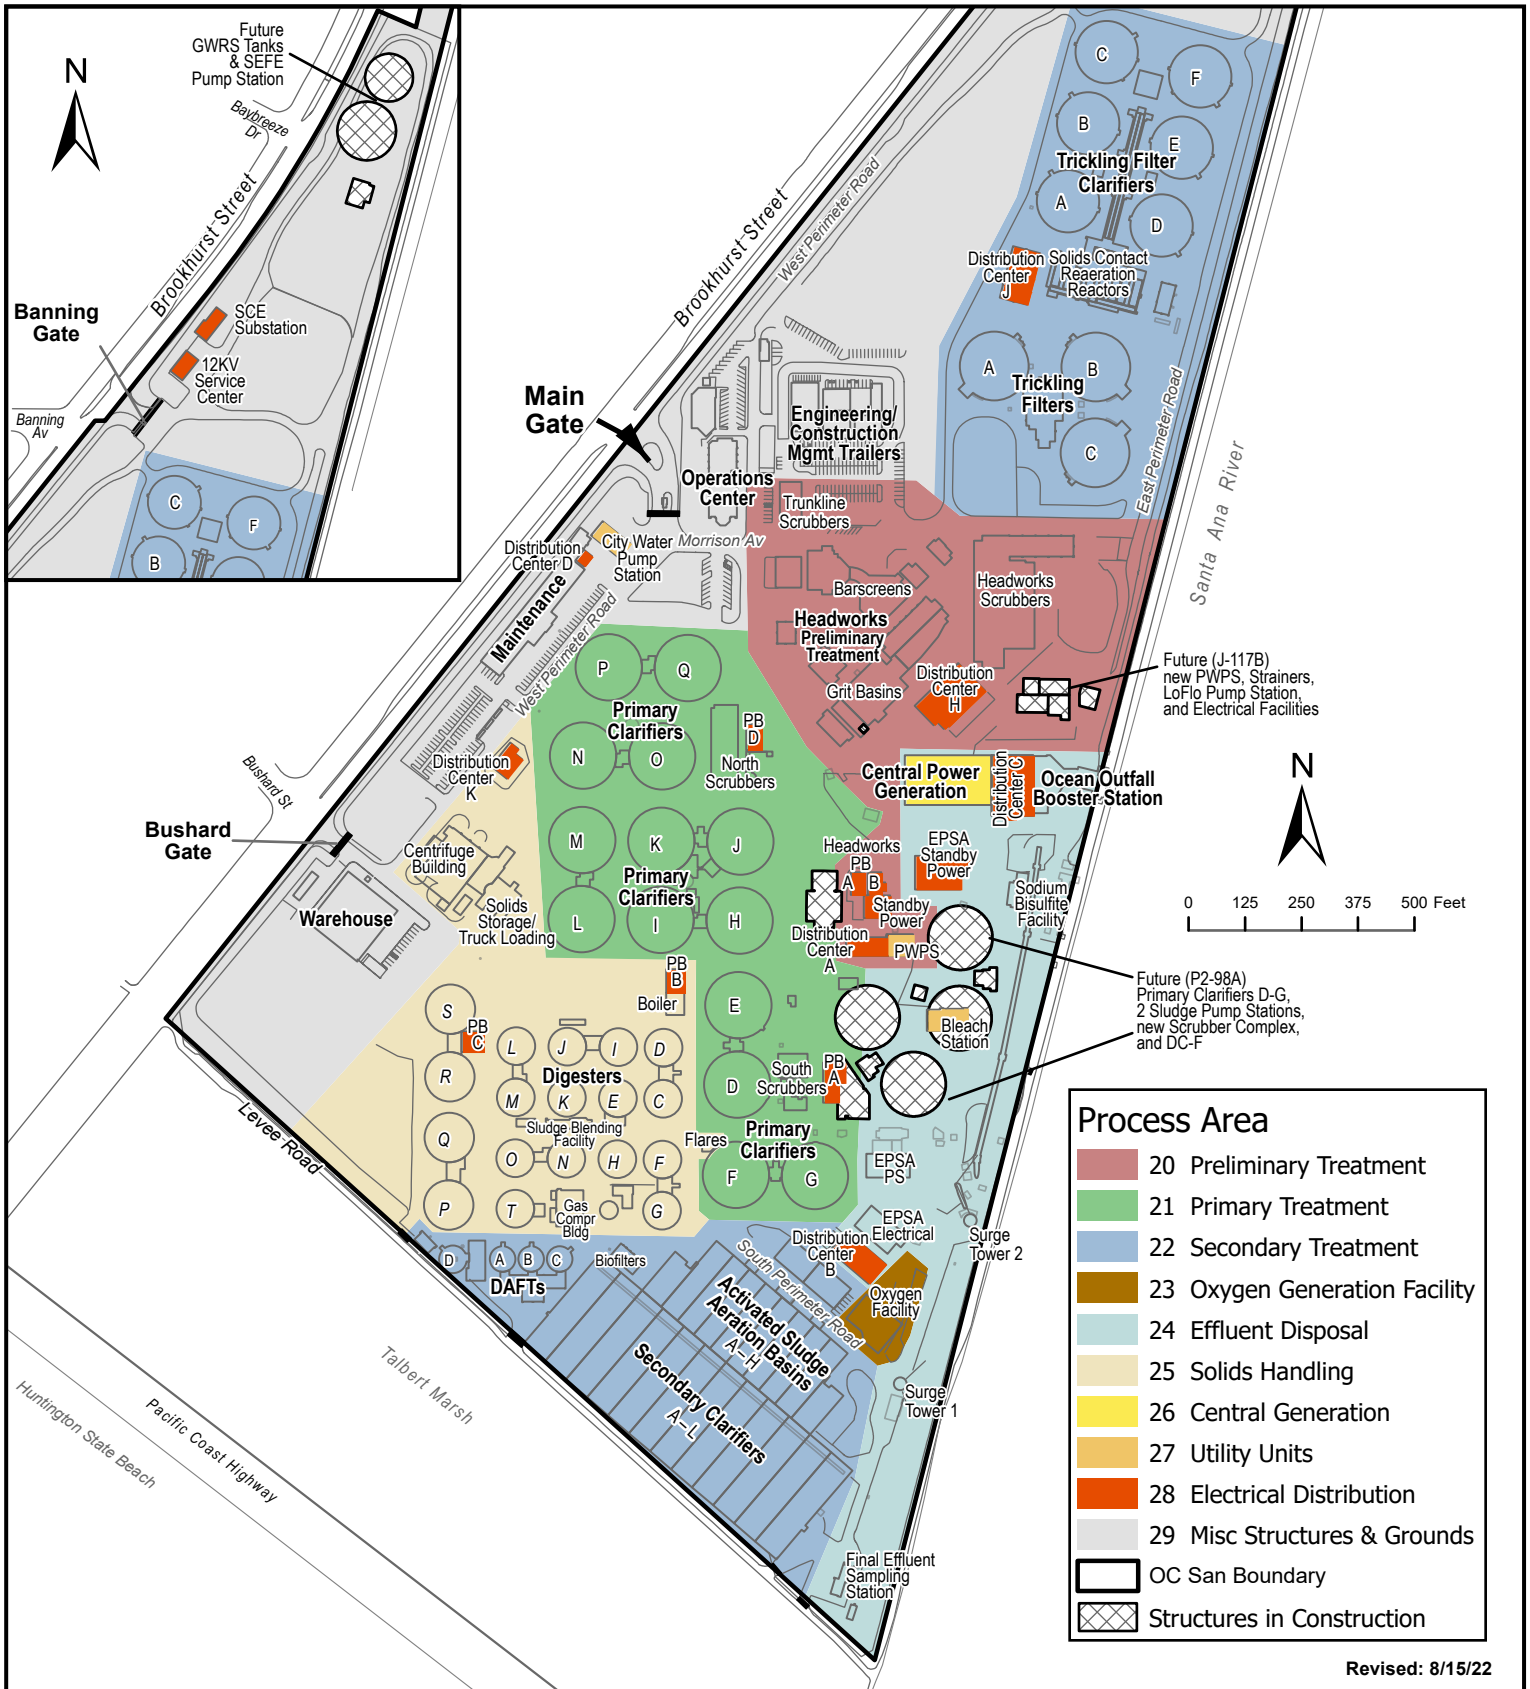
PROCESS AREAS – Treatment Plant No. 2

Process Area	
	20 Preliminary Treatment
	21 Primary Treatment
	22 Secondary Treatment
	23 Oxygen Generation Facility
	24 Effluent Disposal
	25 Solids Handling
	26 Central Generation
	27 Utility Units
	28 Electrical Distribution
	29 Misc Structures & Grounds
	OC San Boundary
	Structures in Construction

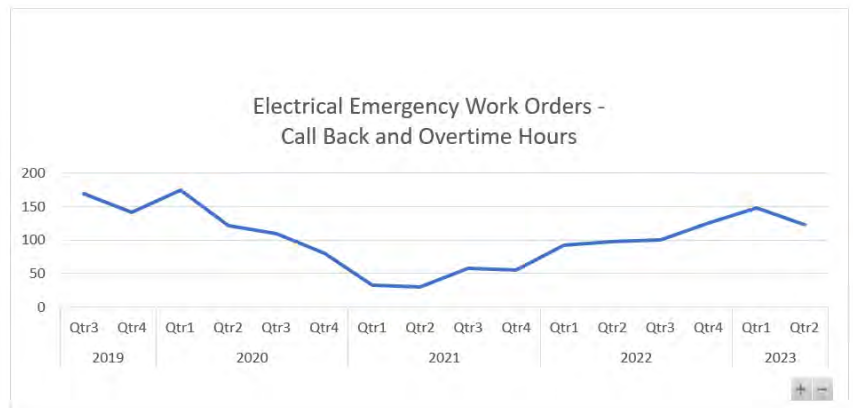
Electrical Emergency Work Hours

Row Labels	Sum of Overtime
2019	310.5
Qtr3	169.75
Qtr4	140.75
2020	485.5
Qtr1	174.25
Qtr2	121.75
Qtr3	109
Qtr4	80.5
2021	174
Qtr1	32.25
Qtr2	30
Qtr3	57
Qtr4	54.75
2022	413.75
Qtr1	92
Qtr2	97.25
Qtr3	99.5
Qtr4	125
2023	270.5
Qtr1	147.5
Qtr2	123
Grand Total	1654.25
