# Asset Management Plan

2025

## Overview of OC San's Infrastructure

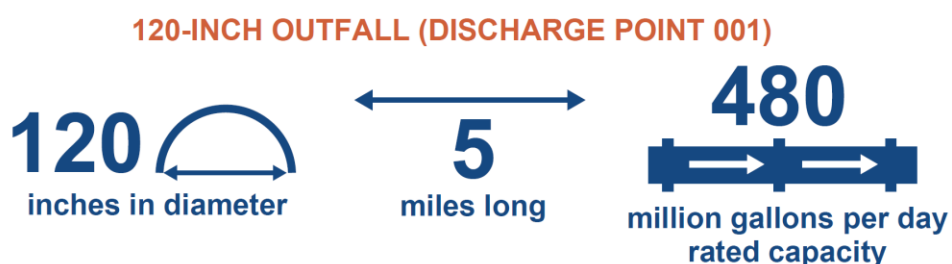
**120-inch Outfall (Discharge Point 001)** serves as the primary ocean outfall, discharging treated wastewater approximately 5 miles offshore at a depth of approximately 200 feet. It began service in 1971. Based on the findings of a comprehensive assessment study completed in 2022, a rehabilitation project is in progress to ensure the outfall's reliability for many years to come.
