# Asset Management Plan

2023

### ASSET MANAGEMENT SYSTEM SUMMARY – PLANT NO. 1 OVERVIEW

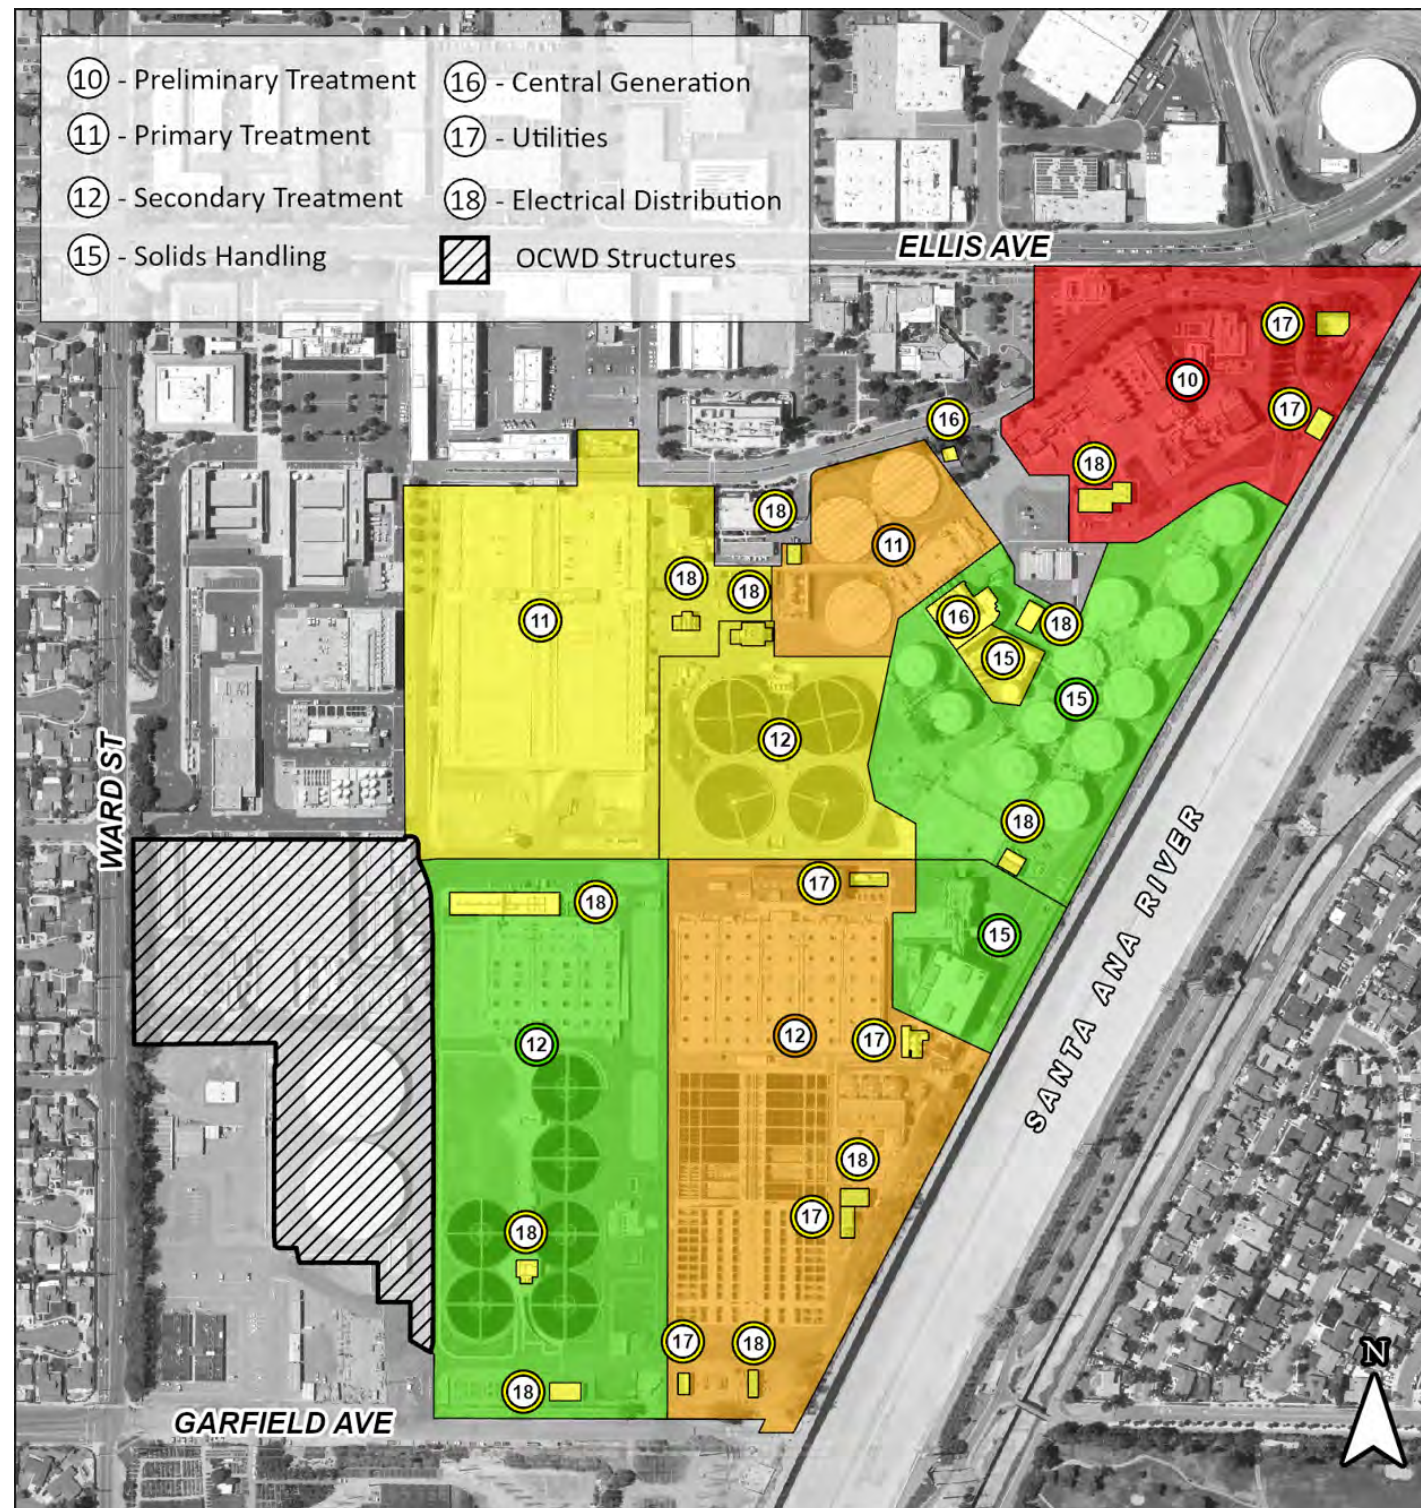
Figure ES-1-3. Plant No. 1 Process Area – Remaining Useful Life Score Map

The following system-level summary tables and condition score maps provide a high-level overview of the Area Asset Management (AM) Summaries contained in Section 2. The system-level summaries are organized as follows:

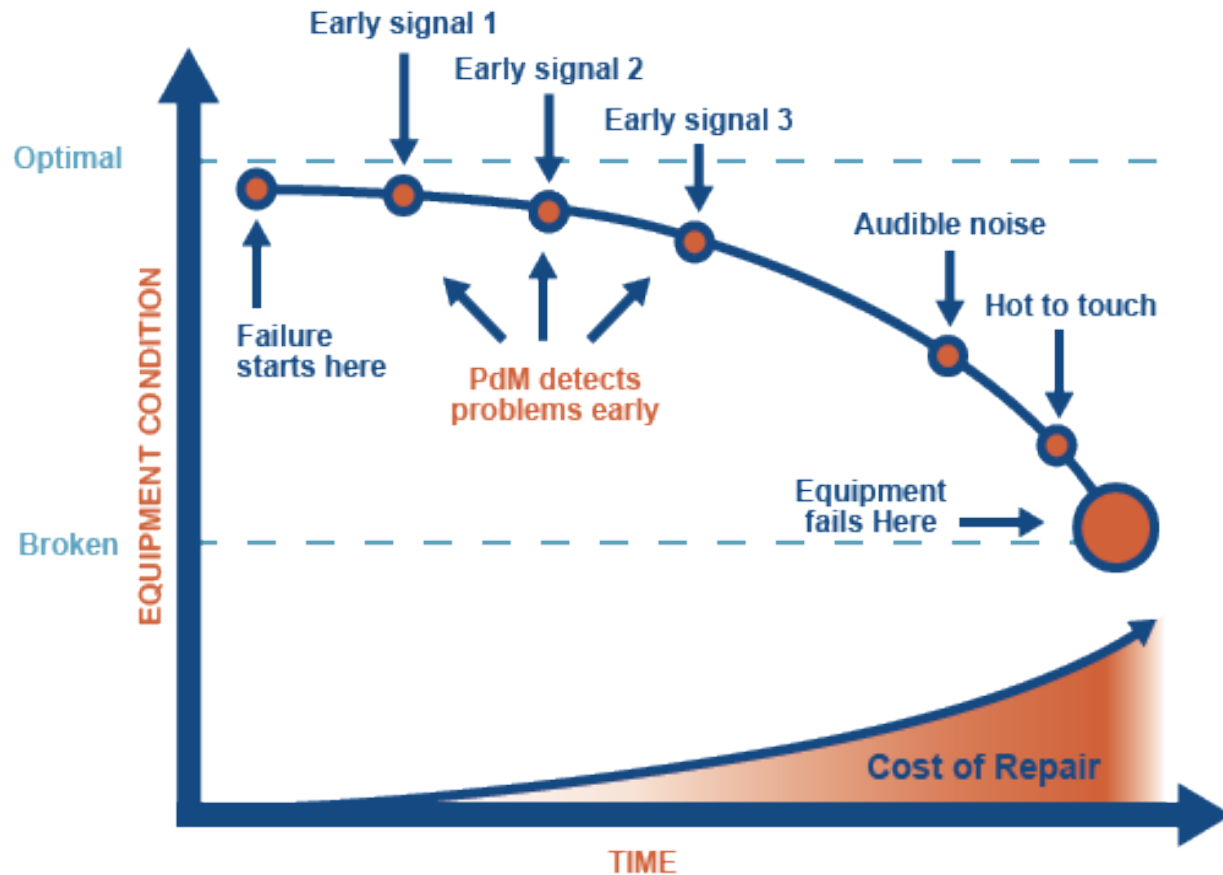
Figure 1-4. PdM Summary

In asset management, Predictive Maintenance (PdM) strategies are used to regularly monitor the condition of assets. OC San’s Maintenance Reliability Group implements the PdM Program, which collects data through condition monitoring, enabling the real-time performance of assets. The premise of PdM is a proactive approach that minimizes unexpected breakdowns, reduces repair cost, extends the Mean Time Between Failure (MTBF), monitors the actual equipment health through quantifiable means, and performs advanced analysis and failure detection (Figure 1-4). In addition, when sudden changes or variations in the process manifest, they are often found during the regular Maintenance Reliability rounds as part of the group’s everyday work. The ability to monitor equipment lends itself to helping Maintenance optimize intervals

between corrective repairs, minimizing the number and cost of unscheduled repairs created by machine-train failures, improving the overall equipment reliability, and assisting the Asset Management Group with accurately determining an asset's RUL.

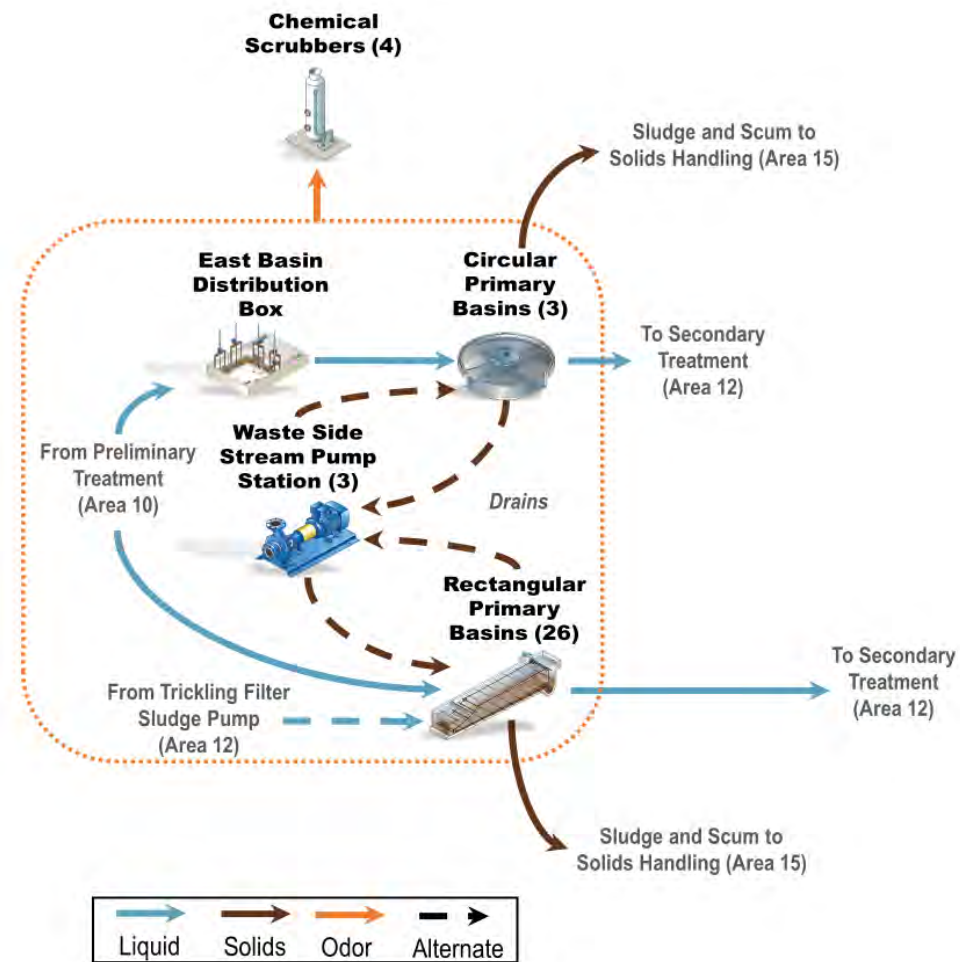
### Process Schematic

Note: Primary Basins No. 1 and No. 2 are not shown. The facilities are available for emergency capacity during high flows and are scheduled to be demolished within the next 10 years.

Key Issues	Actions and Recommendations
<ul style="list-style-type: none"> <li>• <b>Rectangular Primary Basins 6–31</b> – The rectangular primary basins experience relatively frequent issues with mechanical part replacement and sludge pumping systems that require maintenance. These issues require ongoing attention from Maintenance and can affect Plant No. 1's treatment capacity.</li> </ul>	<ul style="list-style-type: none"> <li>• Project P1-133 is planned to address rectangular primary basin reliability and replace launders in the PISB and sludge pumps for primary basins 17–31, and improve the lighting in the area.</li> <li>• X-017 is the future project that will rehabilitate the basins and improve the scum removal system.</li> <li>• Inspecting some areas such as center/influent feed channels remains a challenge. Operation and maintenance need to perform regular preventive maintenance on scum pits and pumps to prevent scum accumulation in the basins, especially during times when capacity is reduced by construction.</li> </ul>

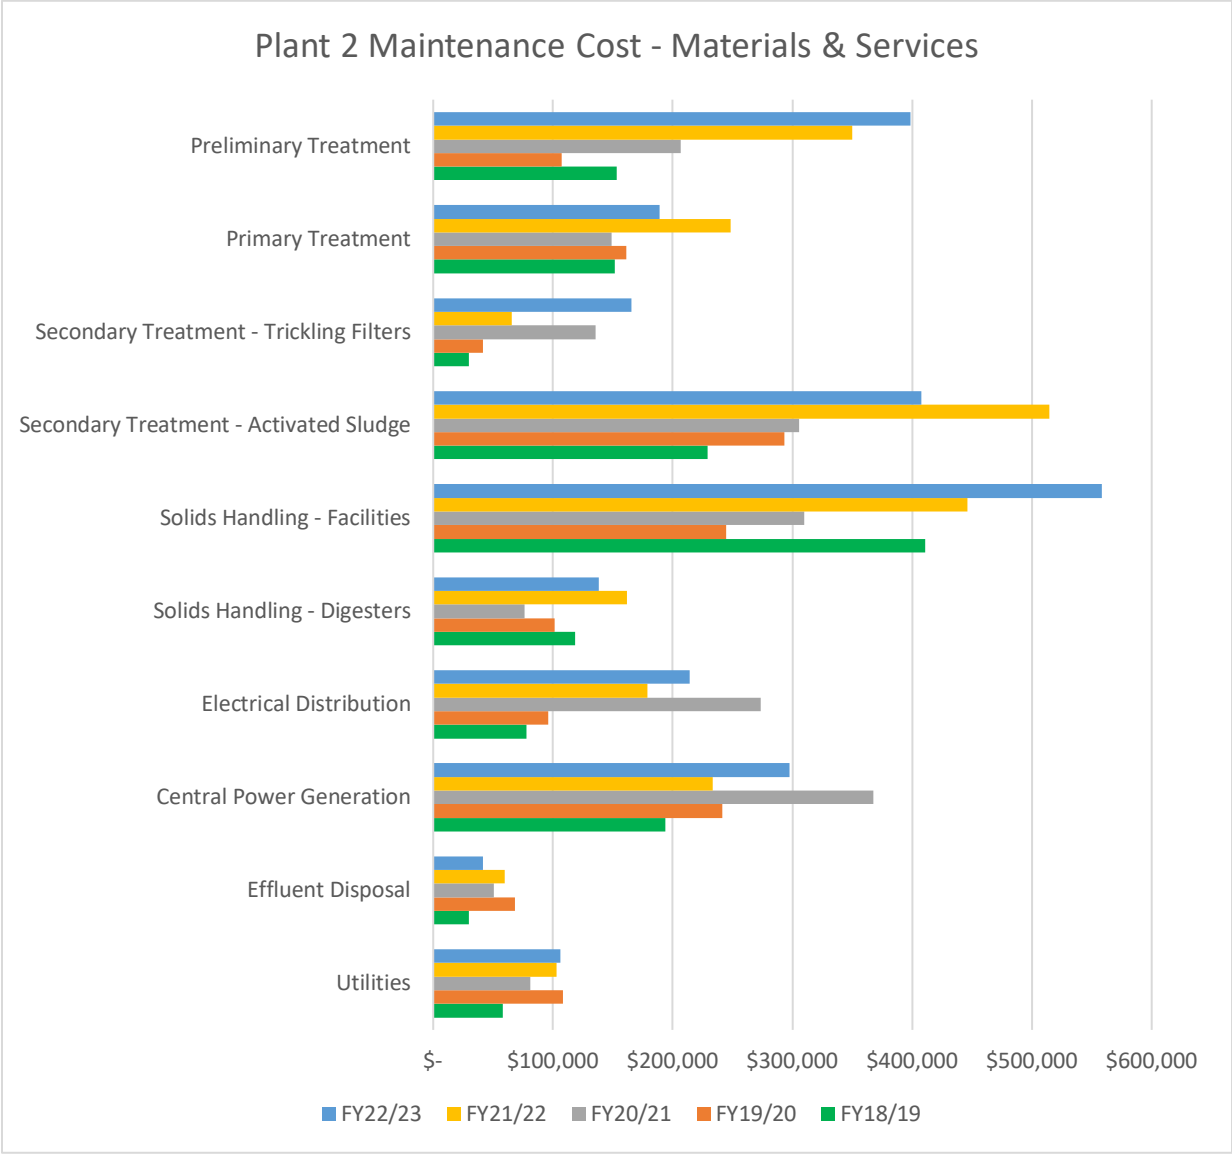
**Figure 3-5. Graph of Maintenance Costs (Materials and Services) at Plant No. 2**

Figures 3-5 and 3-6 show maintenance costs (materials and services) and labor hour per FY broken down by process area at Plant No. 2. The maintenance cost at Plant No. 2 were higher for FY 2022–2023 for the solids handling facility due to overhaul of the hydraulic power unit for the truck loading facility and other maintenance activities in the area. At Cen Gen, the air compressor overhaul, Engine 3 repairs, and auxiliary heat exchanger repairs were contributing to higher material and services costs in the past year. Repair of the failed bar screen rake at the headworks and biotower flow transmitter repairs were among the costliest and labor-intensive repairs at preliminary treatment facilities at Plant No. 2. Overall, the labor hour graph follows the trend in material and services.

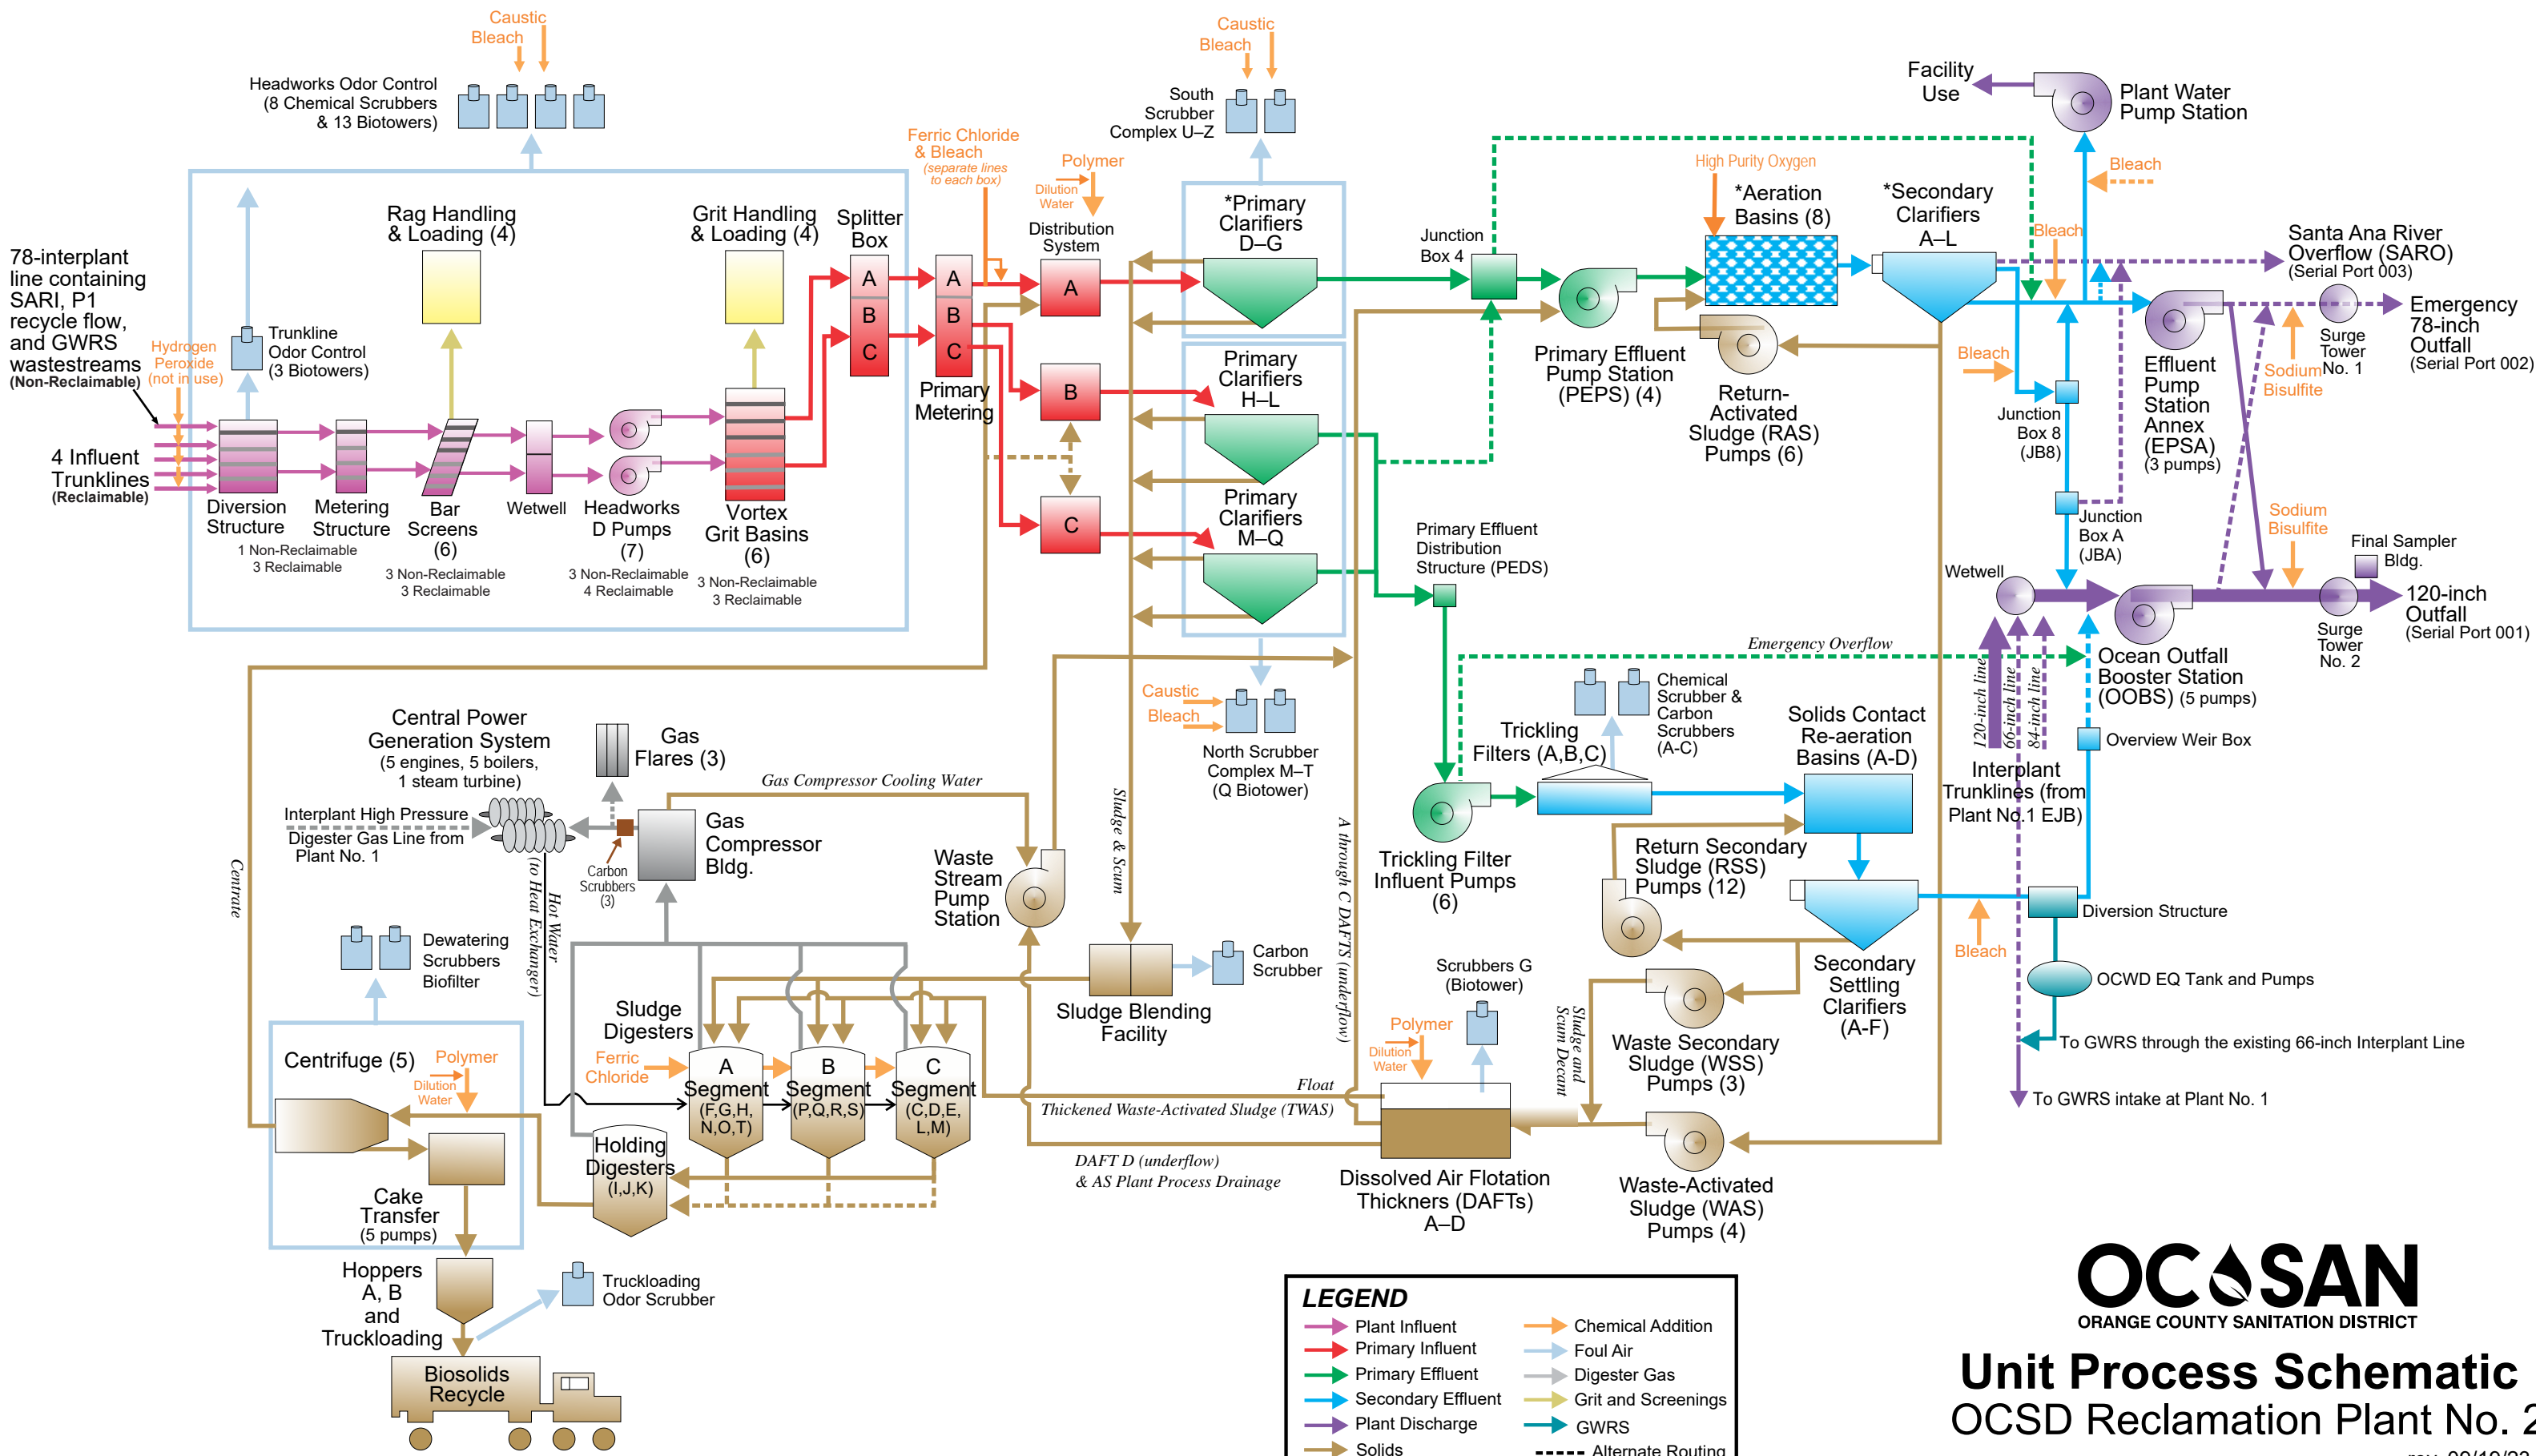
Appendix D  
Plant No. 2 Process Diagram – After GWRS  
Expansion

# Unit Process Schematic — OC San Treatment Plant No. 2
