Seismic Evaluation of Structures at Plant Nos. 1 and 2

Project PS15-06

Kathy Millea, Director of Engineering
Operations Committee

May 6, 2020

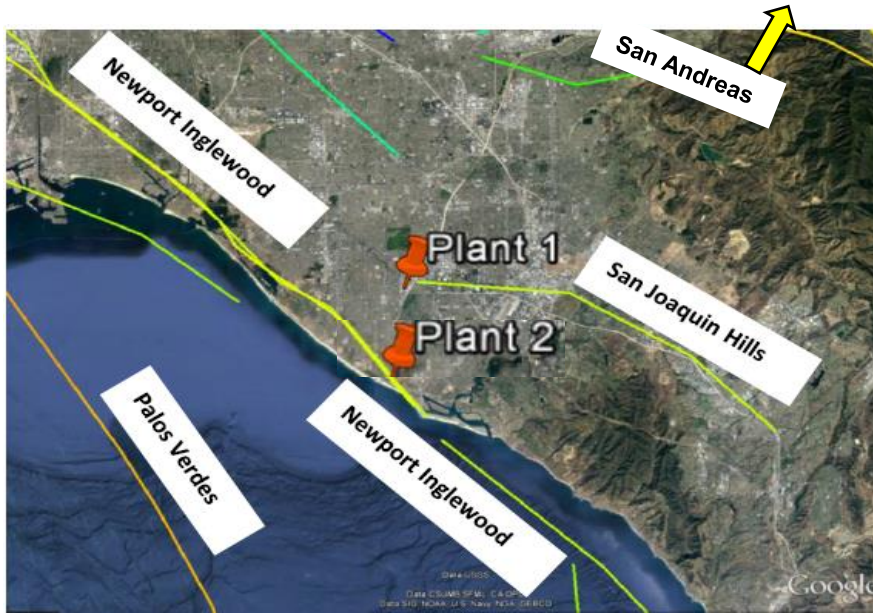
Several Local Faults Impact Seismic Hazards

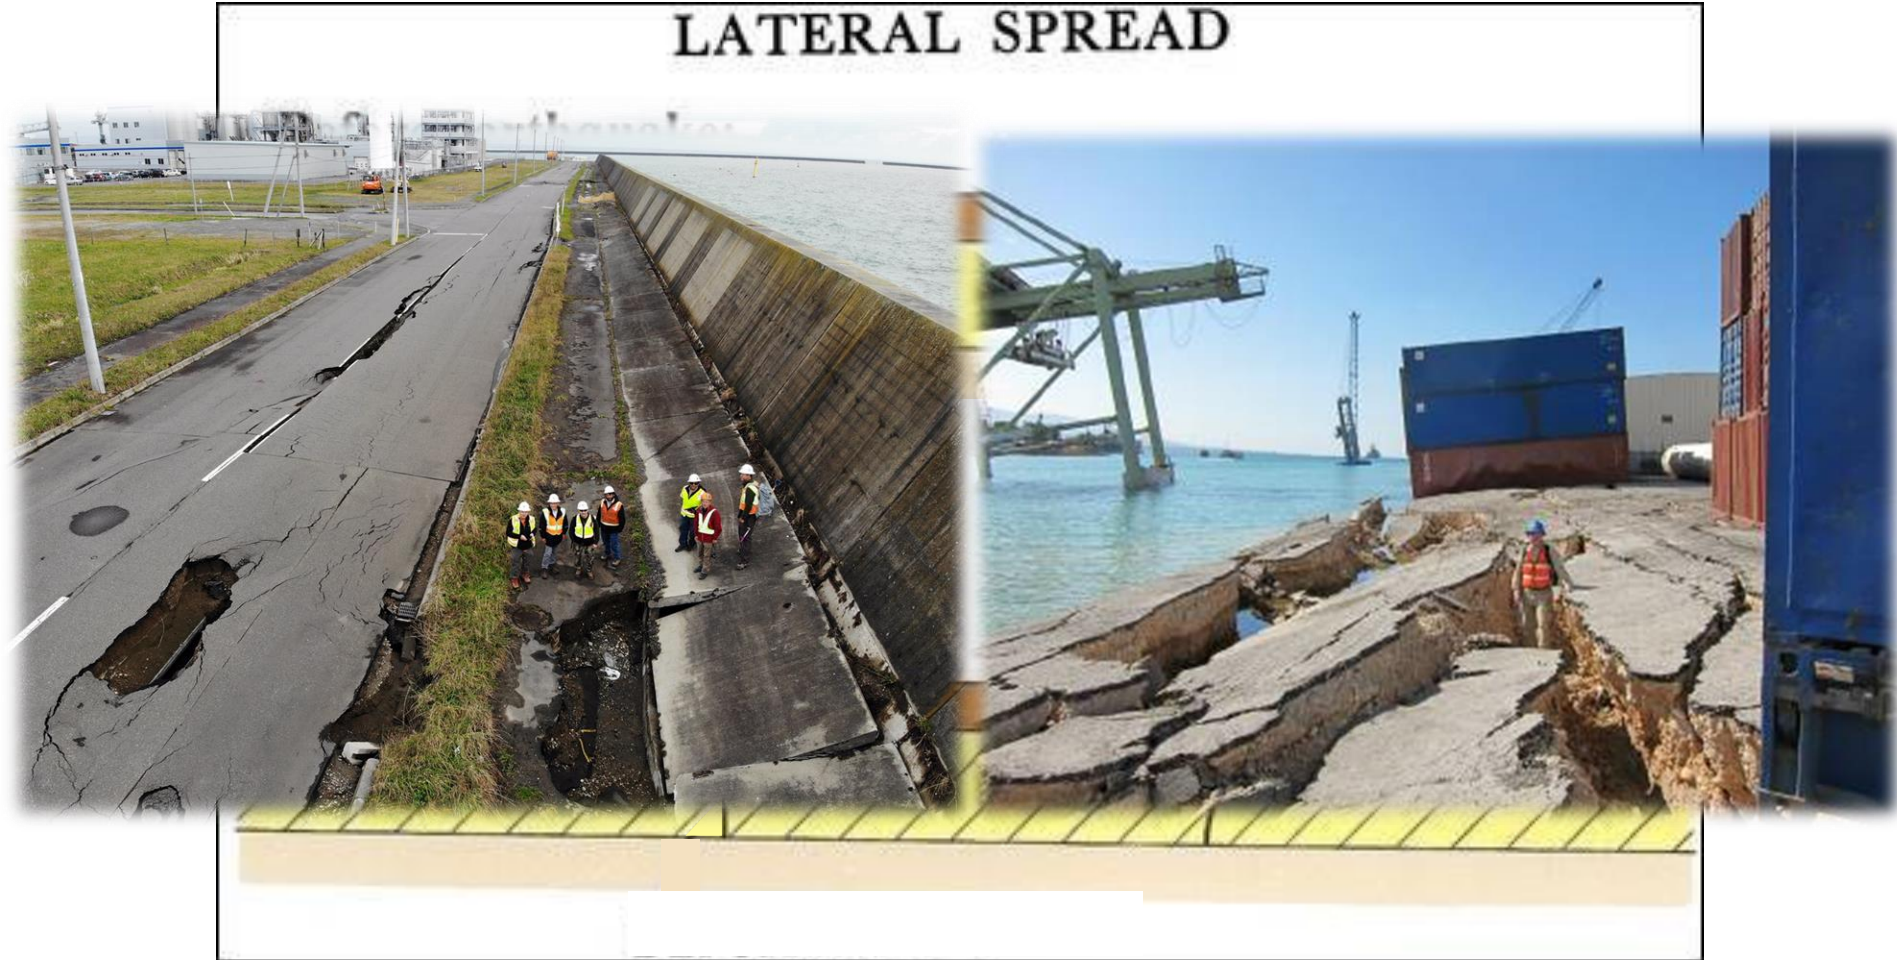
LATERAL SPREAD

Lateral Spread a Risk

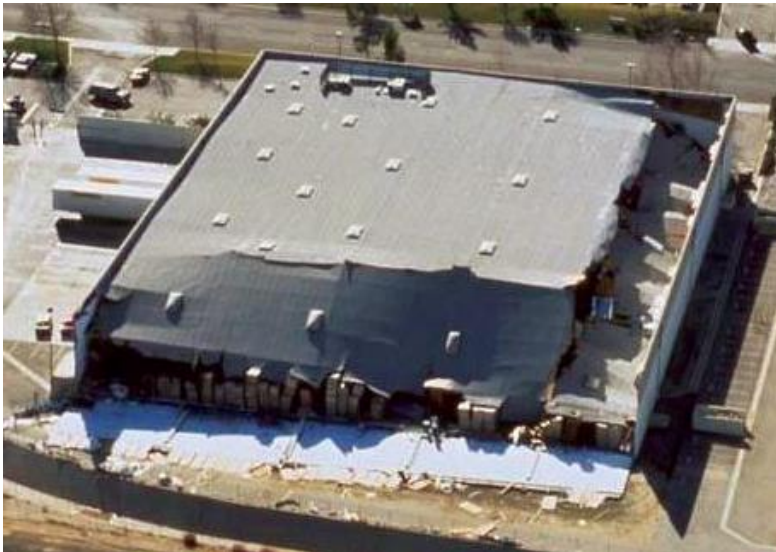
Ref: 1994 Northridge Earthquake. EERI, Earthquake Engineering Research Institute

Vulnerability

Separation of the roof element from the wall caused roof to collapse

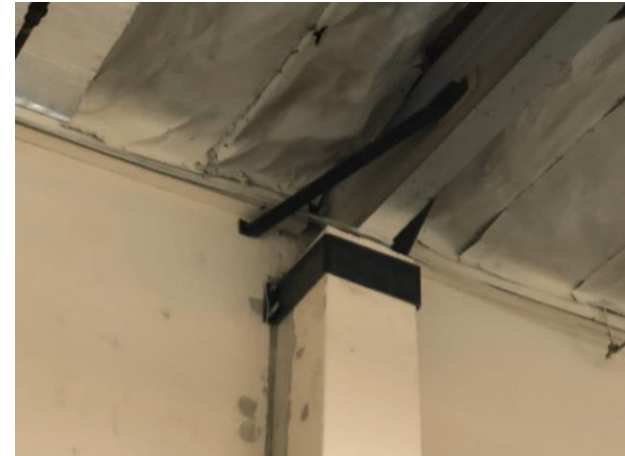
Mitigation

Installation of wall anchorage

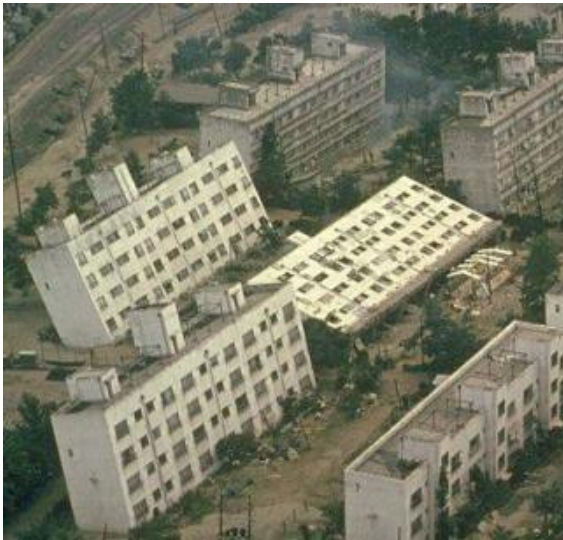
Niigata Japan, June 16, 1964
Photo Credit: National Geophysical Data Center

Vulnerability

Soils became liquified during a seismic event, reducing the ground's ability to support loads

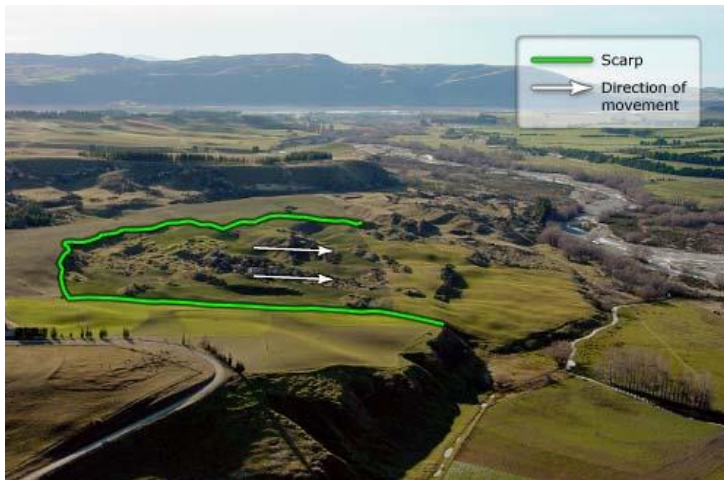
Vulnerability

Seismic event causes soil to move laterally towards a free surface of lower elevation (river bed)

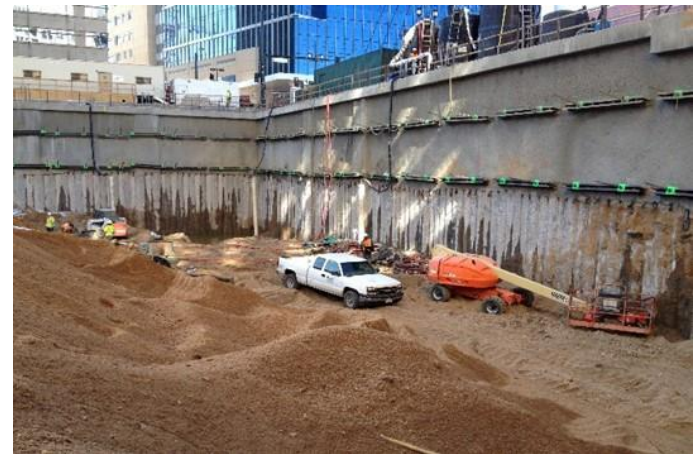
Mitigation

Installation of closely spaced piles effectively creates a “wall” that is designed to resist lateral soil movement
